TOURTELOT CLEANUP PROJECT

TOURTELOT PROJECT ANNUAL INSPECTION AND REPORT FORM

Benicia, California

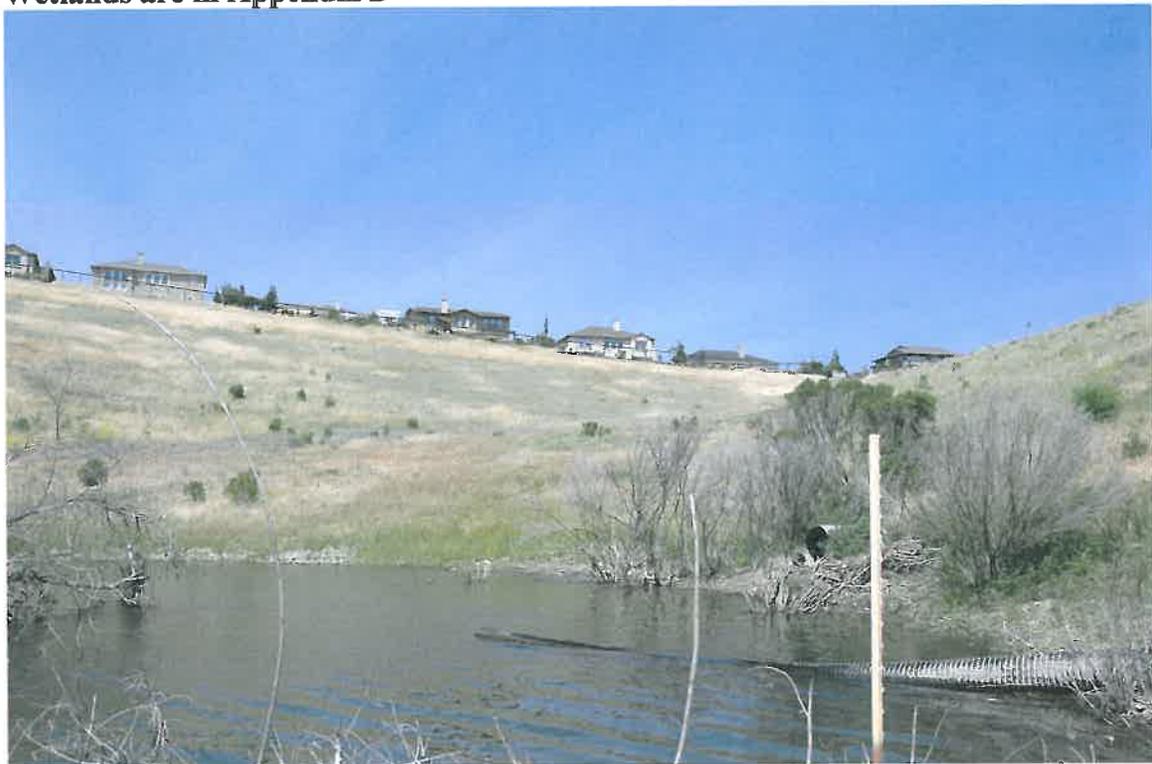
Area I – Station S16 | Photo access limited by water height. Additional Photos of Wetlands are in Appendix D

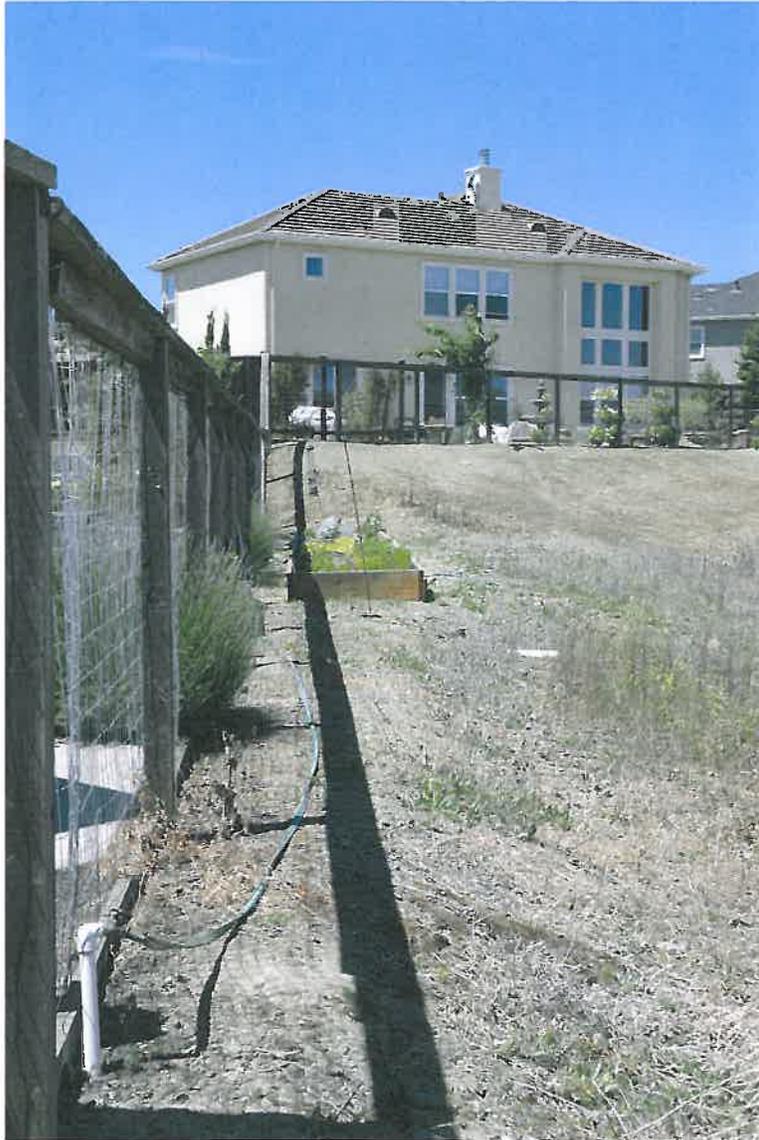
Two encroachments were found in Parcel 083-210-180. One encroachment was found in Parcel 083-210-240 and existing encroachments were found in Parcel 083-210-260. All of the encroachments have been photographed and included in Appendix B.

The sizes of the encroachments range from small raised bed planters (5'x8'), to pavers running the length of the property line.

**Encroachment 1
366 Silas Ct. | Small raised bed planter garden**

Notices will be sent to all of the homeowners with encroachments into the Open Space.

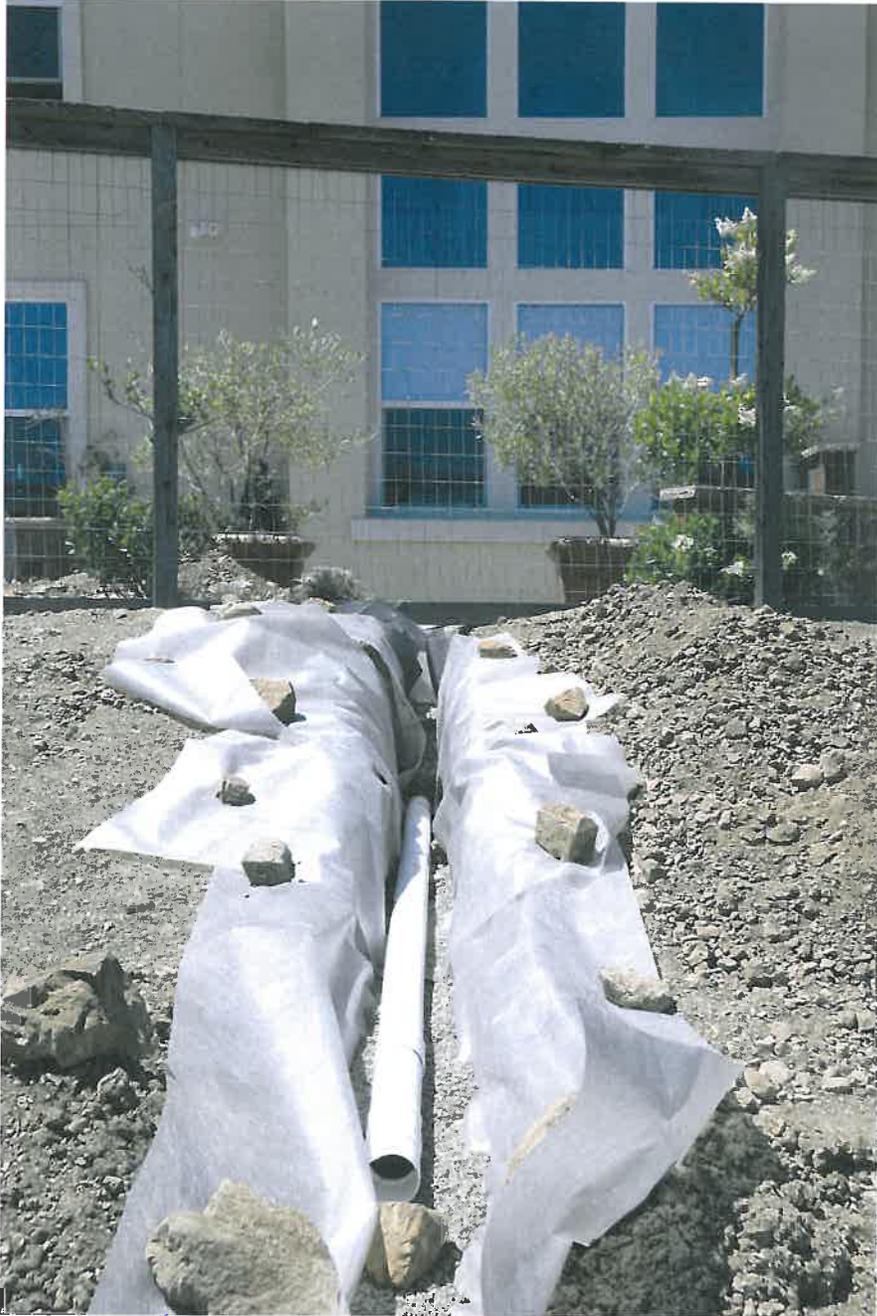
Unauthorized trenching in Parcel 083-210-180. The source of the trenching appears to be coming from 383 Wool Ct. A photograph is included in Appendix B.

A trench 12 inches deep, 12 inches wide and 10 feet long.

**Encroachment 2
383 Wool Ct. | Drainage construction within Open Space Restricted Area**

The trenching activity shown here is in violation of Title 12, Chapter 12.12.020 of the Benicia Municipal Code.

A Stop Work Order was issued by the Building Inspector on June 1, 2012. The homeowner has been advised that no digging can take place in the Open Space Restricted Area. The homeowner has been instructed to call the City when all of the unauthorized pipe is removed and the trench backfilled and returned to normal.

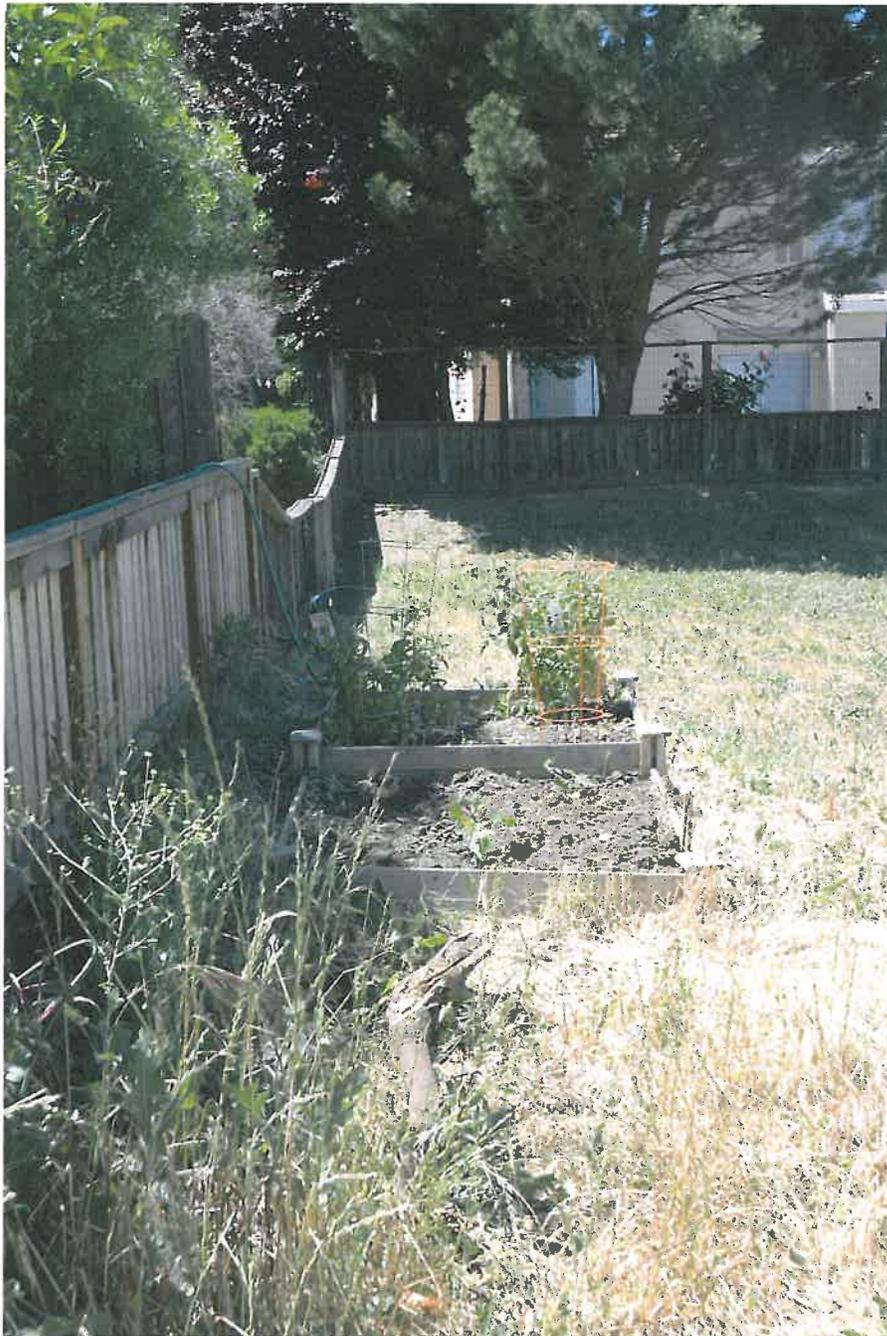
**Encroachment 3
476 Casey Ct. | Raised bed garden in the Open Space**

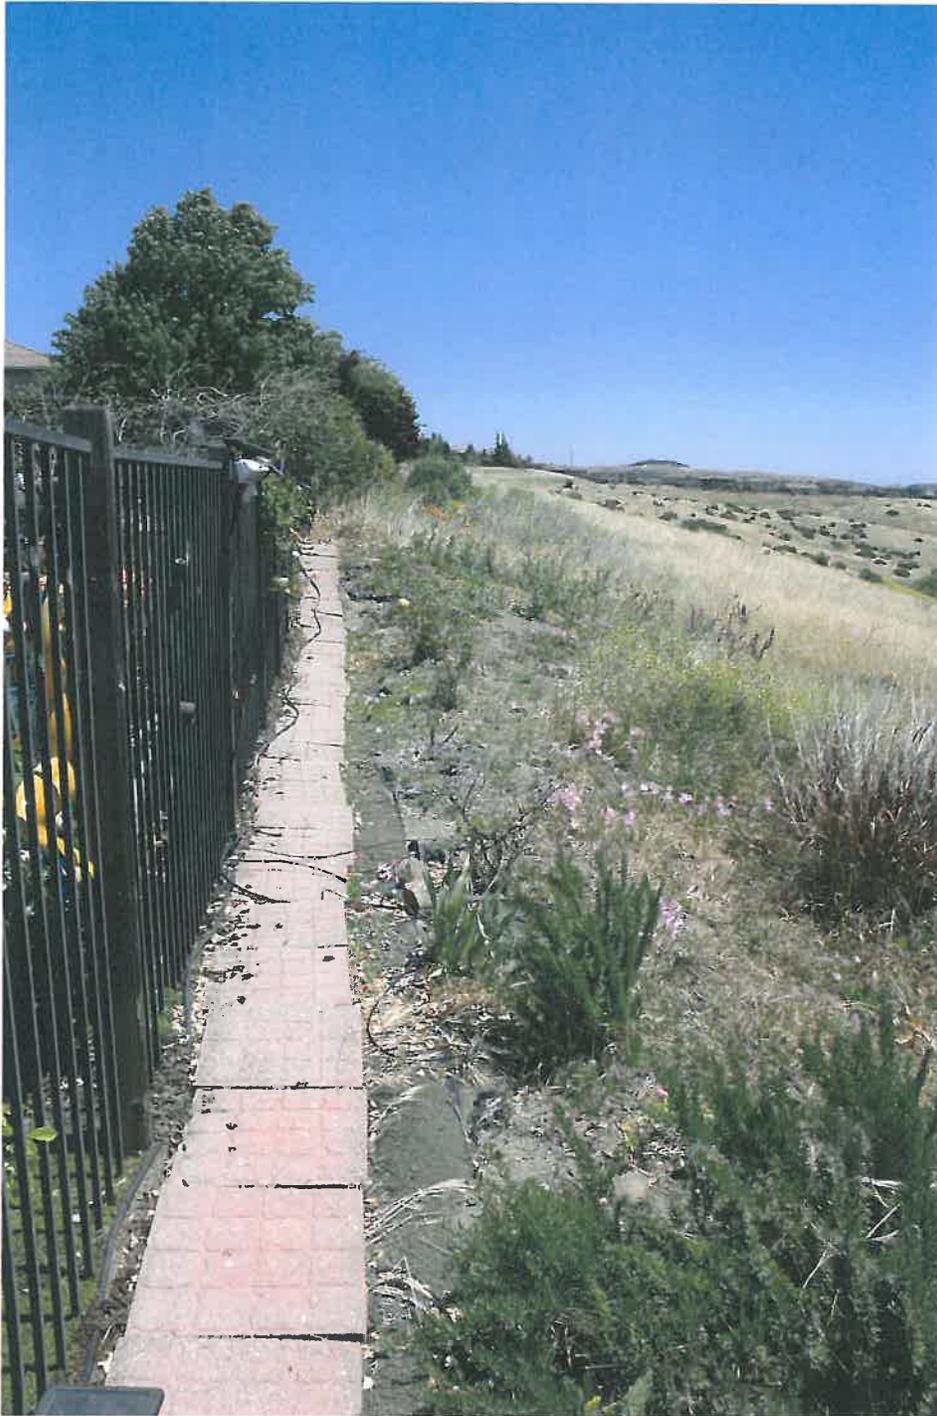
603 Kearny St. | 2011 survey showed pavers lifted up. 2012 shows pavers replaced.

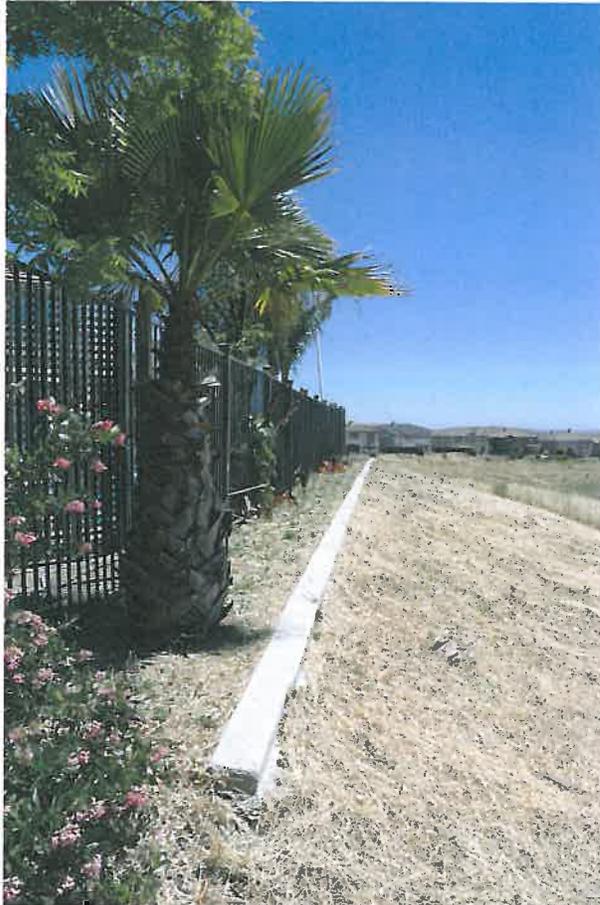
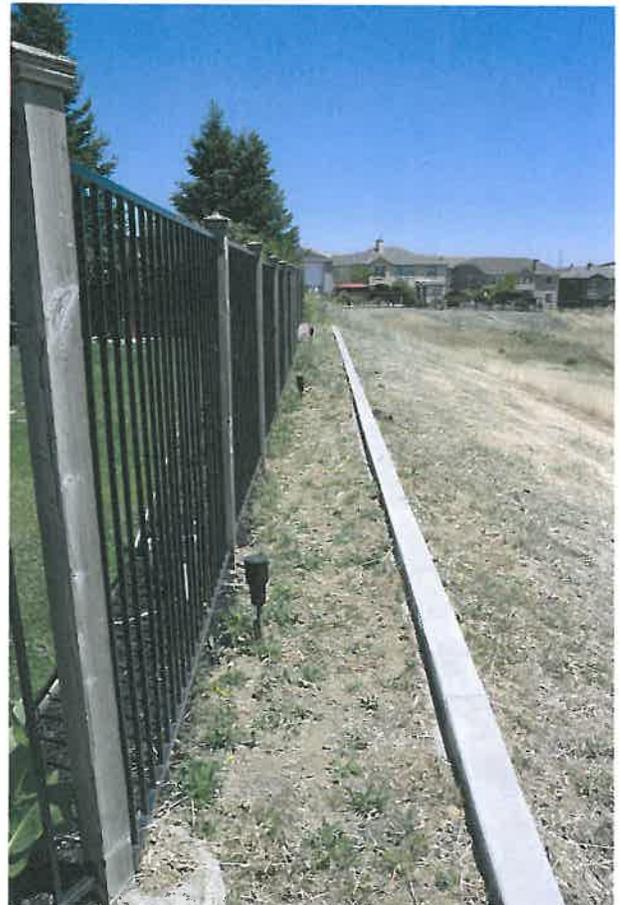
699 Andrew Ct. | Concrete curb (first reported during the 2009 survey)

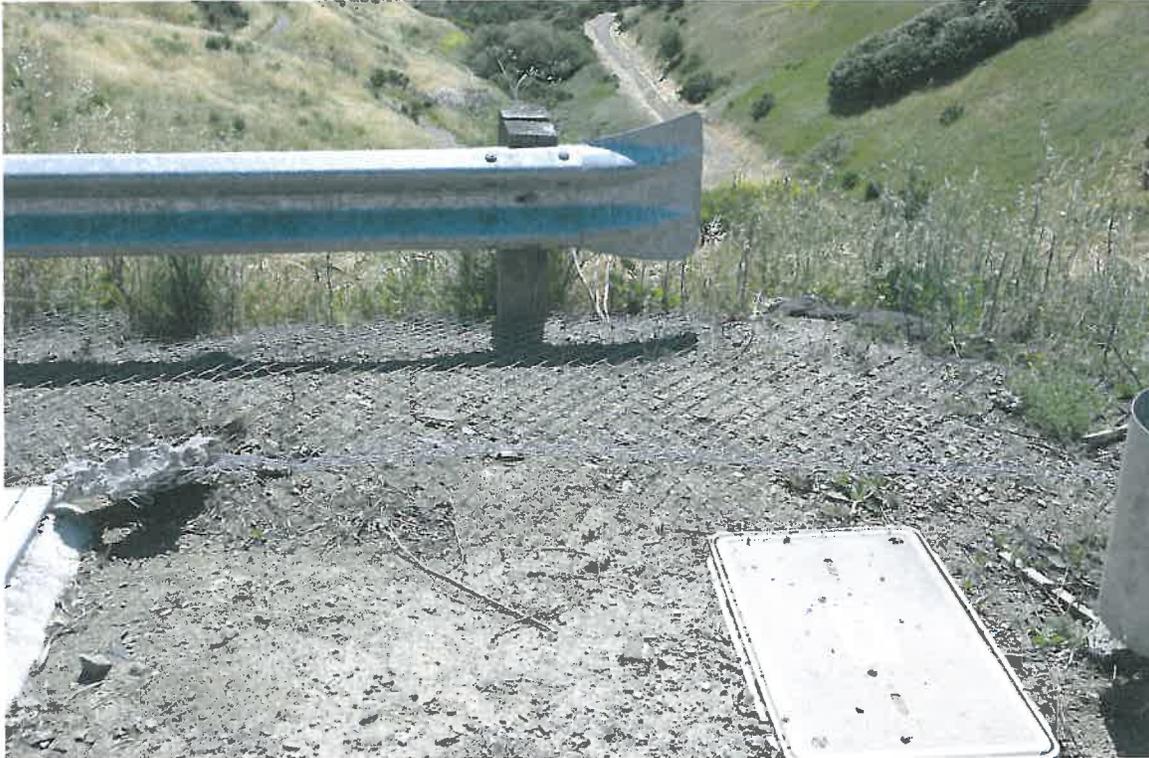
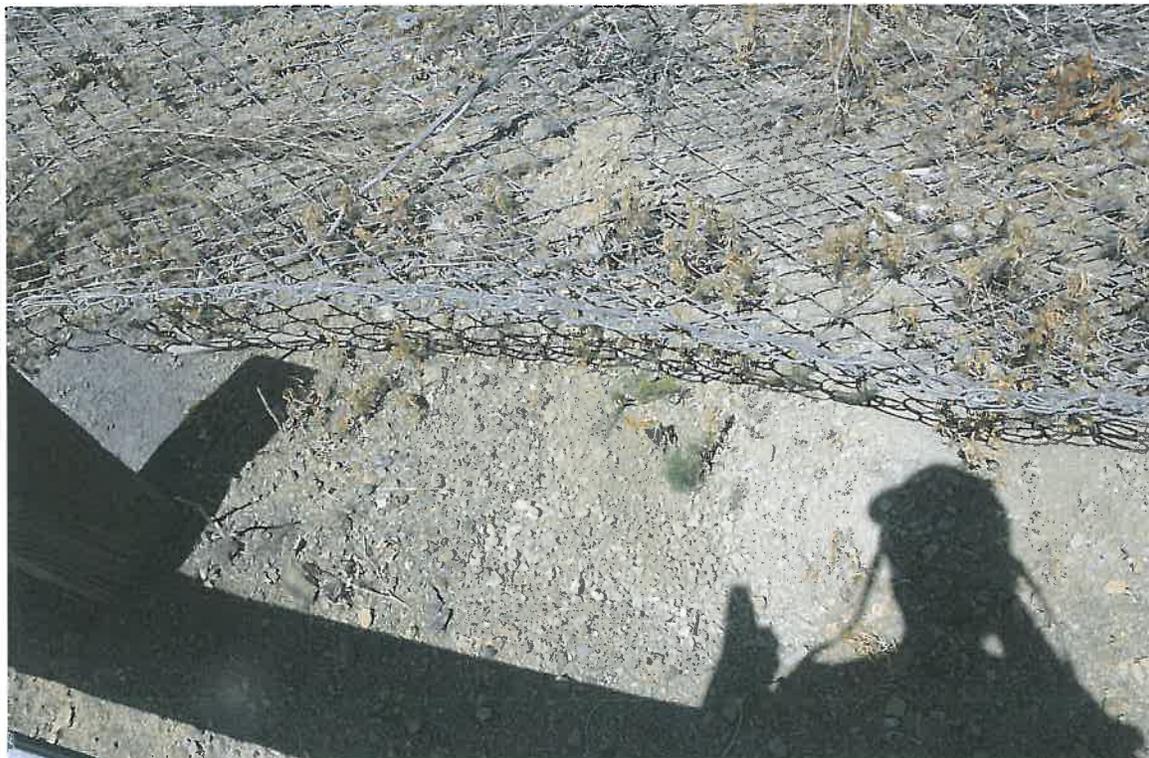
As mentioned above, the current conditions are similar to conditions found over the last six years. The photos included are representative of the lifting that has occurred along McAllister Drive. It is our recommendation that maintenance be performed in accordance with the O&M plan and the CAP (Contingency Action Plan) to re-pin the mesh barrier to the surface to prevent further “lifting” from the slope. The condition of the barrier on the western and eastern slopes is satisfactory and we do not recommend any maintenance in these areas. The ground cover is established and maintains the hold of the mesh barrier adequately on the slopes.

McAllister Drive | Photos are all from the Top-of-slope along the sidewalk.

It does not appear that anything has been done to repair the Land Bridge Mesh Barrier. It is the recommendation of the consultant that the Mesh Barrier be affixed at the top of slope locations along McAllister Drive.

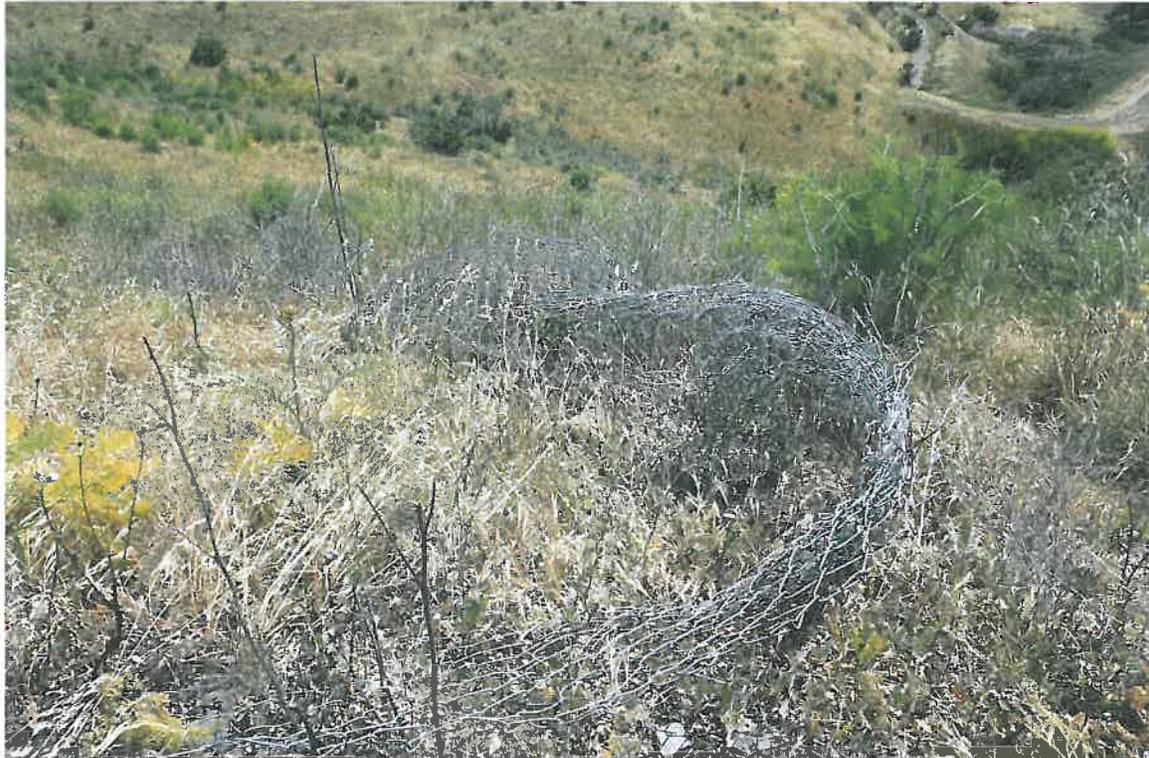
Isolated location on the eastern slope showing damage to the mesh barrier. This has remained unchanged for many years.

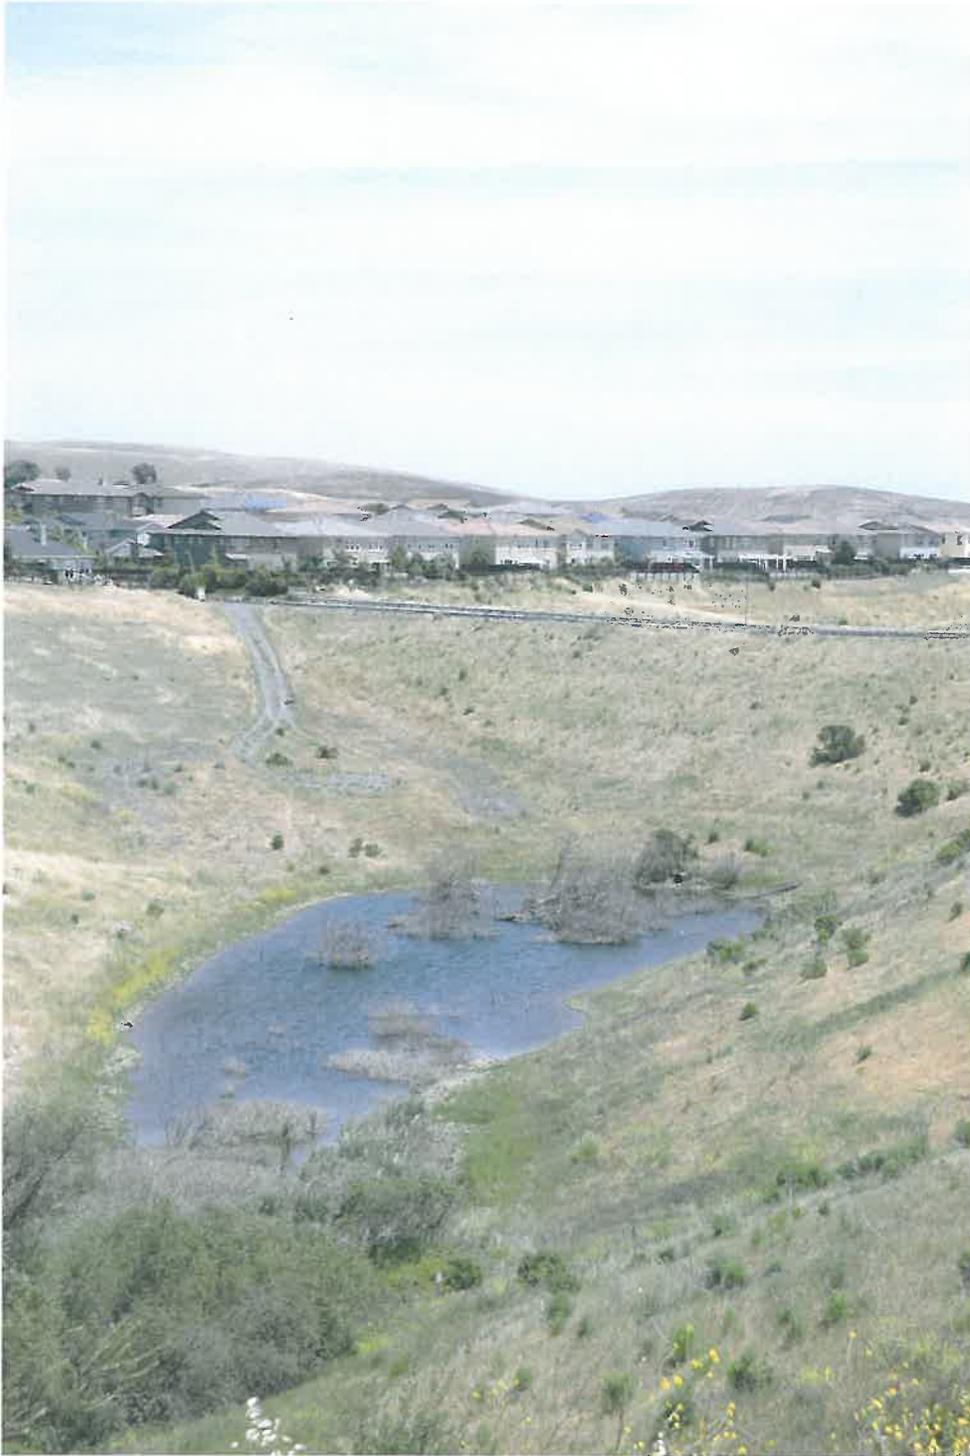
This year, conditions in the Wetlands Area were observed as being similar to that of last year. An established shoreline was noted and significant changes to the habitat were observed as well. Most of the trees in the Wetlands Area near the headwall and culvert at McAllister Drive have not survived from being submerged in water. The Thorny Plants appear to have suffered from this condition as well.

Wetlands Area | Prior to May maintenance.

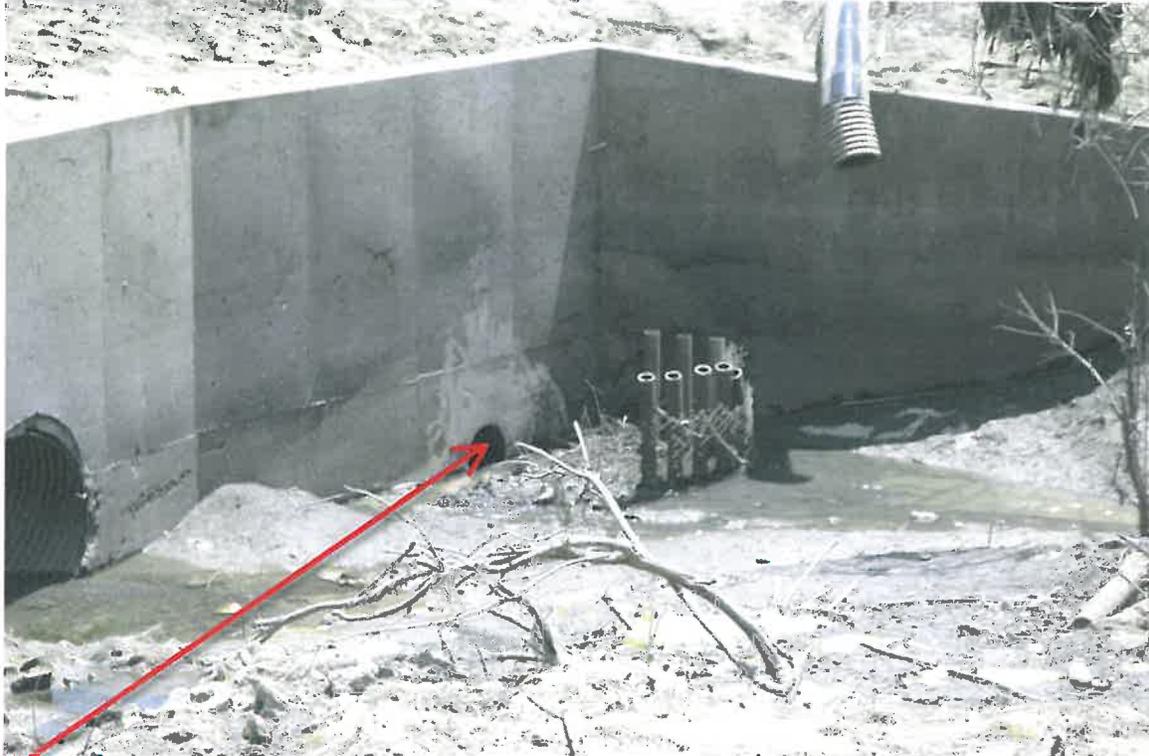
View of culvert that requires maintenance

18 inch culvert for outgoing flows. The 54 inch line is an inbound line into the Wetlands Area.

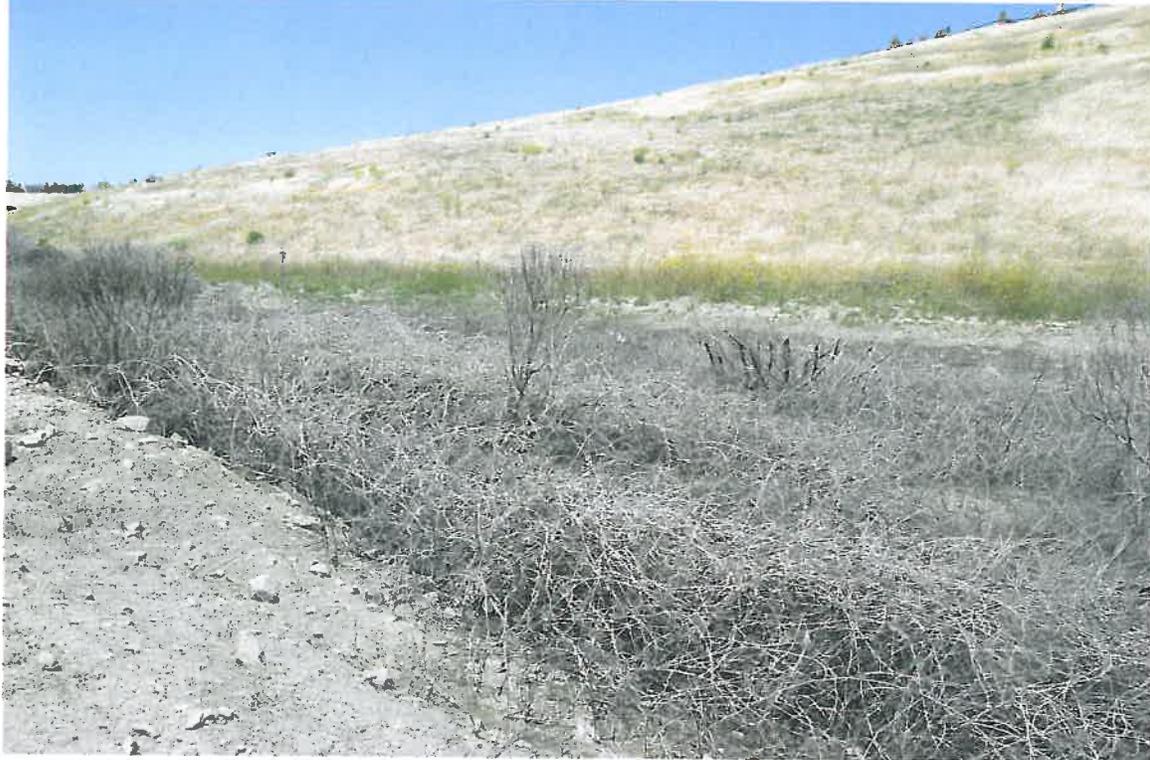
The thorny plants installed around the Wetlands Mitigation Area appear to have died off. It is the opinion of the consultant that the blockage at the culvert, caused the wetlands to flood and this flooding may be the cause for the thorny plants perishing. Photos of the thorny plants are included in Appendix D - Wetlands Area. There is a summary report included in the appendix.

Photo of the Thorny Plants in the Wetlands
