# TOURTELOT CLEANUP PROJECT

## TOURTELOT PROJECT ANNUAL INSPECTION AND REPORT FORM

Benicia, California

**Appendix A – Slope Stability and Erosion Areas  
Tourtelot Annual Inspection Report  
May 2013**

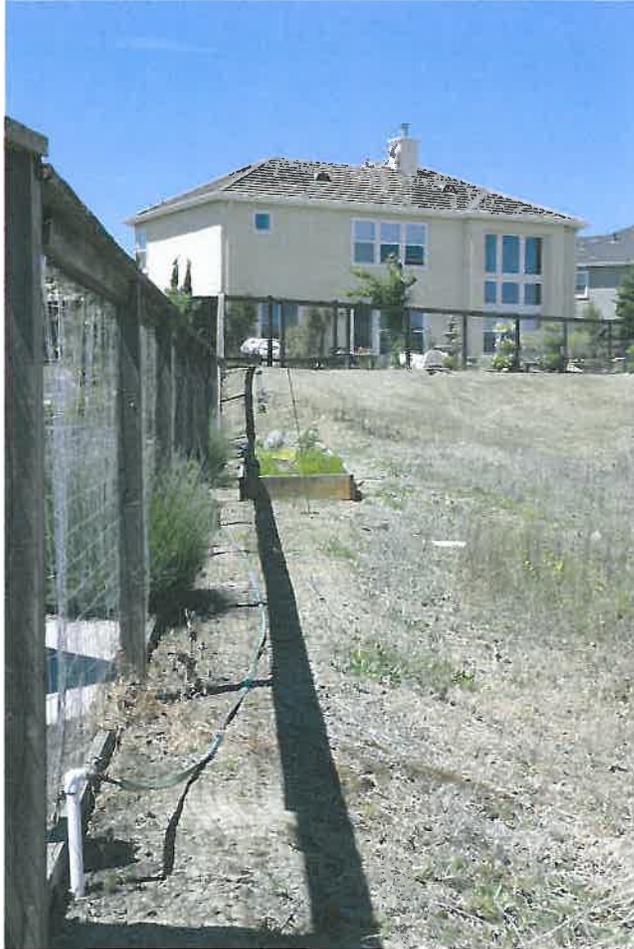
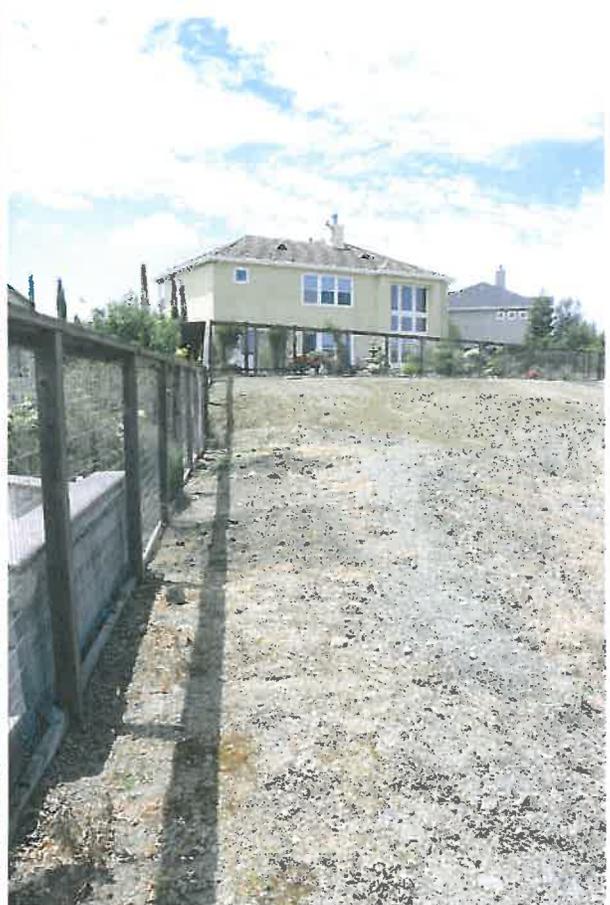
**Encroachment 1  
366 Silas Ct. | Small raised bed planter garden removed.**

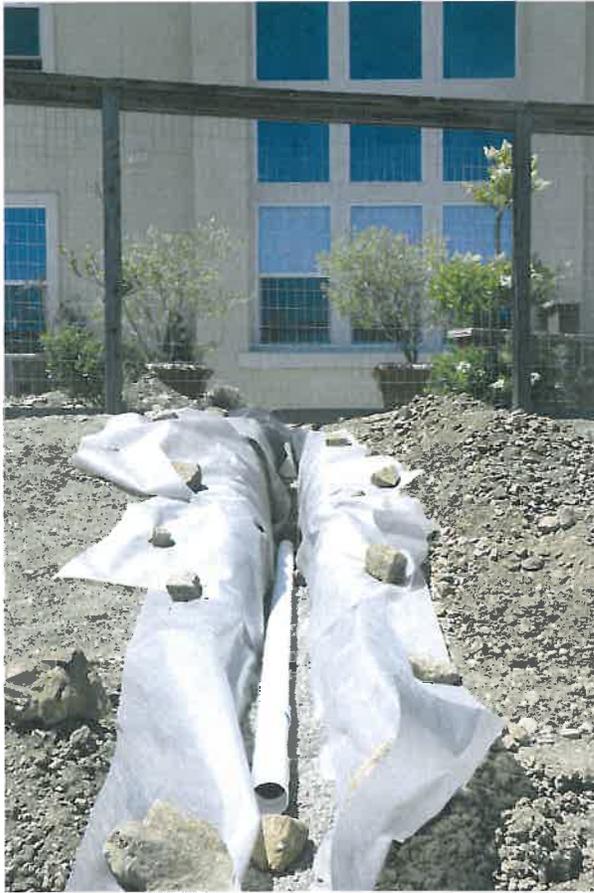
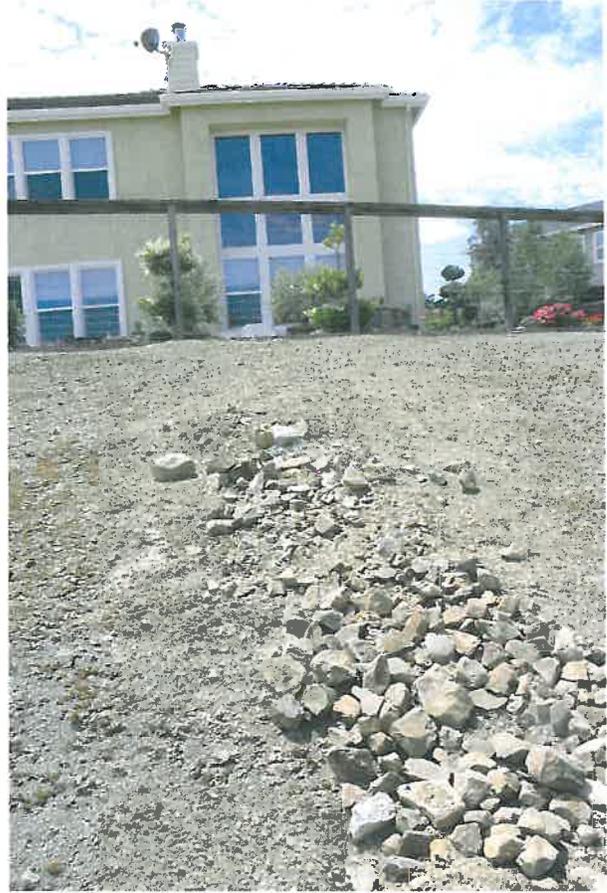
**Encroachment 2**

**383 Wool Ct. | Drainage construction within Open Space Restricted Area appears to have been capped and plugged with concrete.**

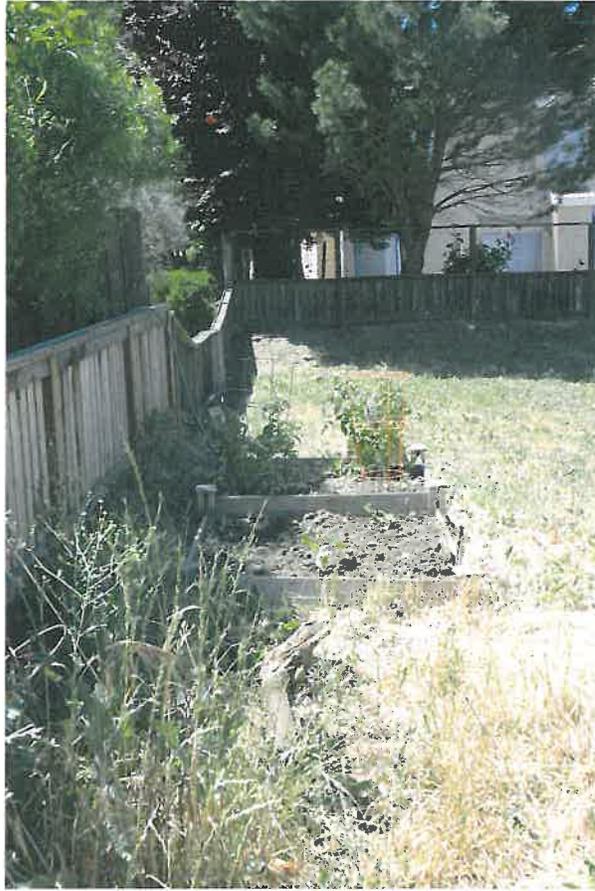
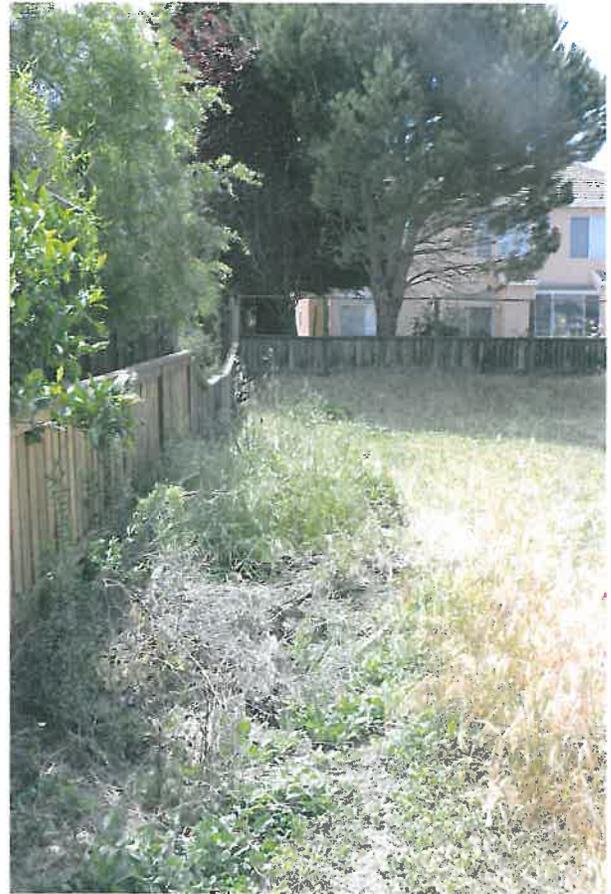
**Encroachment 3  
476 Casey Ct. | Raised bed garden in the Open Space removed**

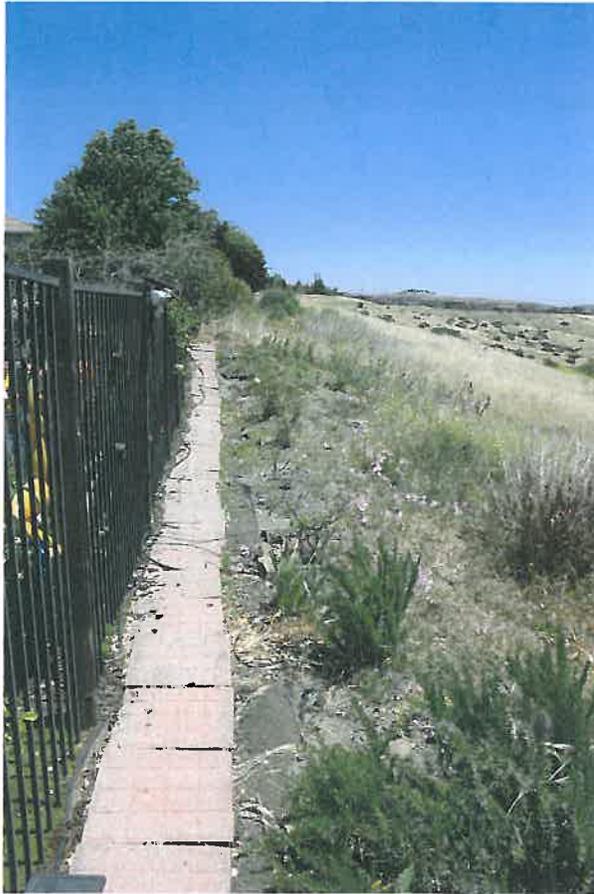
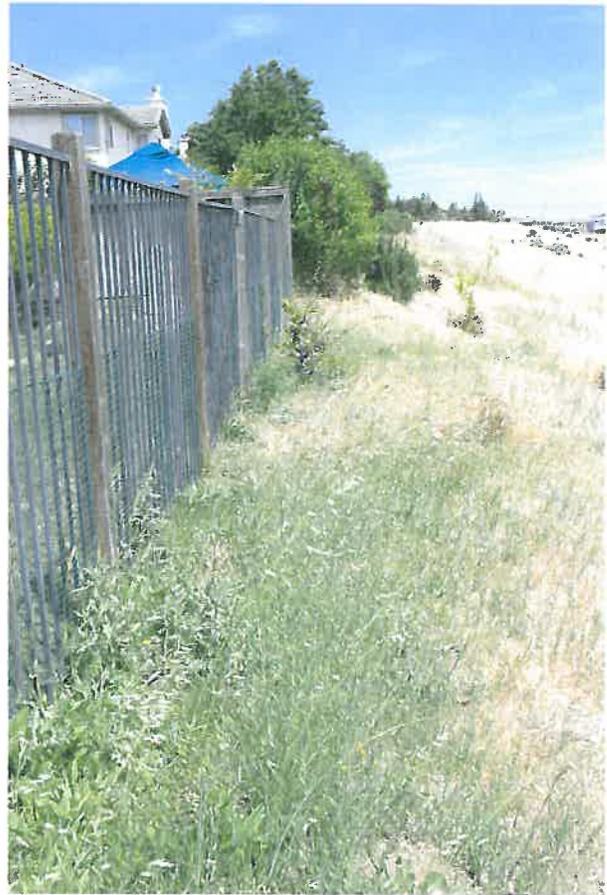
**603 Kearny St. | 2011 survey showed pavers lifted up. 2013 shows pavers removed.**

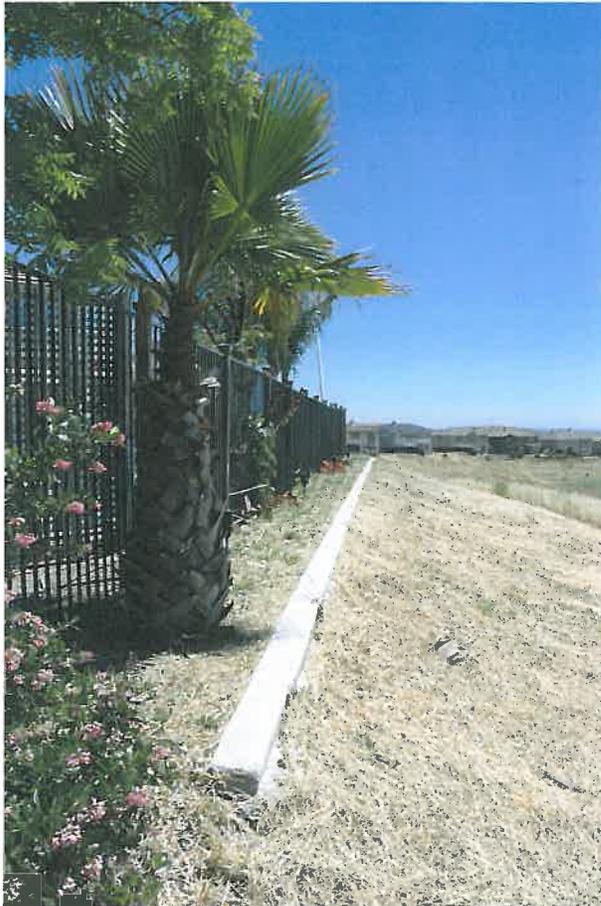
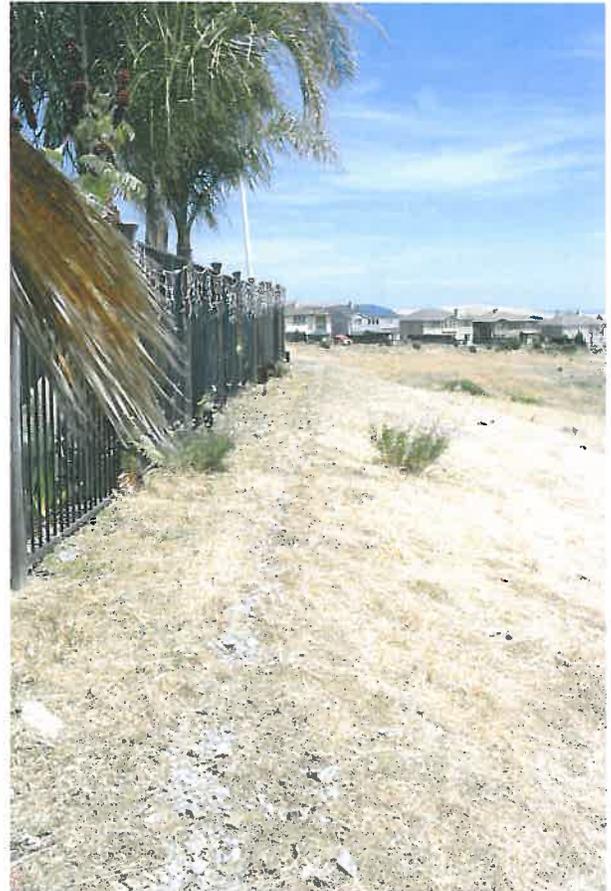
**Southwesterly Boundary**

**699 Andrew Ct. | Concrete curb removed (first reported during the 2009 survey)**

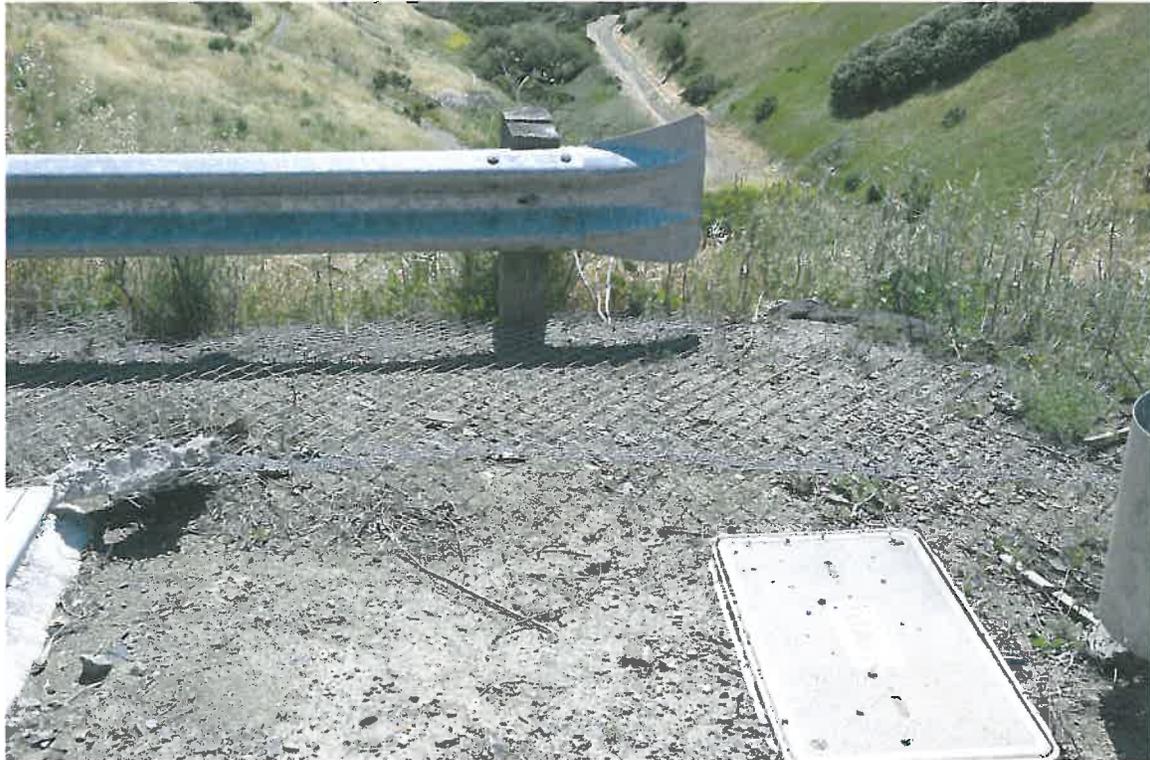
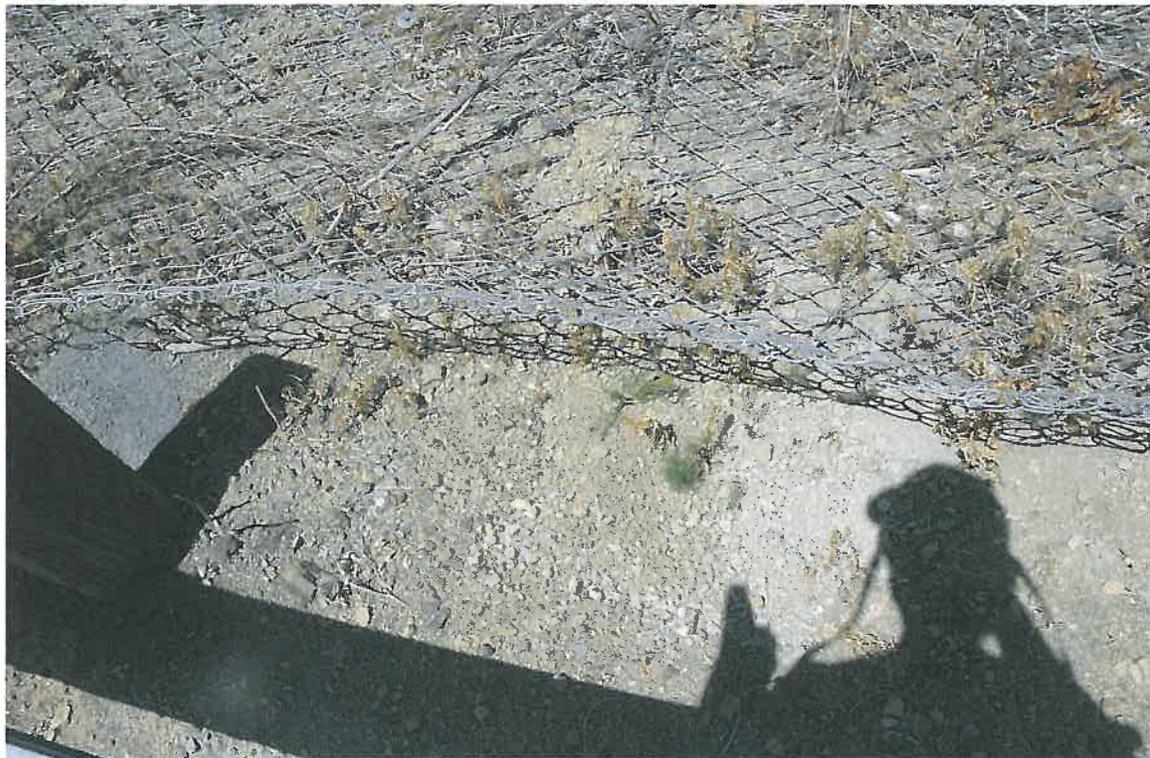
The Mesh Barrier is in the same condition as reported on in previous years. The Mesh Barrier has lifted along numerous edges at the top of slope on McAllister Drive. There are also areas on the slope that have lifted and need repair.

The barrier has been affected by the lifting of the pins that secure the barrier to the slope. The areas affected may need replacement because the mesh barrier is bent upwards.

The affected areas vary in size and shape. Some of the damage is along edges that run 2-3' in length. Other areas are sheets of mesh barrier approx. 5 foot square.

**McAllister Drive | Photos are all from the Top-of-slope along the sidewalk.**

As noted in previous years, it is the recommendation of the consultant that repairs be made to the mesh barrier. The City has informed the consultant that repairs are being planned and the City is awaiting construction support.

As mentioned above, the current conditions are similar to conditions found over the last six years. The photos included are representative of the lifting that has occurred along McAllister Drive. It is our recommendation that maintenance be performed in accordance with the O&M plan and the CAP (Contingency Action Plan) to re-pin the mesh barrier to the surface to prevent further “lifting” from the slope. The condition of the barrier on the western and eastern slopes is satisfactory and we do not recommend any maintenance in these areas. The ground cover is established and maintains the hold of the mesh barrier adequately on the slopes.

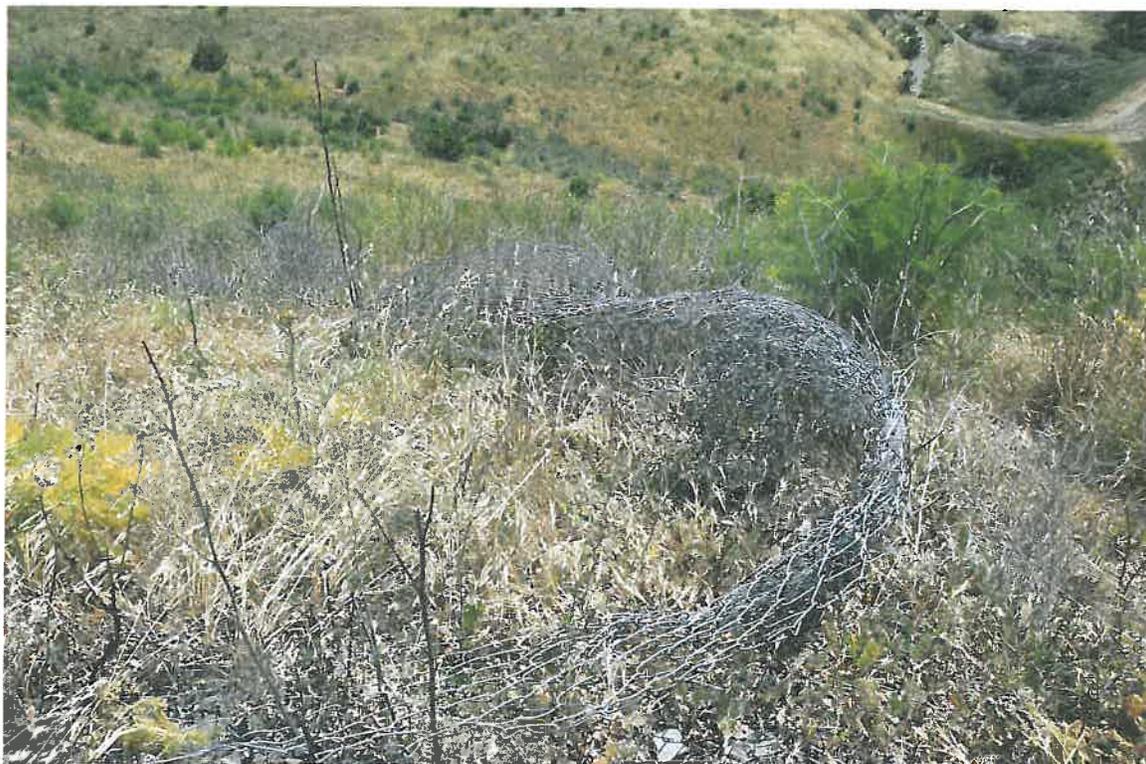
**Isolated location on the eastern slope showing damage to the mesh barrier. This has remained unchanged for many years.**

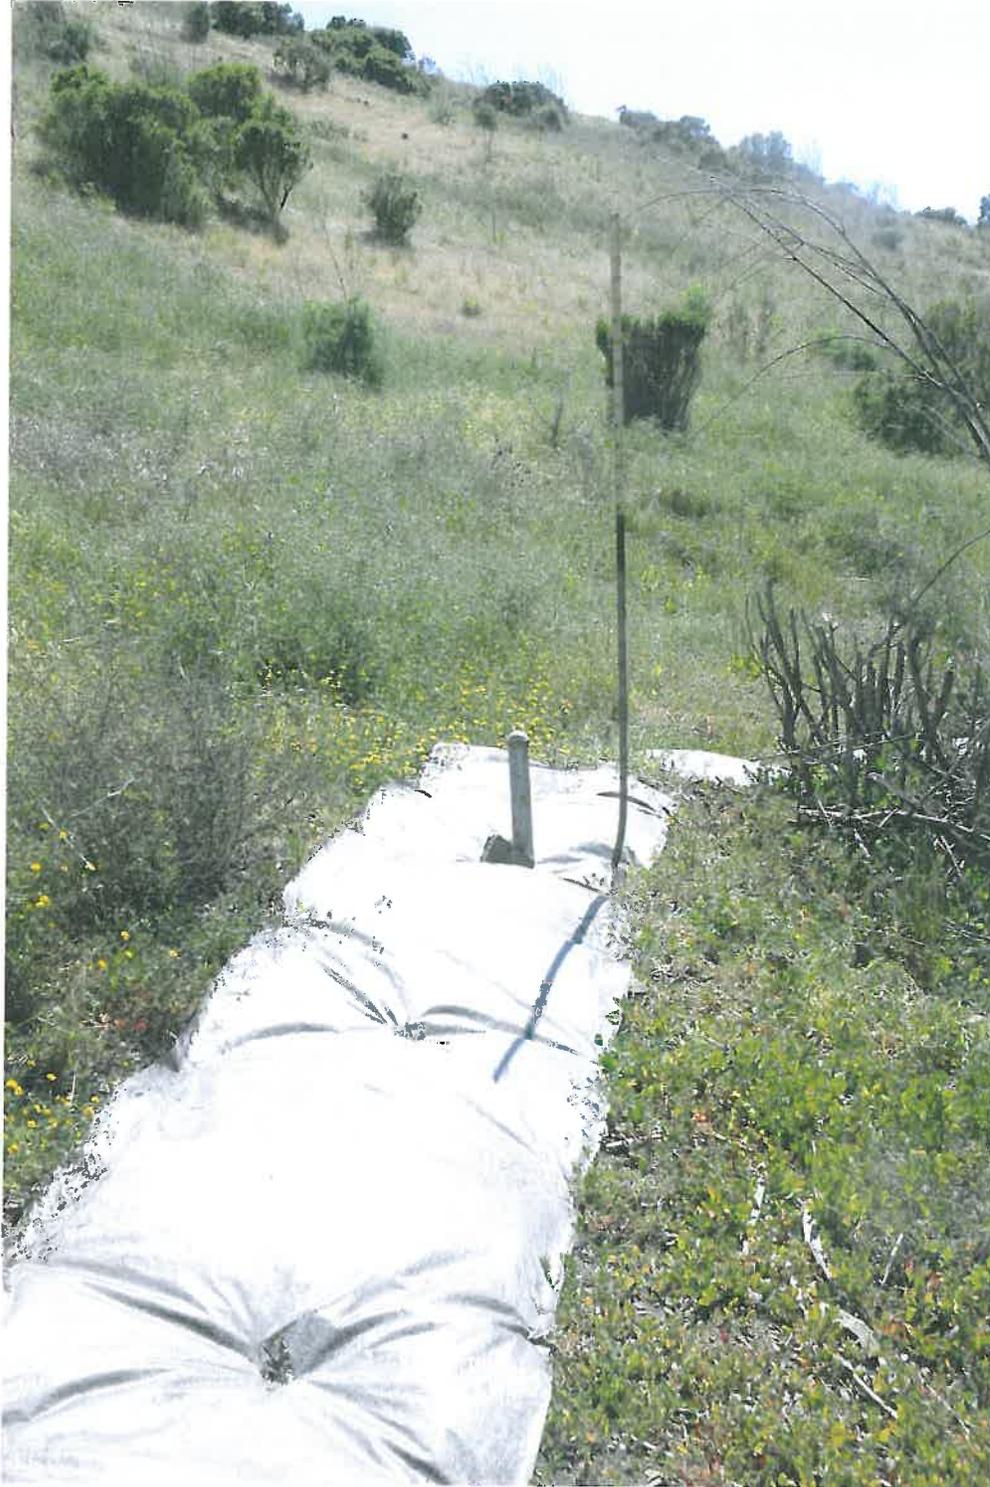
**Thorny Plants planted on and around Station S16. Removal is recommended.**

It is the recommendation of the consultant that the thorny plants that have been planted on and around the Station marker S16 be removed so that photographs for the Slope Stability and Erosion Monitoring Plan requirement of this inspection and report can be completed in years to come.

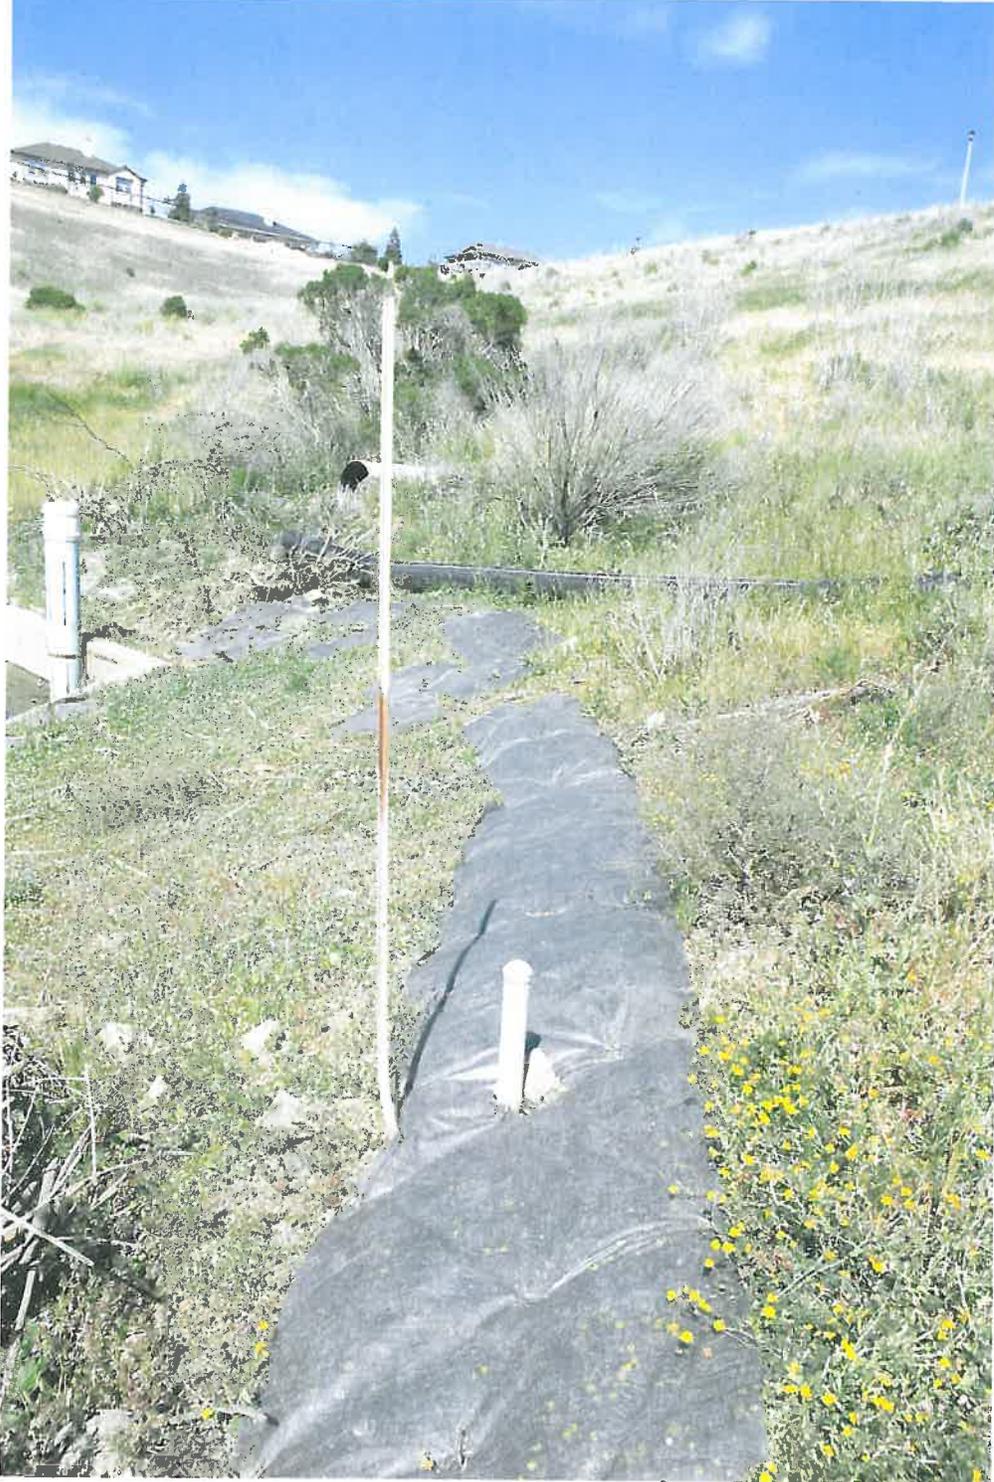
**Thorny Plants planted on and around Station S16. Removal is recommended.**
