EXPANDED SITE INSPECTION REPORT

Environmental Investigation at the Formerly Used Defense Site (FUDS)
at the Benicia Arsenal, Benicia, California
FUDS Number: J09CA075600

FINAL

September 2005

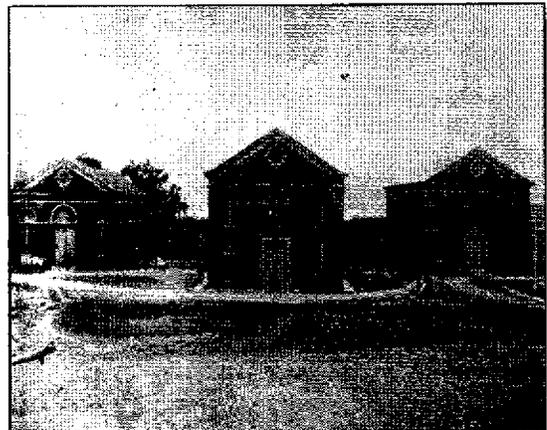
Photo B55-56-57. Looking southwest at Buildings 55, 56, and 57, from left to right. (Circa Early 1900s)

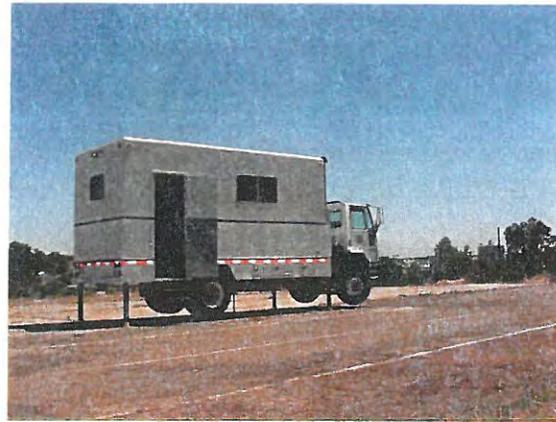
CPT rig positioned at TO-131.
