**Storm Drain Investigation Letter Memorandum**

7 December 2004

Subject: Storm Drain Investigation Letter Memorandum, Former Benicia  
Arsenal, Benicia, California

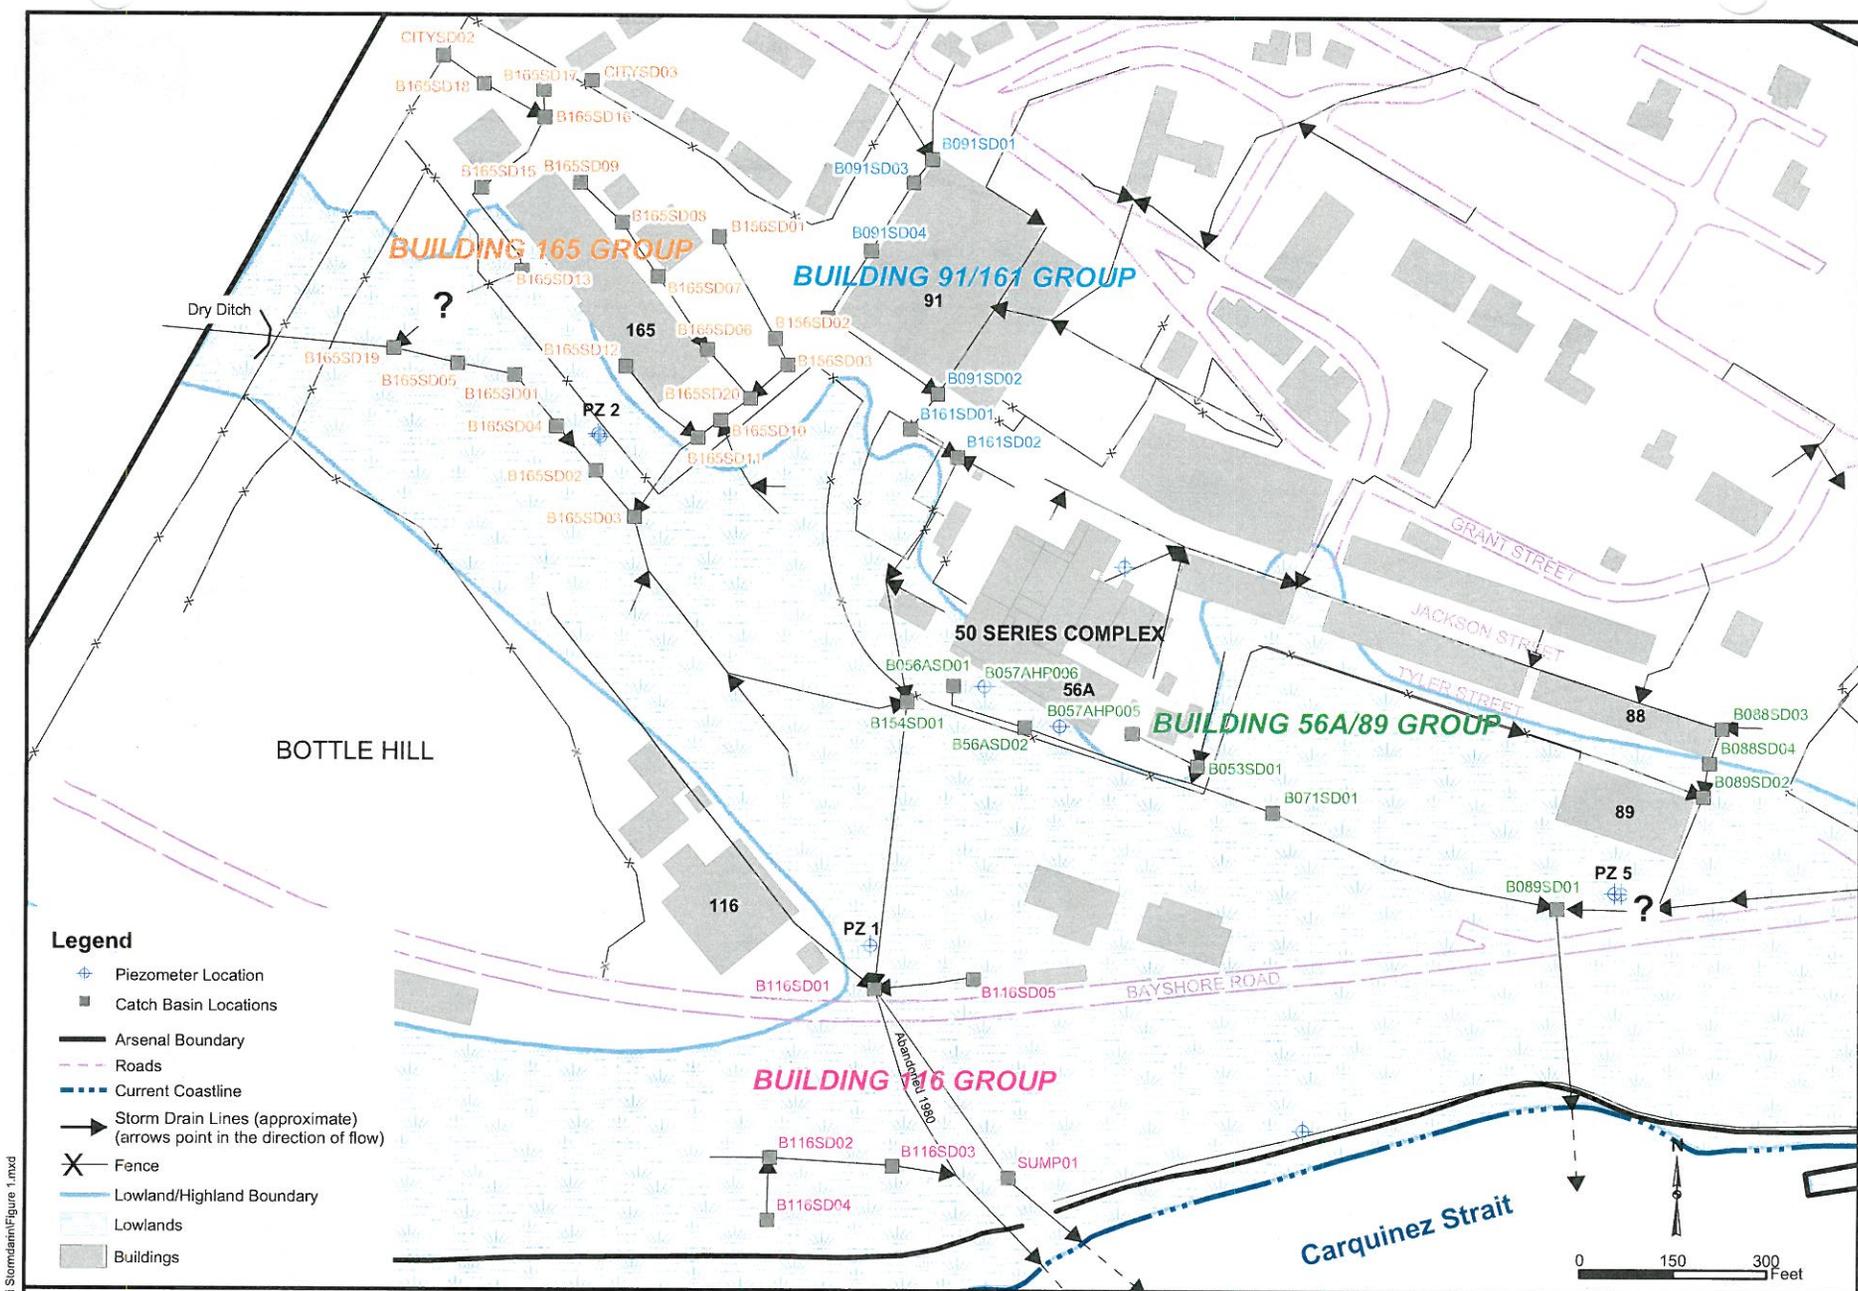
included a series of concrete catch basins connected with corrugated steel pipe and then drained into the Carquinez Strait through two tide gates. These tide gates are labeled "TIDEGATE01" and "TIDEGATE02" on Figure 1. The City of Benicia changed the original system by abandoning a line in 1980 that once connected to TIDEGATE02. A new line was installed with a sump labeled as "SUMP01" and the outfall is labeled "SSP01OUTFALL" on Figure 1.

Arrows on the storm drain lines indicate the direction of water flow (Figure 1). The Building 165 Group transmits water from the City of Benicia (labeled "dry ditch" on the figures) and from a residential area north of Building 165 (catch basins CITYSD02 and CITYSD03). The connection of the storm water drain lines from the residential area to the line that connects to the "dry ditch" is not clear. Army and City of Benicia maps indicate these two lines connect at catch basin B165SD19, but the line sizes observed in the catch basin do not match. Therefore, a question mark has been placed on the line segment next to

The Building 56A/89 storm drain line transmits water solely from the 50 Series Complex, in which building 56A is the southernmost building. This storm drain line then flows toward Building 89 and turns south to flow out to TIDEGATE01 (Figure 1).

Based on the City of Benicia and the 1958 Army storm water drainage maps, TIDEGATE01 receives storm water from the east side of the industrial area including the 50 Series Complex, businesses along Jackson Street and Tyler Street, the hills north of these streets, and Building 48 (Figure 1) (Building 48 is not shown on the figures provided in this memorandum but is located approximately 300 feet east of Building 88.). The connection to TIDEGATE01 from storm water draining from the businesses along Jackson Street and Tyler Street, the hills north of these streets, and Building 48 could not be confirmed. Flow was observed on the east side of Building 89, but the water in the next downstream catch basin (B089SD01) was not flowing. As a result, a question mark has been placed along this segment of storm drain line east of catch basin B089SD01.

Locations of the storm drain catch basins were then identified in the field, if possible, and are shown on Figure 1 in grey. Several measurements were collected from the catch basins: depth of the basin, the number of inlet/outlet pipes visible, depth to the pipes, and the general orientation of each pipe. These observations are summarized in Table 1. Although the storm water catch basins are shown on the figures as connecting, these connections are not certain. As stated above, there are some discrepancies between the City of Benicia's storm water drain map and the 1958 Army map; however, the information in this investigation is believed to be accurate based on field observations.

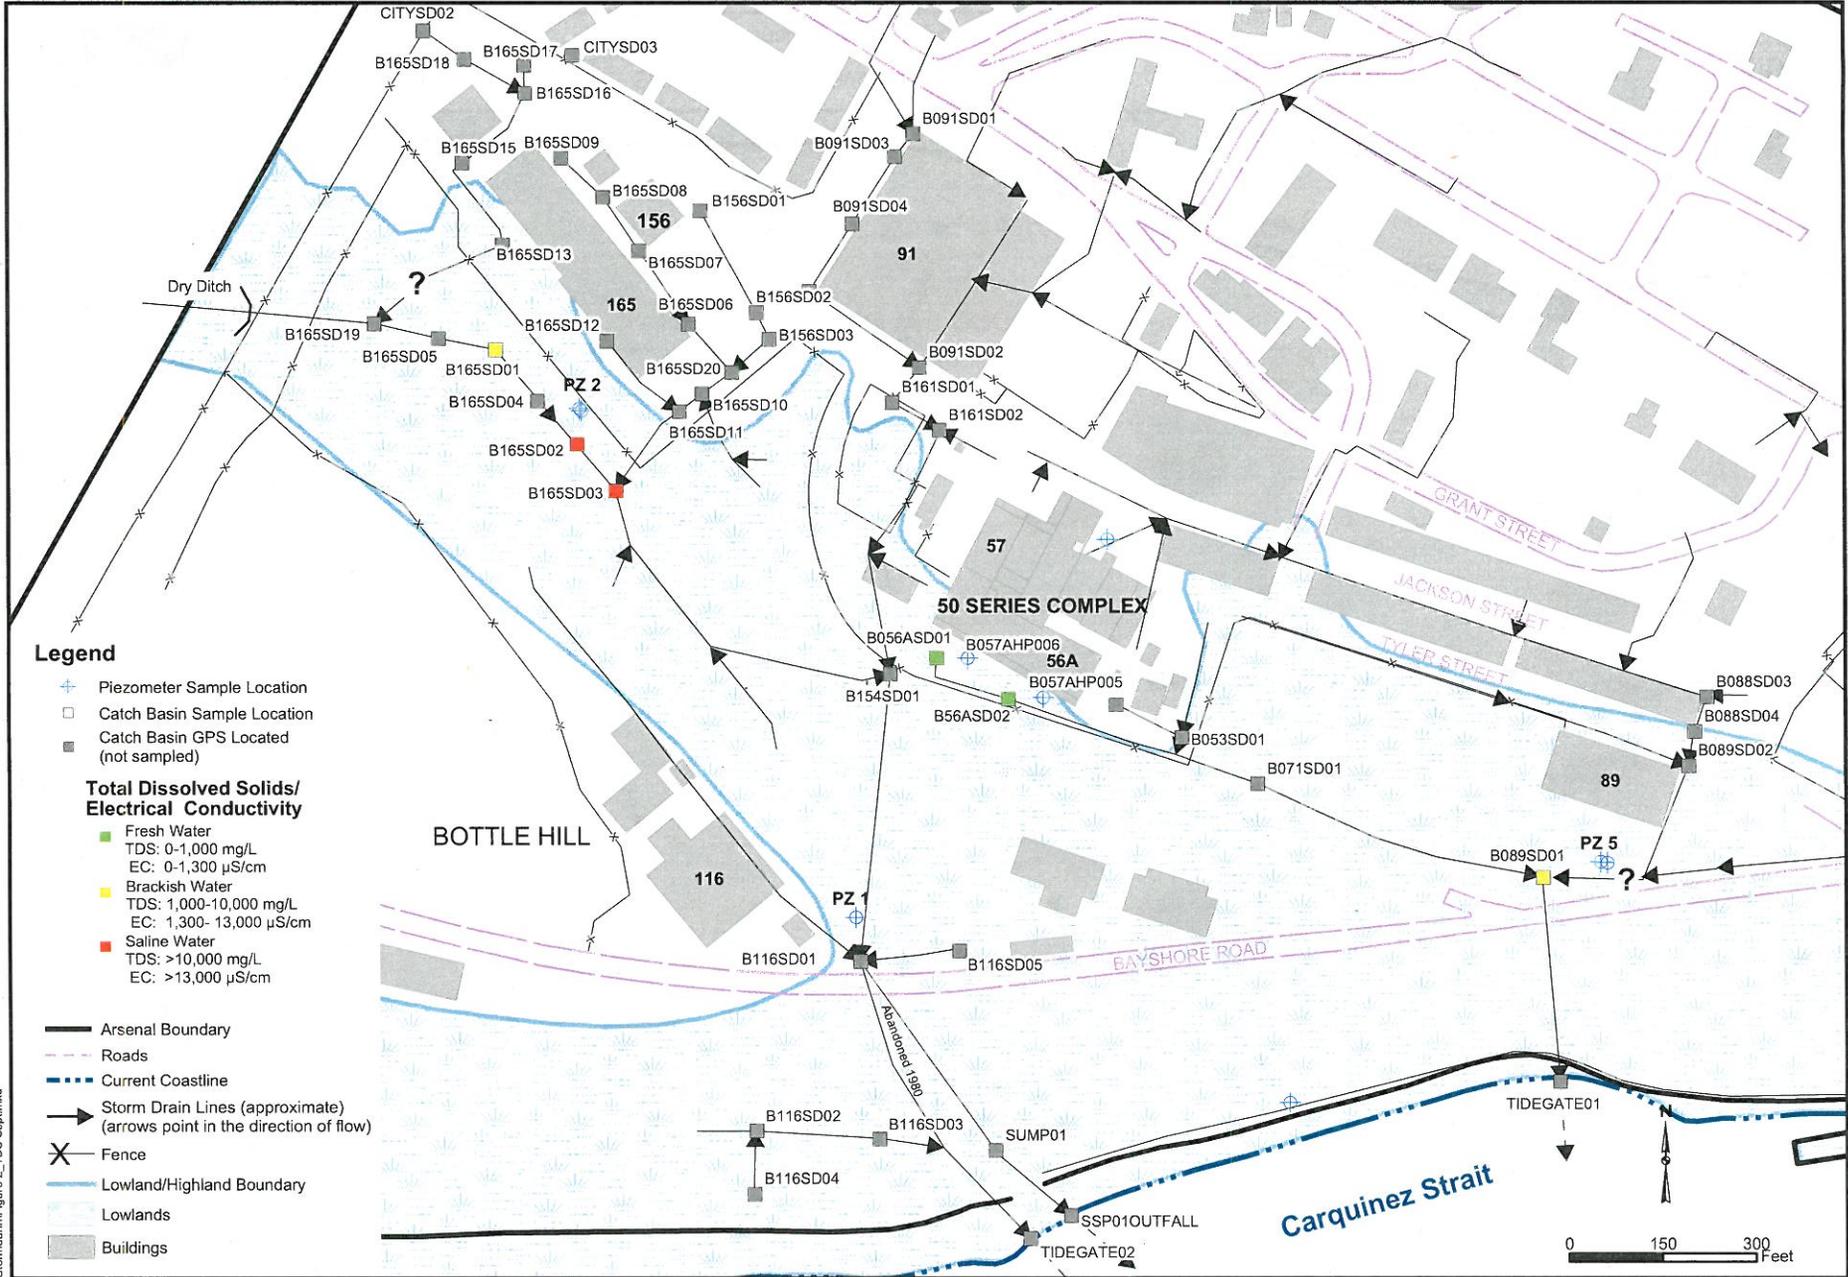
**Figure 2**

**TDS.** During the September 2004 sampling event, the catch basin water samples and the nearby piezometer, PZ-2, collected from this group were all brackish to saline based on a concentration of TDS greater than 1,000 milligrams per liter (mg/L) (Figure 2 and table above). This coincides with historical groundwater sampling results. The catch basin water samples collected during the October 2004 sampling event were mostly fresh (<1,000 mg/L TDS) to brackish water (Figure 3). As shown in the table above, concentrations of TDS dropped between the two sampling events. The change from more saline in September 2004 to less saline or fresh in October 2004 can be attributed to the 3 inches of precipitation that occurred between the two sampling events.

**TDS.** TDS concentrations ranged from 240 mg/L to 6,050 mg/L. Groundwater samples from piezometers B057AHP005 and PZ-5 were brackish during the September 2004 sampling event. However, groundwater samples from nearby piezometer B057AHP006, sampled in 1999 for TDS, had fresh water (TDS concentrations = 395 mg/L) and in catch basins B56ASD01 and B56ASD02 in September 2004. Piezometer B057AHP006 could not be sampled in September 2004. The border between the fresh and brackish groundwater, or the Lowland/Highland boundary, is estimated to be just north of, or upgradient of catch basins B56ASD01 and B56ASD02 (Figure 2).

Catch basin B089SD01 had brackish water during the September 2004 sampling event (Figure 2). Catch basins B089SD01 and B089SD02 had fresh water during the October 2004 sampling event based on the concentration of TDS (Figure 3).

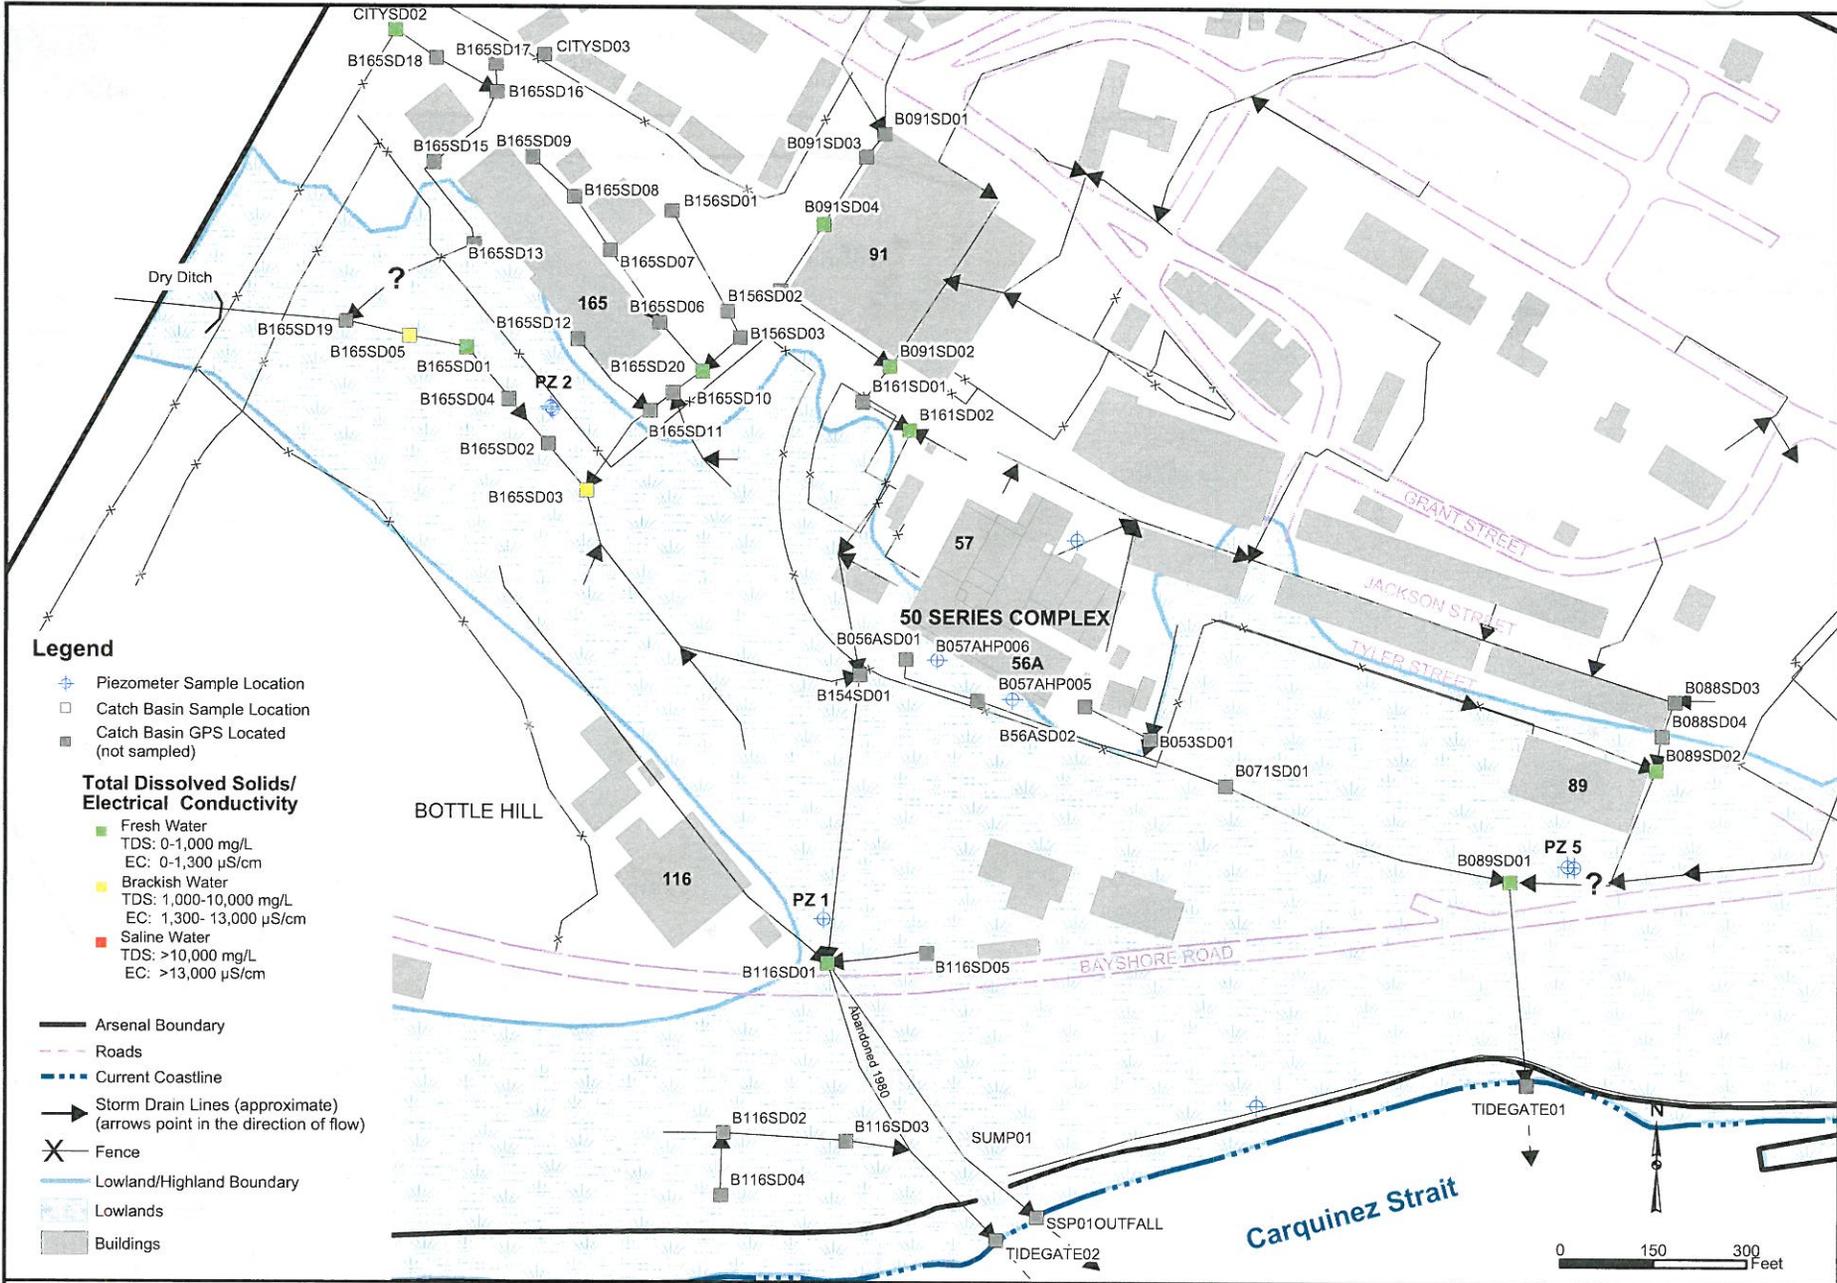
Figure 3

**TDS.** TDS concentrations ranged from 910 mg/L to 986 mg/L. These concentrations indicate that the water is fresh (Figure 3).

**TDS.** TDS concentrations were very low in catch basin B116SD01 (114 mg/L) compared with the other catch basin samples in the Building 165 and Building 91/116 groups, and could be reflective of fresh water draining off of the highlands of Bottle Hill (Figure 3).

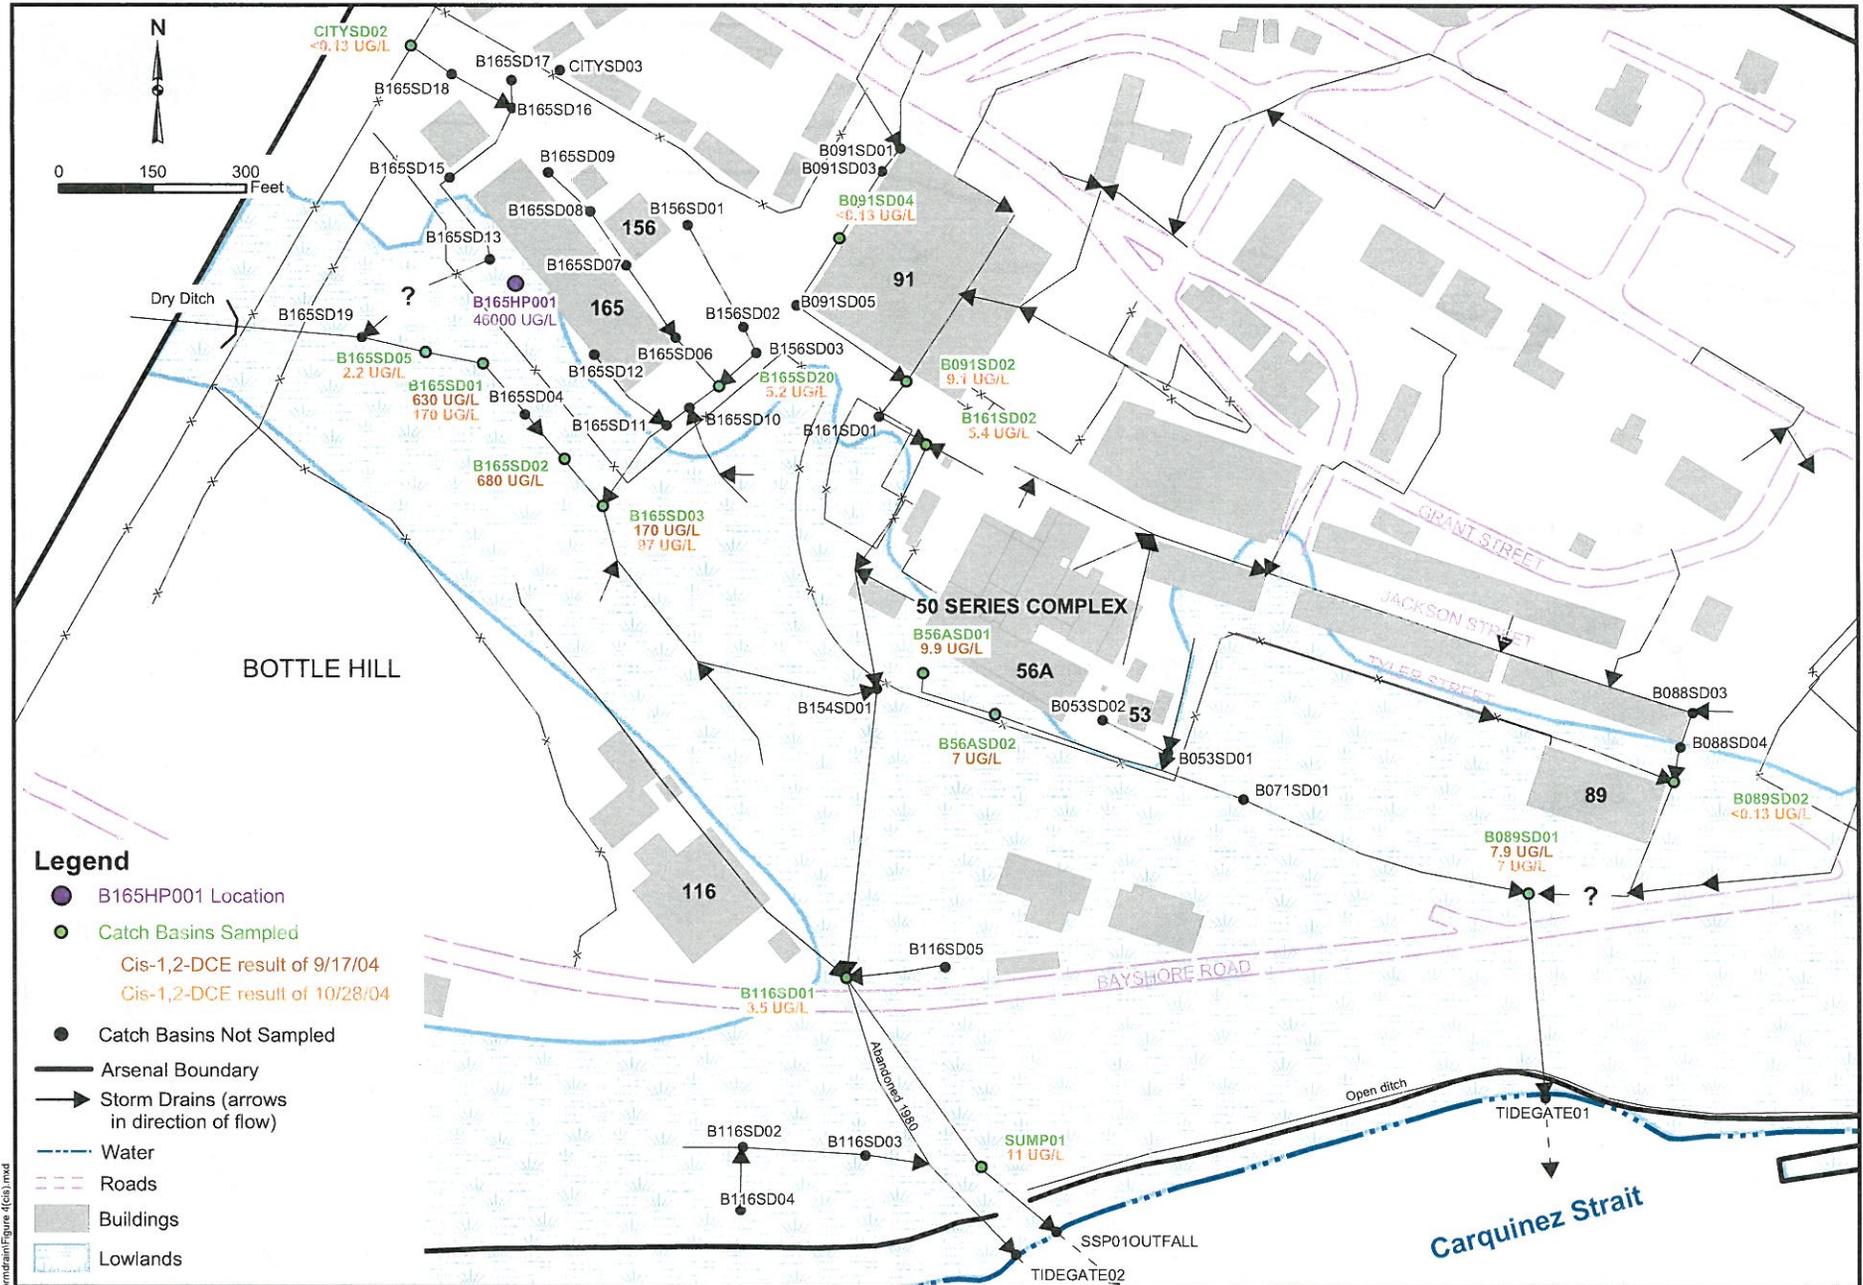
**Figure 4**

**VOCs.** Cis-1,2-DCE concentrations ranged from not detected in B091SD04 to 9.1  $\mu\text{g}/\text{L}$  in B091SD02 (Figure 4) and TCE concentrations ranged from not detected in B091SD04 to 11  $\mu\text{g}/\text{L}$  in catch basins B091SD02 and B161SD02 (Figure 5).

**VOCs.** The concentrations of VOCs in the Building 116 group are more similar to the Building 91/116 group than to the Building 165 group. Cis-1,2-DCE concentrations were detected at a maximum concentration of 11 µg/L (Figure 4) and TCE concentrations up to 31 µg/L (Figure 5).

**VOCs.** VOC concentrations in all of the piezometers and catch basins for this group for both sampling events were below 25 µg/L. Concentrations of cis-1,2-DCE and TCE were consistent in B089SD01, at 7.9 µg/L and 4.9 µg/L in September 2004 and 7 µg/L and 5.4 µg/L in October 2004 (Figures 4 and 5).

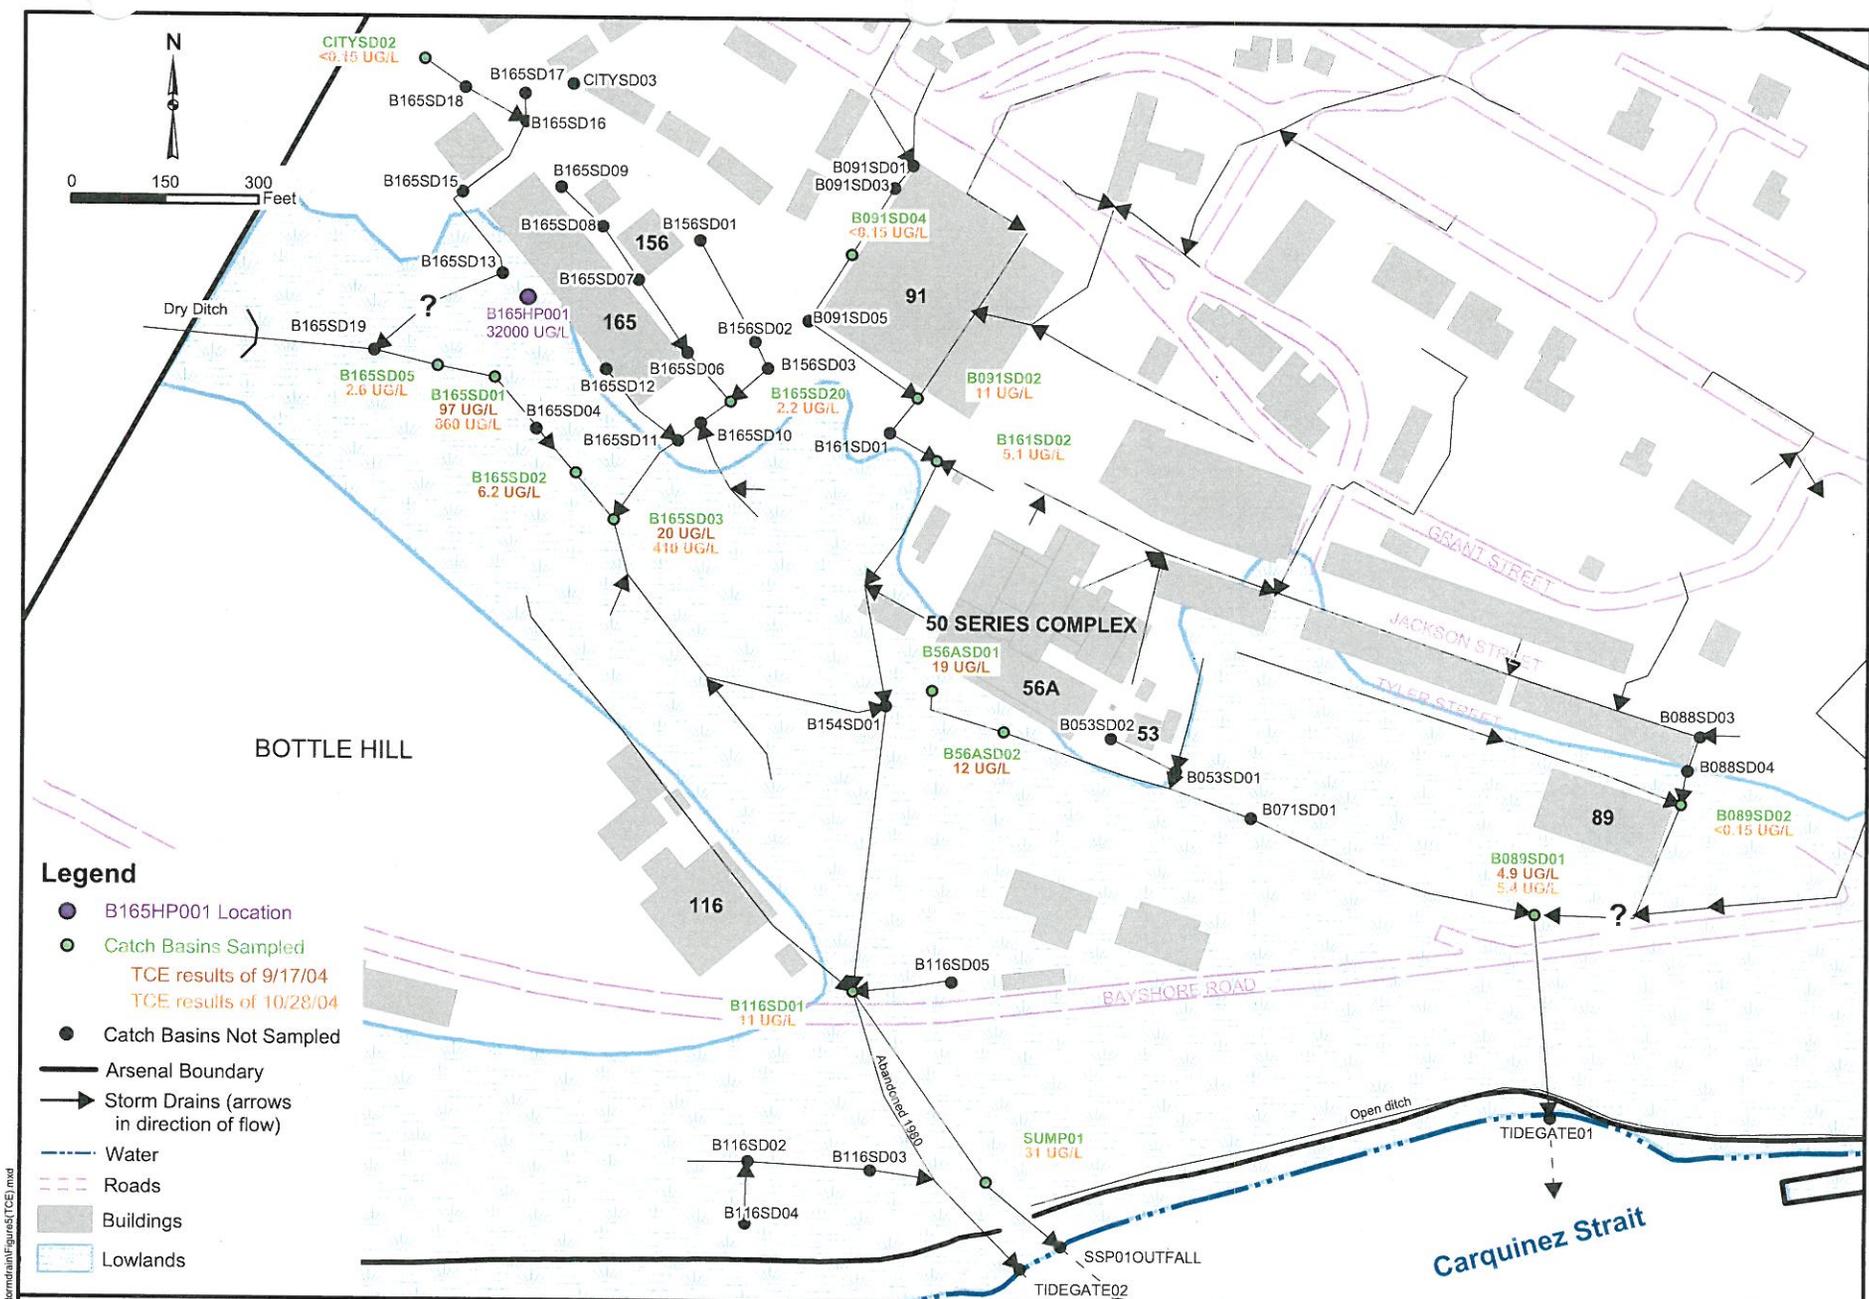
Figure 5

Catch basins B091SD02, B091SD04, and B161SD02 were sampled only during the October 2004 sampling event. The analytical results of the water samples from the three catch basins were similar (Figure 5).
