## SECTION 6 RESULTS AND ANALYSIS

## 6.1 Area R

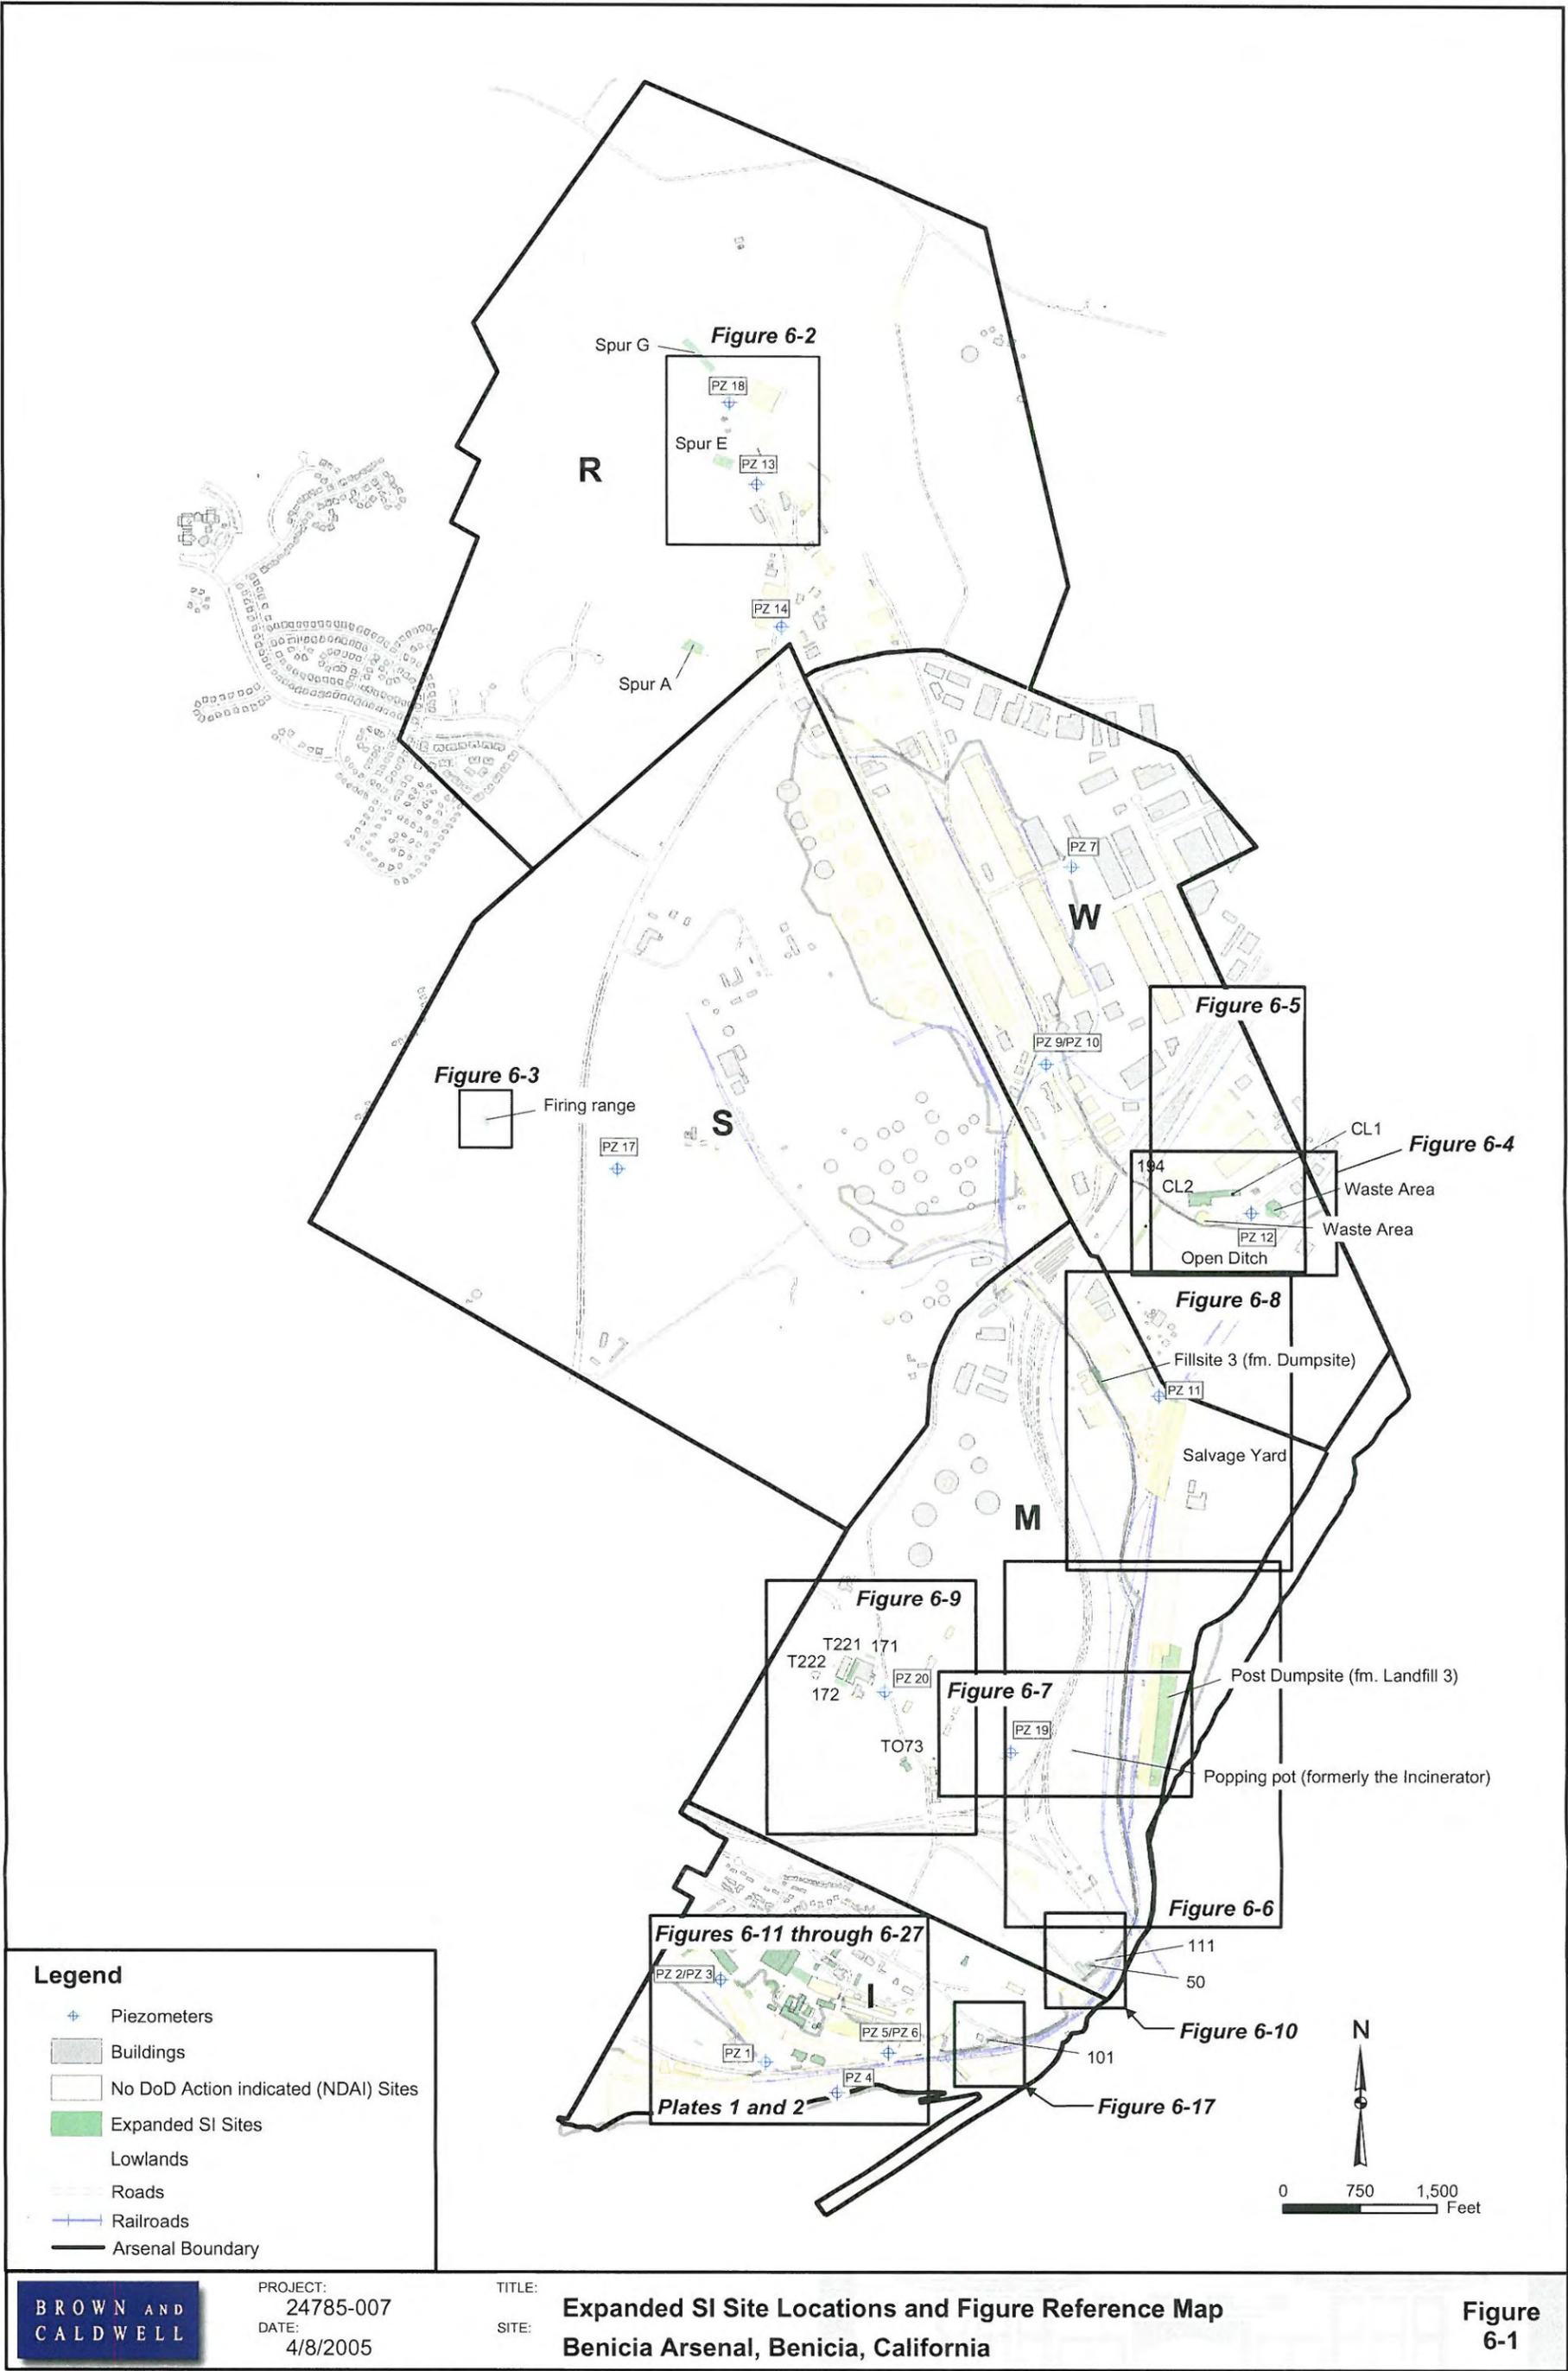
**Figure 6-1**

Area R is described in more detail in in Section 1.3.2 entitled Arsenal History. After the end of World War II, Area R was used primarily to destroy obsolete or damaged ammunition (Jacobs, 1999). Expanded SI Sites within Area R consist of former burn cages at Spurs A, E, and G, and their approximate location is shown on Figure 6-1.

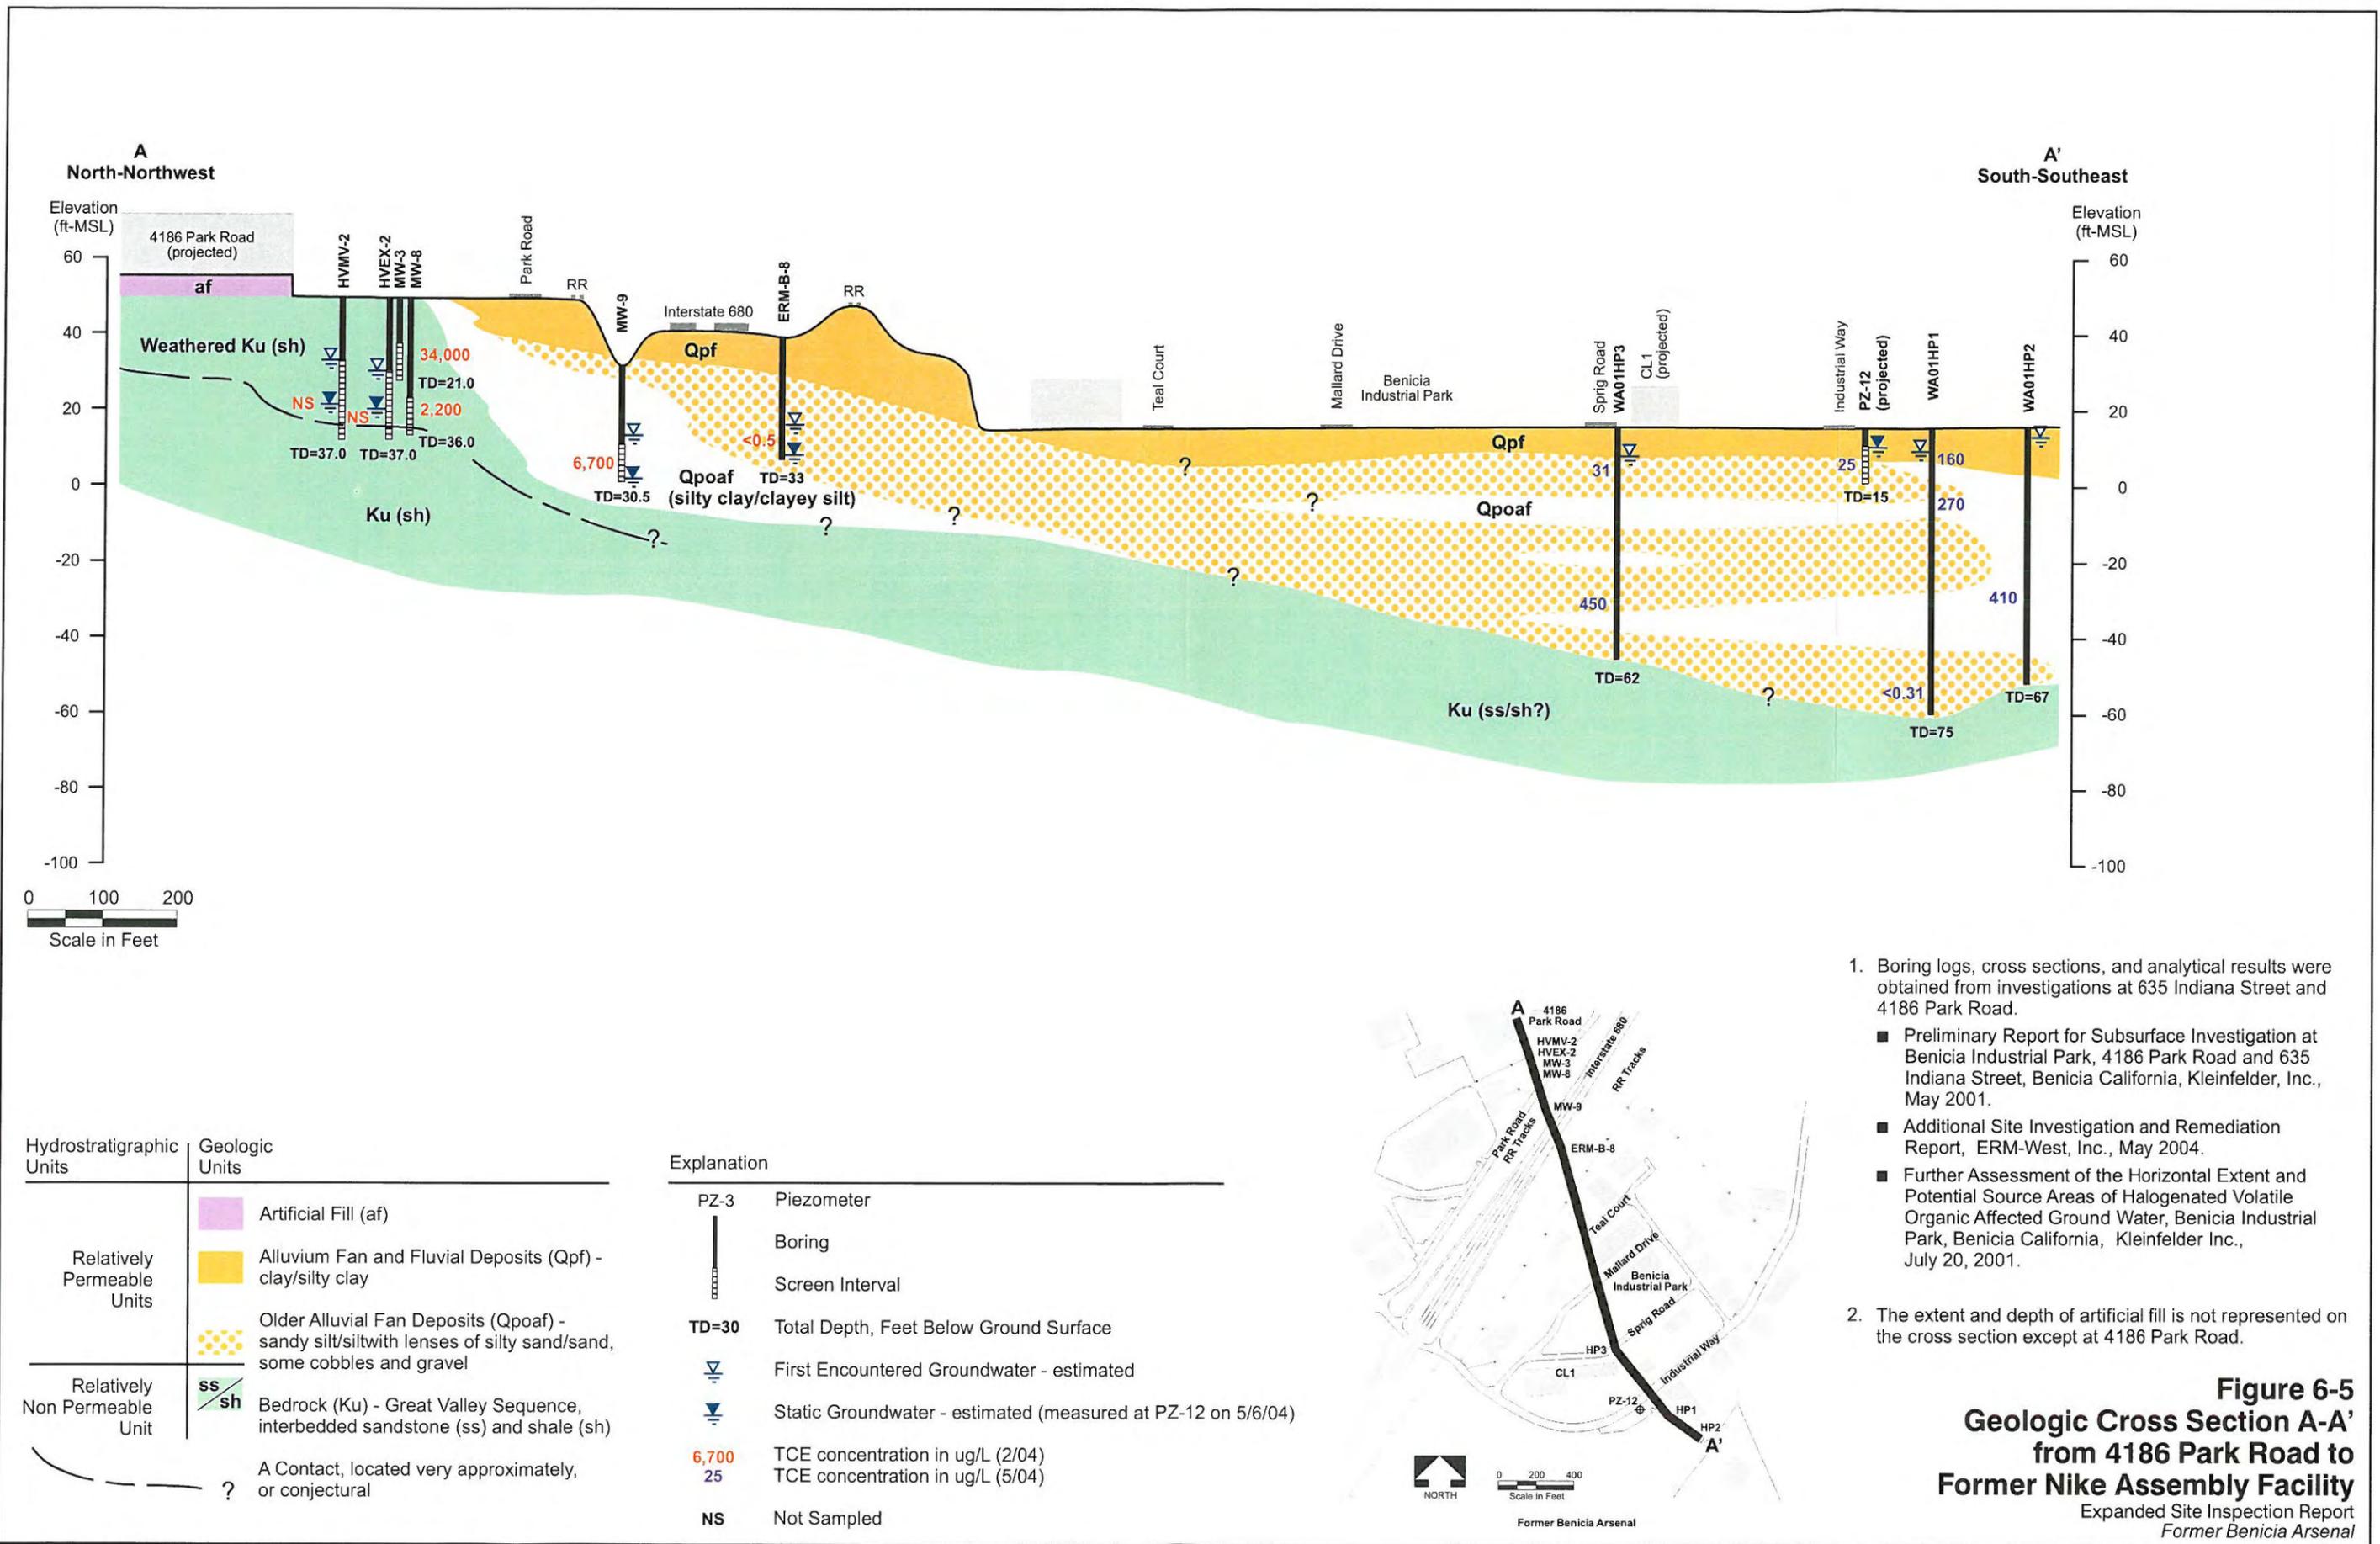
**Figure 6-5**  
**Geologic Cross Section A-A'**  
**from 4186 Park Road to**  
**Former Nike Assembly Facility**  
 Expanded Site Inspection Report  
 Former Benicia Arsenal

Concentrations of TCE, cis-1,2 DCE, and vinyl chloride exceed MCLs in the boring locations downgradient of CL1 and at the eastern Waste Area. TCE was detected in an upgradient boring (WA01HP003), which suggests there may be another source of contamination other than from former DoD activities. RWQCB files provided information on a current RWQCB site nearby, upgradient to CL 1, the Open Ditch and the Waste Areas, 4186 Park Road, as shown on Figure 6-5. This figure illustrates the lithology of the area and TCE concentrations in groundwater from 4186 Park Road to the former NIKE missile Assembly facility (CL1). Reportedly, solvent waste was dumped directly on the ground surface and a sump within the building leaked at 4186 Park Road. TCE has impacted groundwater up to 34,000 µg/L (based on February 2004 sampling). Bedrock at 4186 Park Road is shale with reportedly 10 to 20 feet of the shale weathered. Older reports indicate that the bedrock is sandstone. The geologic unit for this area is the Great Valley sequence, which is characterized by interbedded sandstone and shale.

Once access to Septic Tank 194 and CL2 is granted, a geophysical investigation is recommended at CL 2 to determine if a UST is present and an investigation at Septic Tank 194 is recommended to determine if discharge from CL 1 has impacted groundwater. No further action by USACE can be done until access is provided. No further DoD action is indicated for the Open Ditch and Western Waste due to MtBE and the recent diesel fuel and motor oil concentrations reported in Valero Well #117.

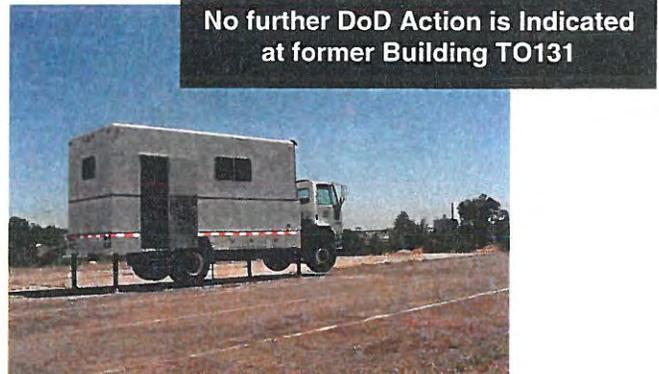
Looking east at the CPT Rig Setup at TO131

A soil boring (TO131HP001) was placed next to the former concrete building pad (Figure 6-11) to determine the possible impact of fuels and solvents from the former DoD degreasing operations. A soil gas sample was planned and sampled in this boring since it was expected that no groundwater would be present on this hill. As suspected, no groundwater was encountered and competent sandstone is present at 6.5 feet bgs. The soil gas was analyzed for VOCs. No VOCs were detected in the sample collected at 4 to 5 feet bgs. Based on the soil gas concentrations, there is no evidence of a release at this building. Therefore, no further DoD action is indicated.

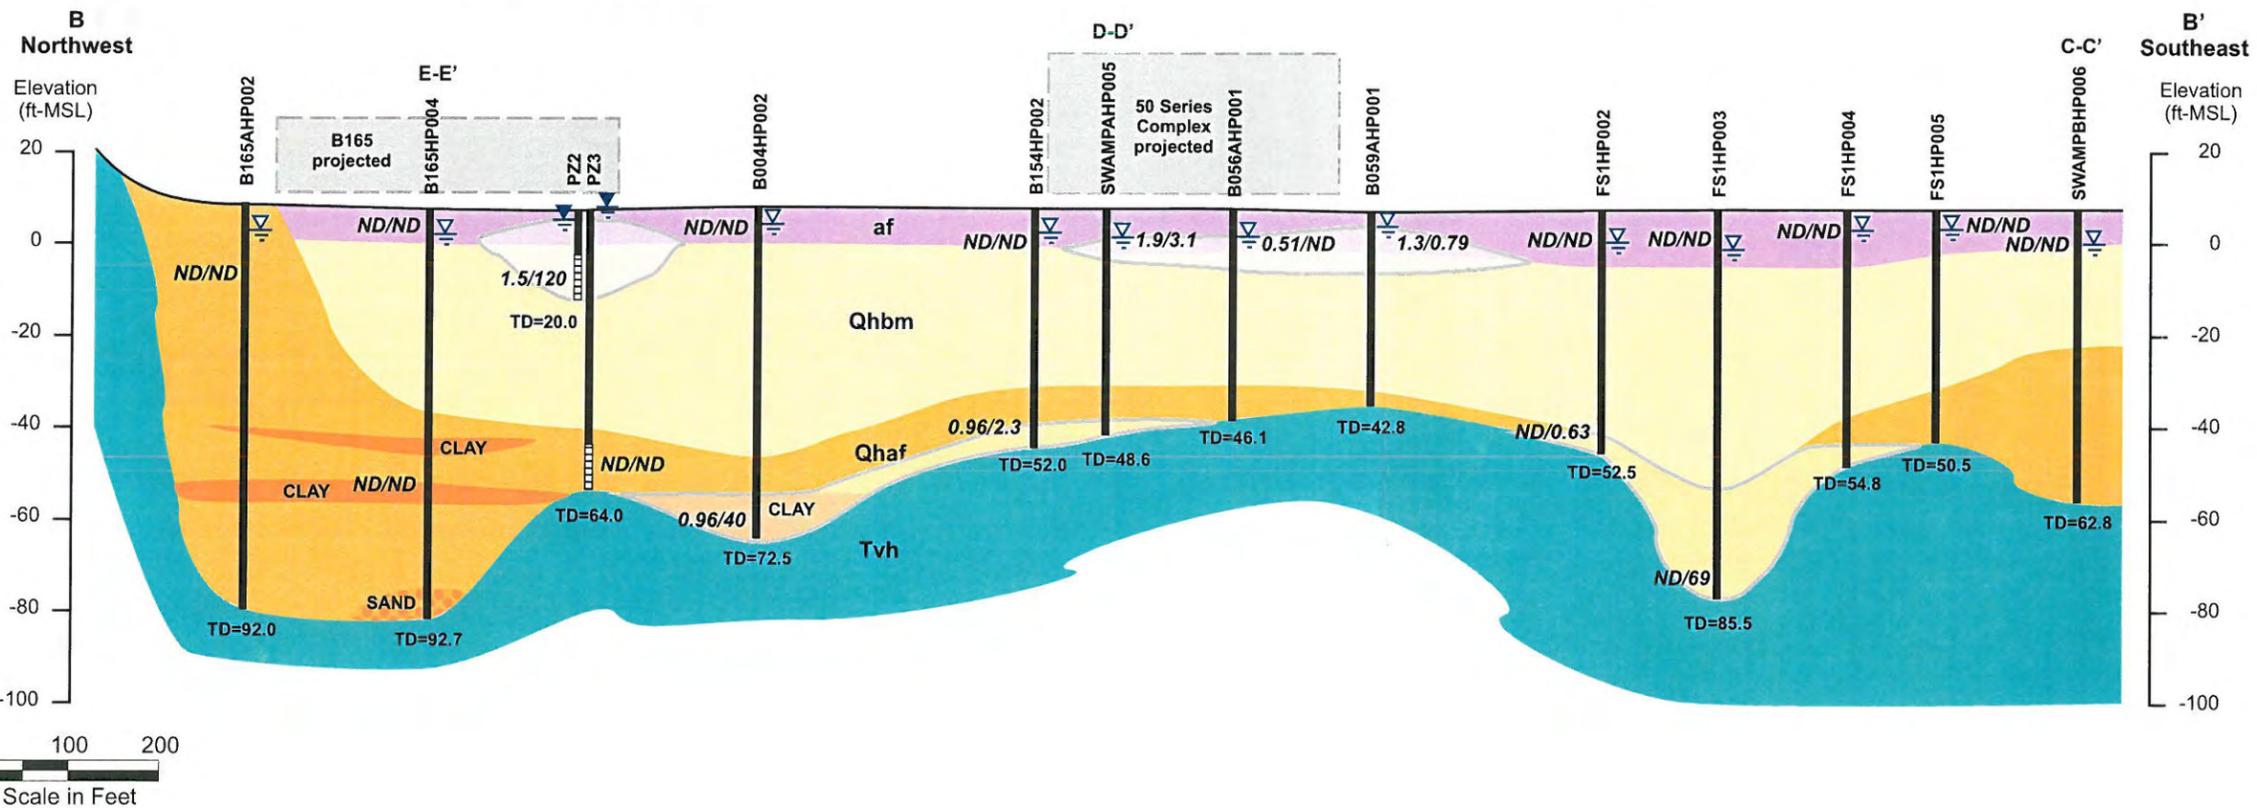
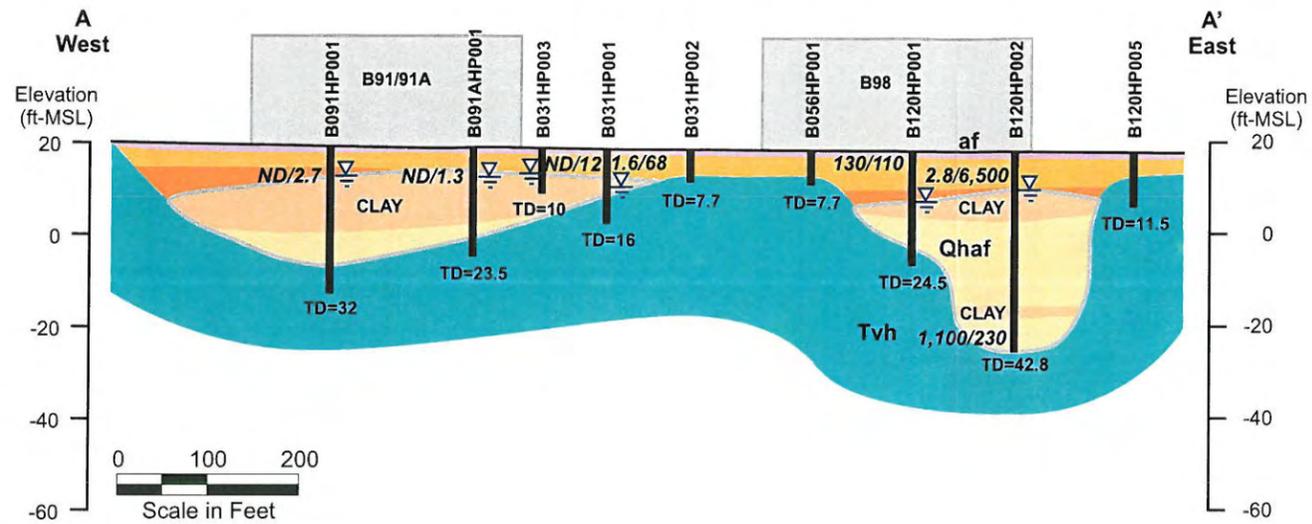
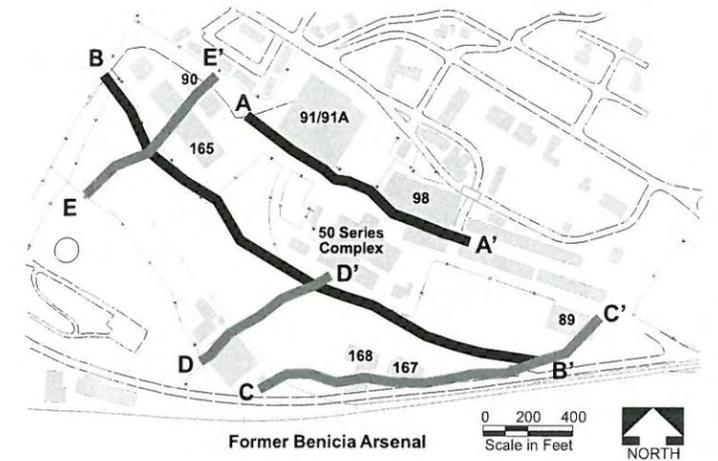
**Figure 6-22**  
**Geologic Cross Sections A-A' and B-B'**  
**Showing TCE and cis1,2-DCE Results**  
Expanded Site Inspection Report  
Former Benicia Arsenal

The alluvial material north of the 50 Series Complex on section A-A' (Figure 6-22) is impacted with solvents from the shallow water table (approximately 3 feet bgs) to the contact of the underlying sandstone. Concentrations in this area are the greatest north of Building 120 (or south of Building 98 as shown on the figure) but do not extend to the west because of a sandstone divide separating the plumes. Between B031HP002 to B056HP001, the sandstone is near the surface. Historic photos, like the one to the right, indicate that there was a small ridge and that the Army subsequently excavated to build Jackson Street. In this area of shallow sandstone there is no groundwater. As a result, the plume has split in two.

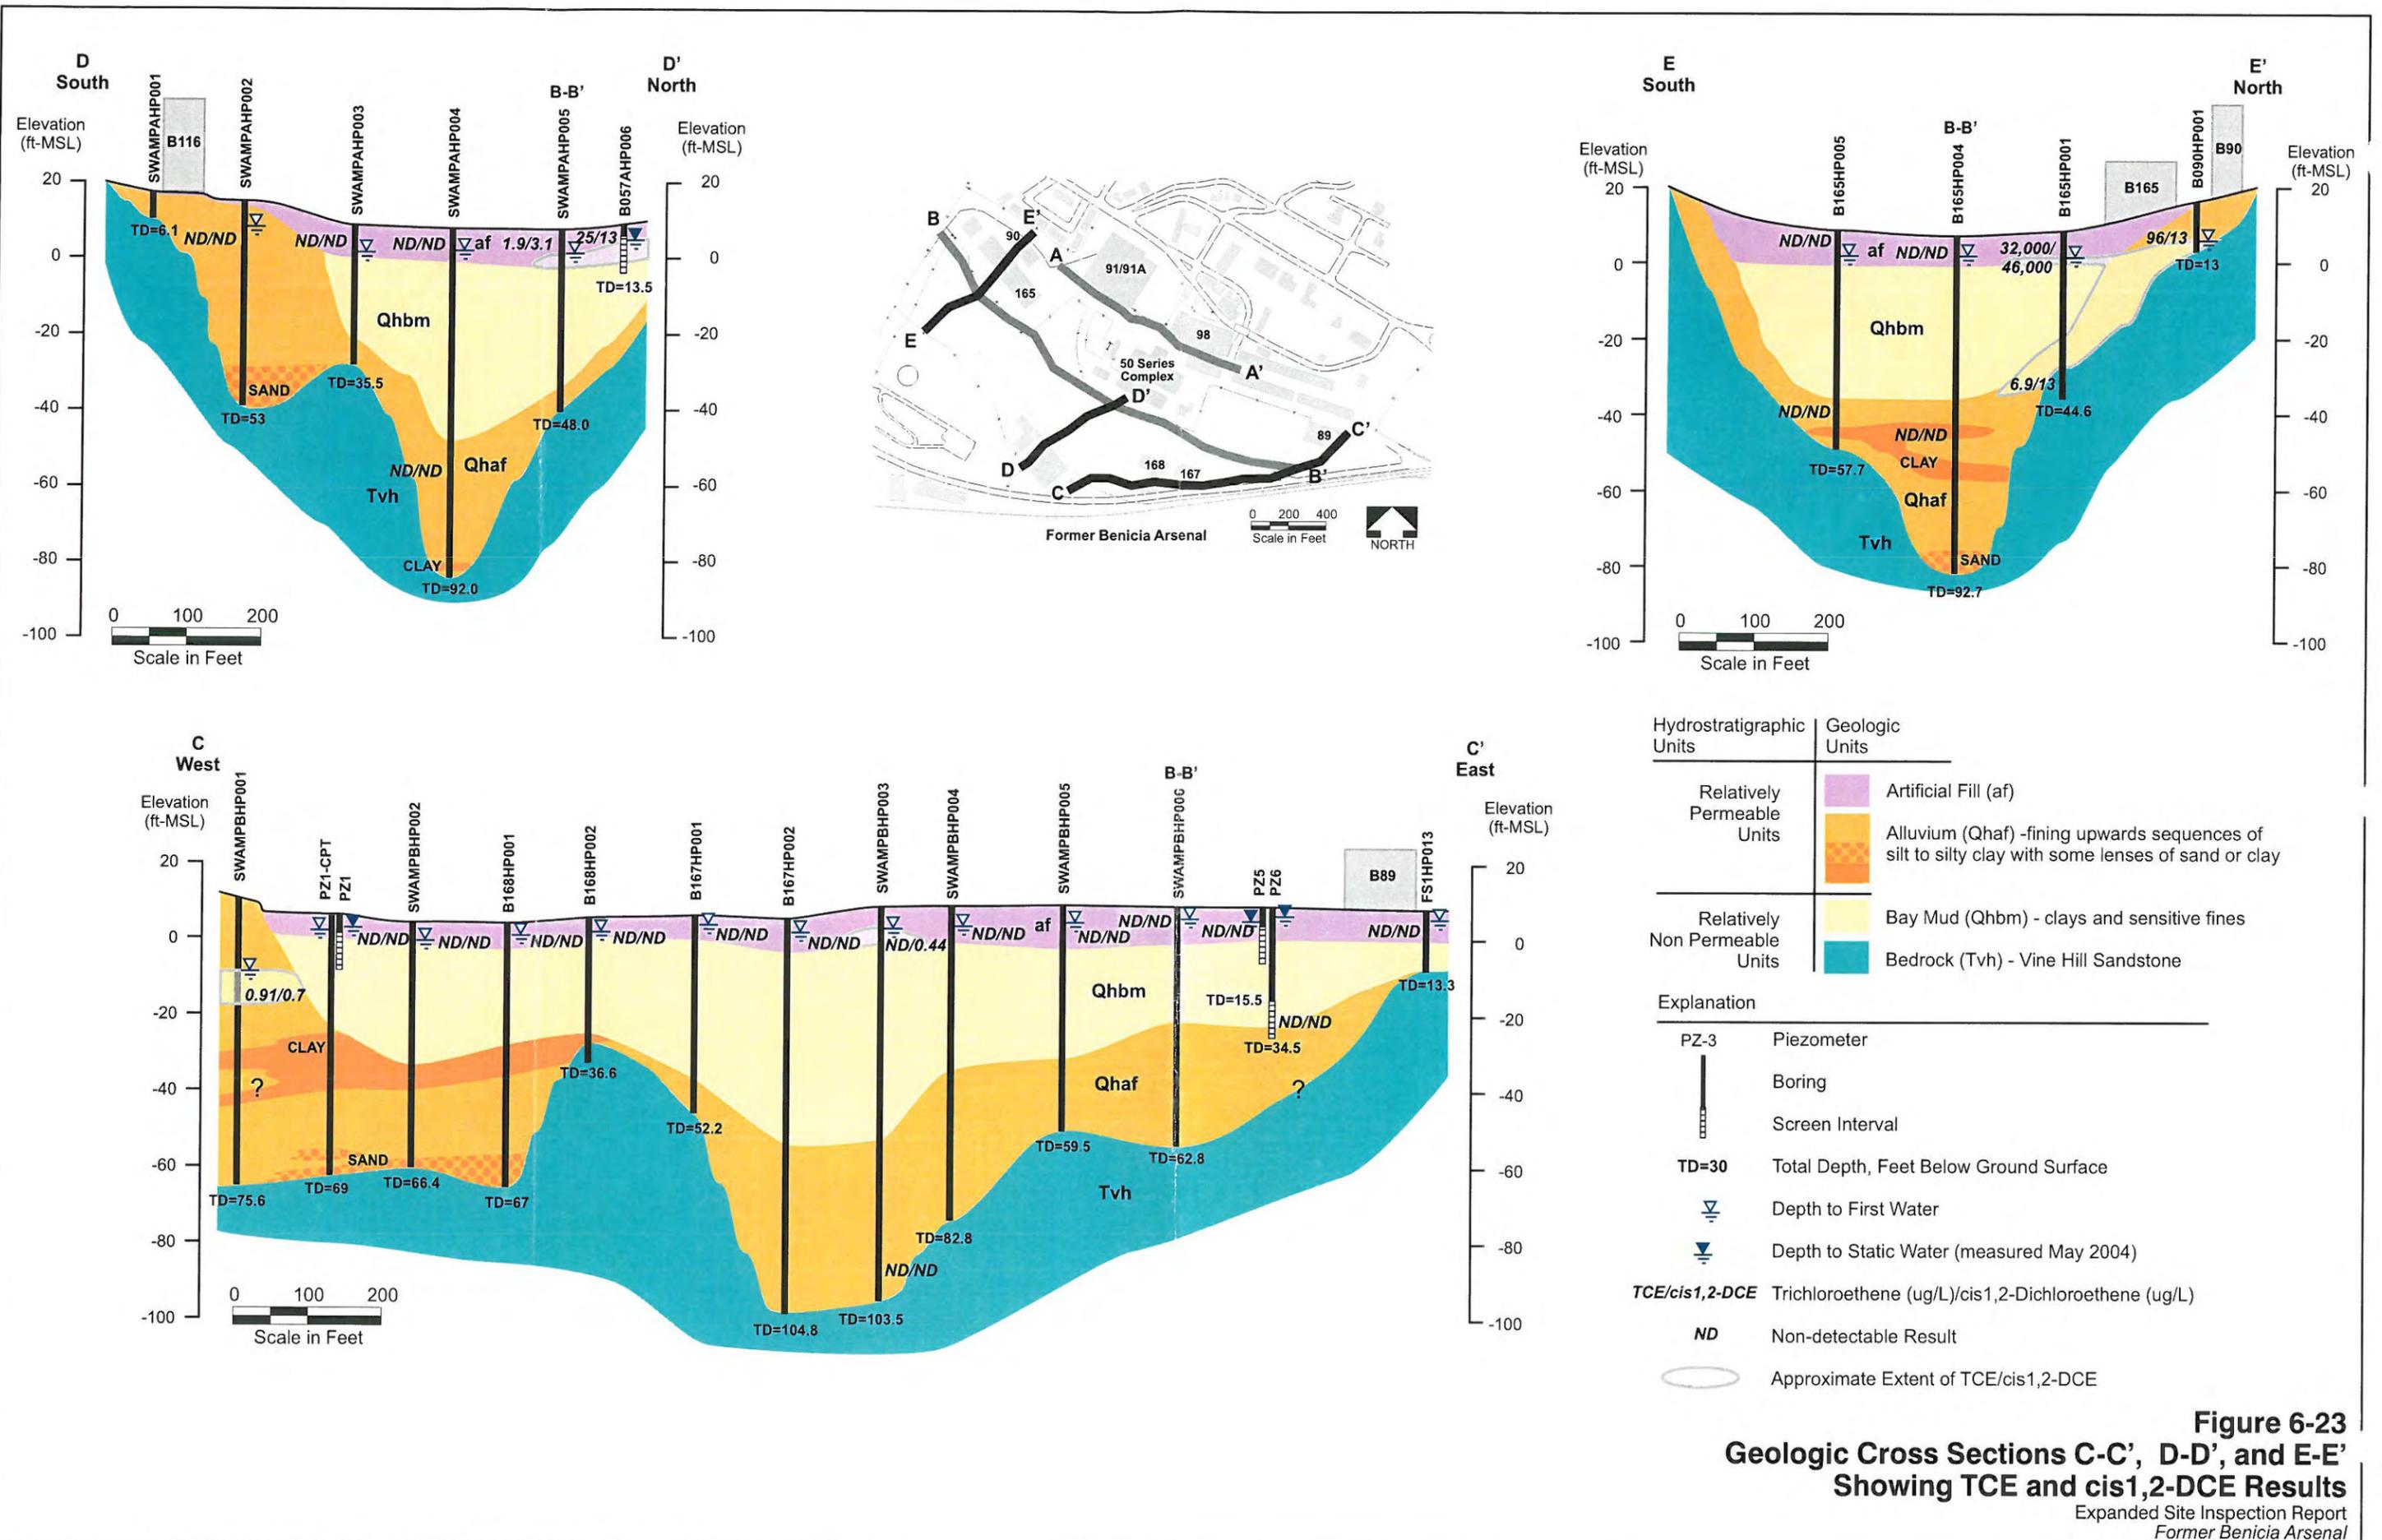
**Figure 6-23**  
**Geologic Cross Sections C-C', D-D', and E-E'**  
**Showing TCE and cis1,2-DCE Results**  
 Expanded Site Inspection Report  
 Former Benicia Arsenal

As the solvent impacted groundwater intersects the alluvial fill, the plume can split into two primary directions vertically: one within the groundwater in the alluvial fill and the other staying within the alluvium as it mantles the steeply dipping sandstone. Both of these units are more permeable than the Bay Mud; therefore, water is flowing more freely in these units than in the Bay Mud.

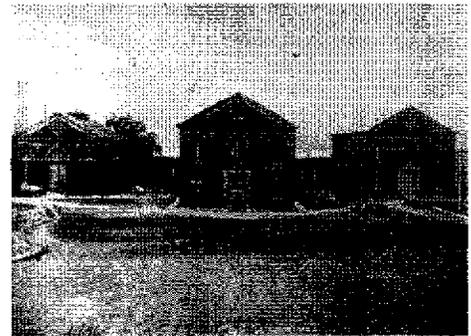
An early 1900s photo of the northern side of Buildings 55 through 57 (from left to right). The photographer taking the picture is standing on a sandstone ridge, now since dug out to form Jackson Street.
