EXPANDED SITE INSPECTION ADDENDUM REPORT

Environmental Investigation at the Formerly Used Defense Site (FUDS)
at the former Benicia Army Arsenal, Benicia, California
FUDS Number: J09CA075600

DRAFT FINAL

June 2006

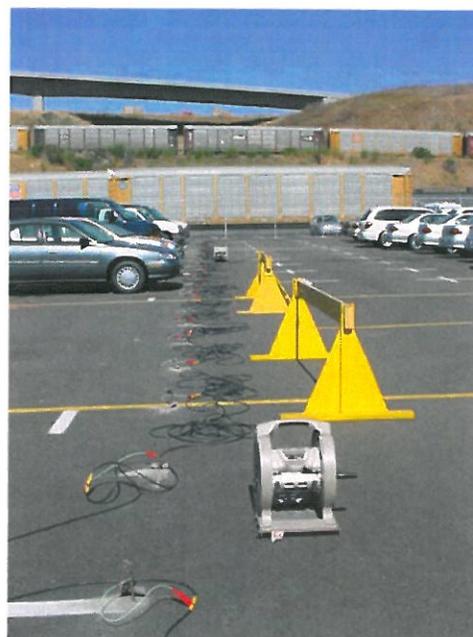
VMG survey setup at the Post Dumpsite

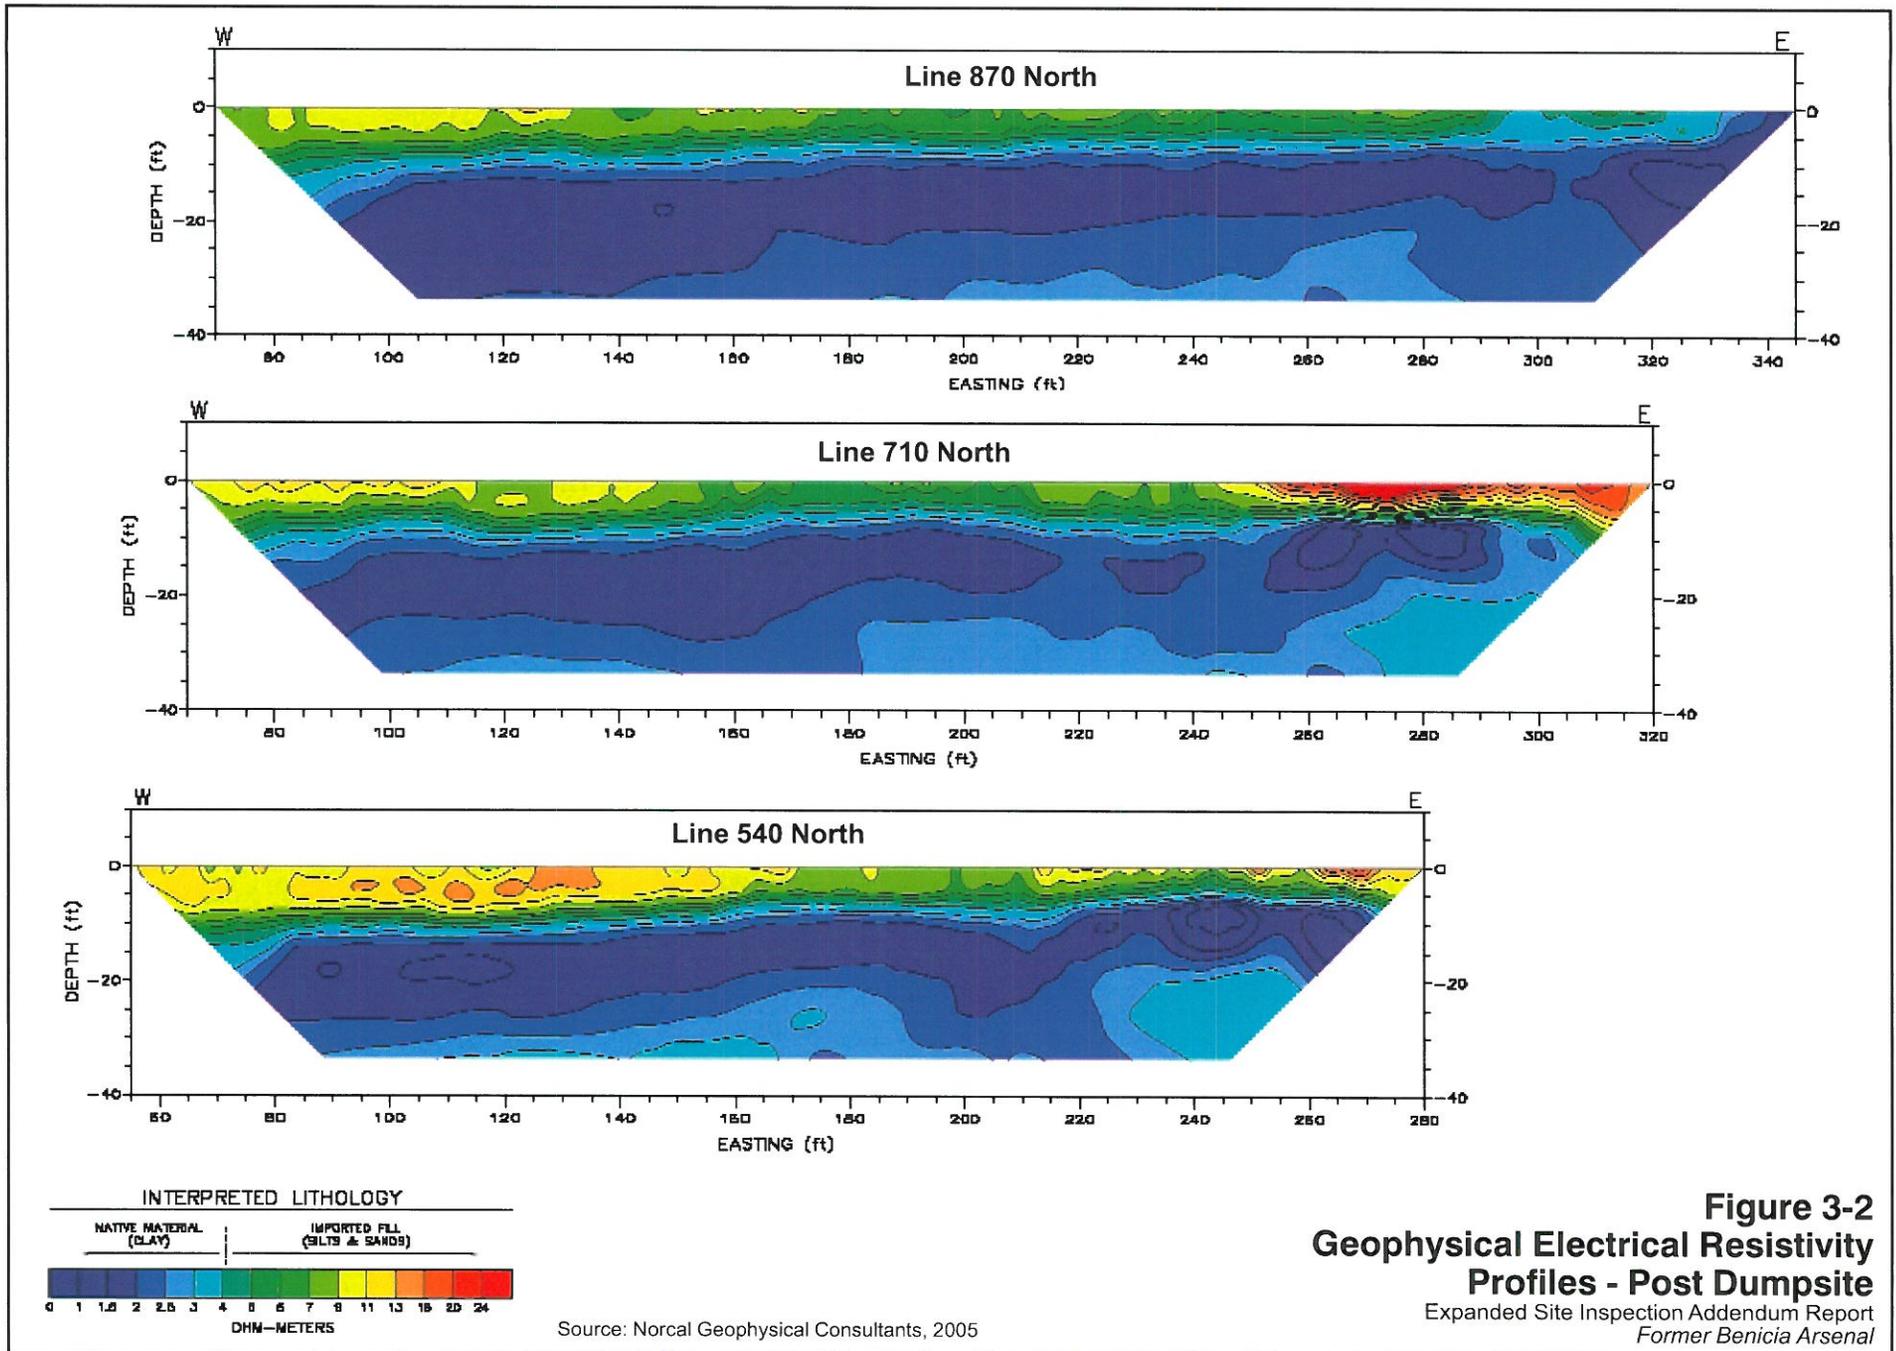
Figure 3-2
Geophysical Electrical Resistivity
Profiles - Post Dumpsite
 Expanded Site Inspection Addendum Report
Former Benicia Arsenal

The ER data indicates that the survey area is comprised of relatively resistive (greater than 4 ohm-meters) material overlying more conductive material (Figure 3-2). The more resistive material is interpreted to consist of silts and sands and probably represents fill material. The fill thickness appears to increase in thickness in a fairly uniform pattern from 5 feet in the east to 10 feet in the west. Below the fill, the conductive material is interpreted to be comprised of clay and/or marsh deposits with high moisture content.

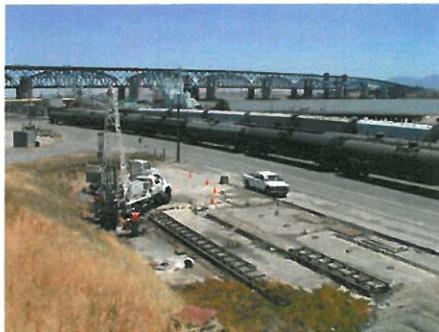
Only the foundation remains. The hillside was carved out for the building. This photo was taken in 2001 and not during this investigation.

No further investigation is recommended at former Building 101. A risk evaluation will be performed.

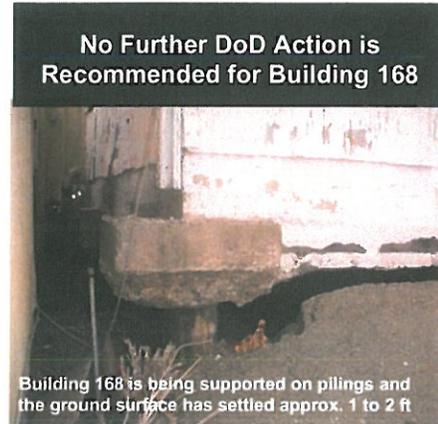
Building 168 was built in 1945 as a vehicle shop during the World War II expansion at the former Arsenal. Historical records did not indicate whether maintenance work was performed. The building is located on the former marshland and is supported by pilings that have been driven to the top of the underlying sandstone. The land surface around these buildings has sunk 1 to 2 feet as shown in the photo at right.

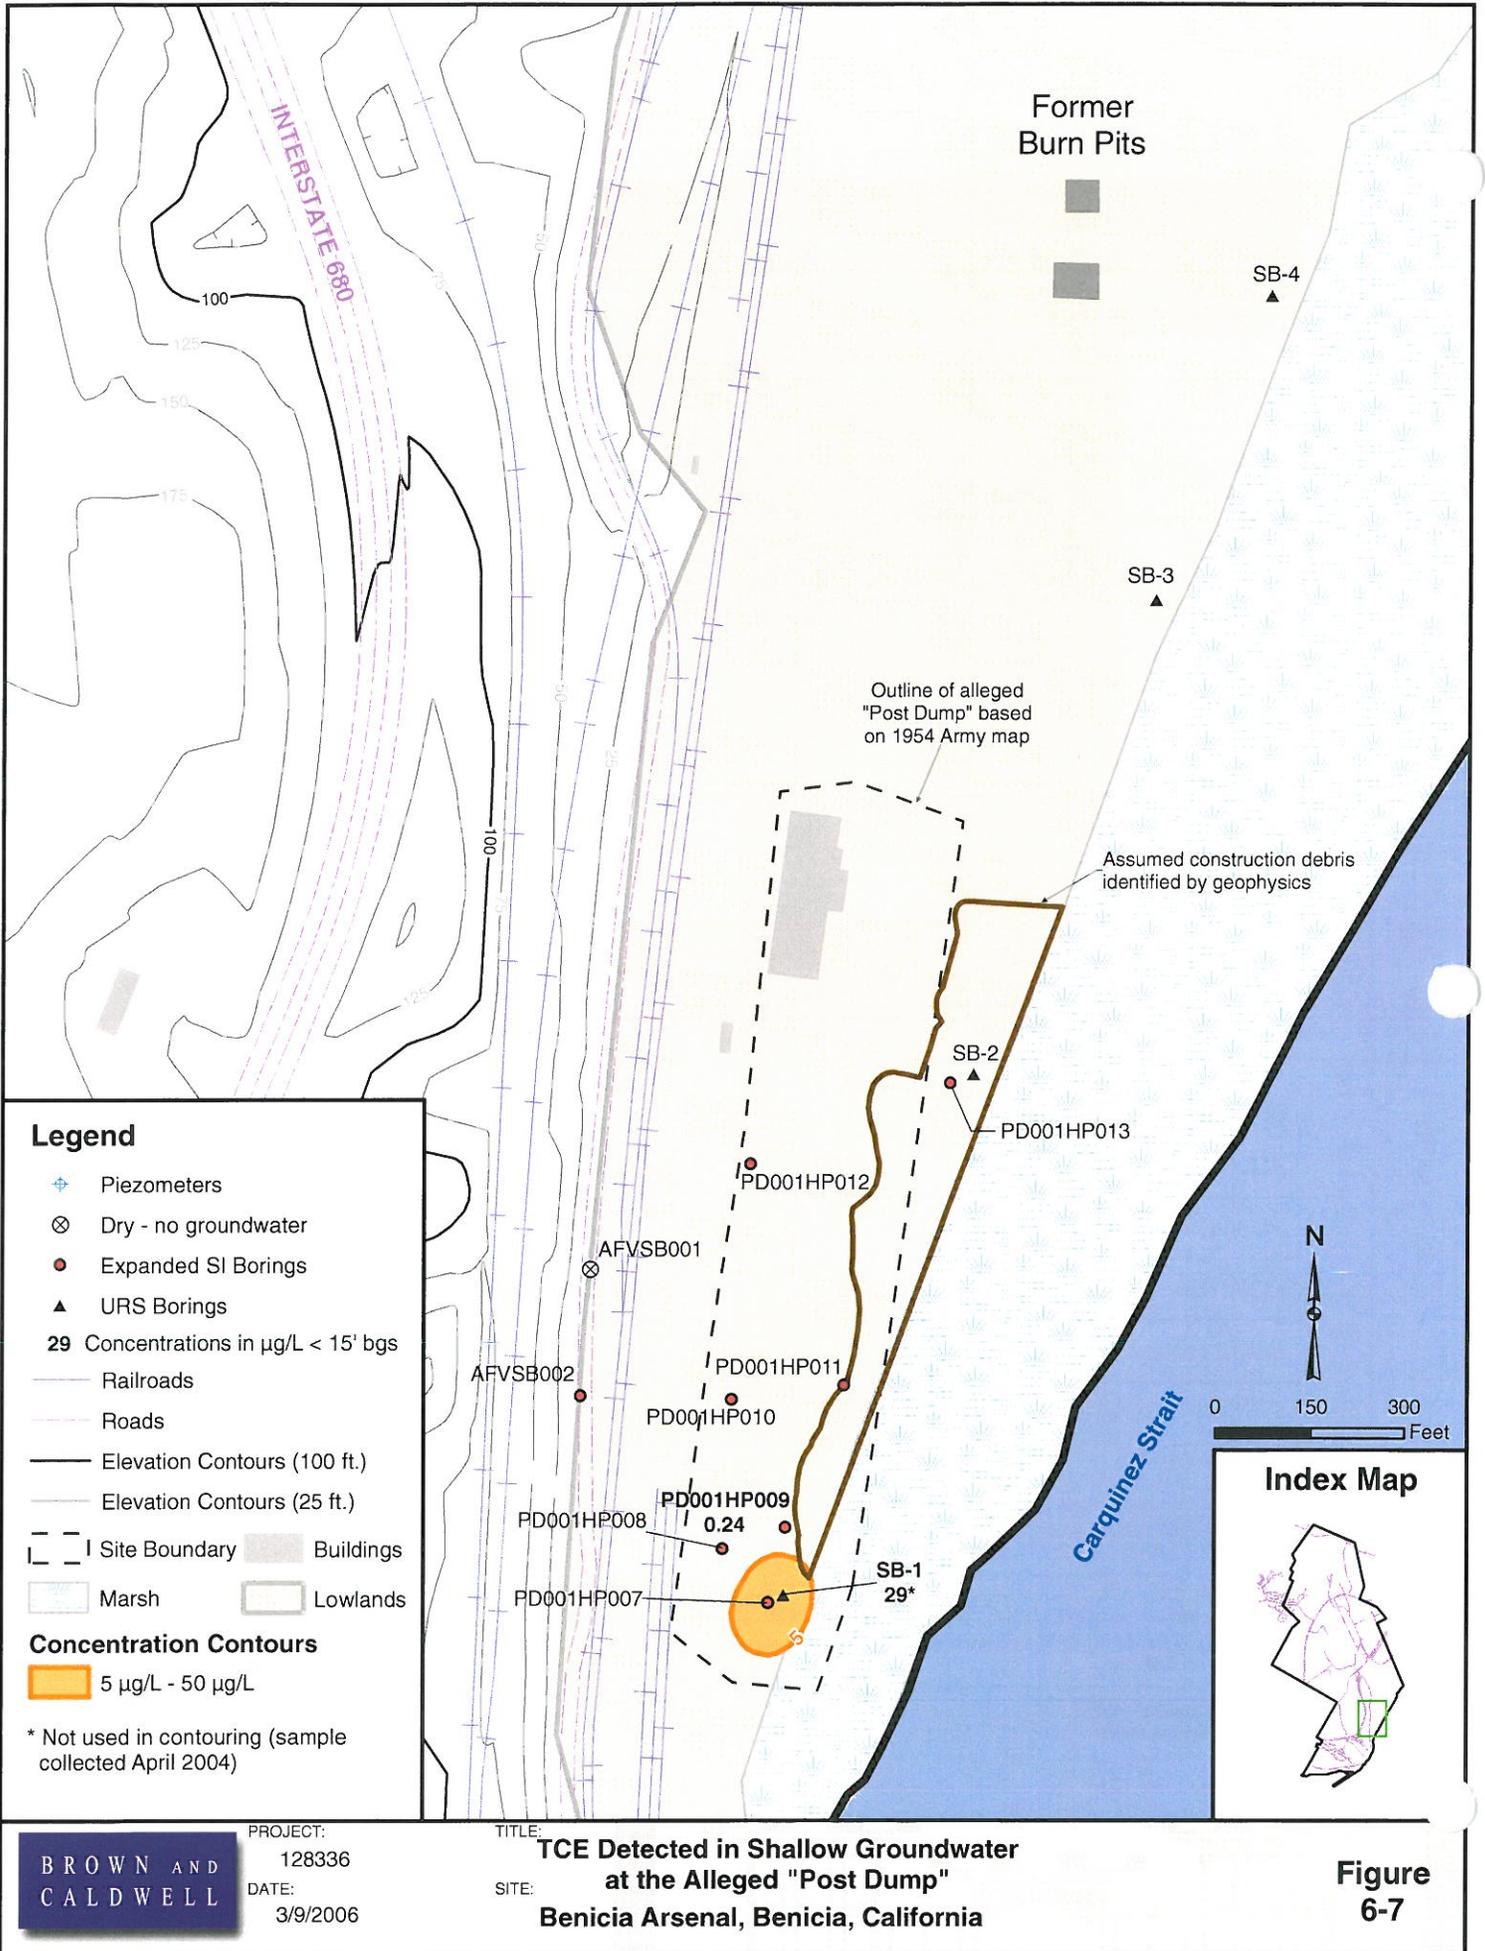
Figure 6-7

TCE was found in shallow groundwater at PD001HP009 at concentrations of 0.24 µg/L, shown in Figure 6-7. No groundwater samples exceeded the TCE ESL of 360 µg/L. Groundwater samples containing cis-1,2 DCE were detected in six of the seven borings advanced (Table 6-6 and Figure 6-8) as shown on Figure 6-8, the highest concentration of cis-1,2 DCE is at the southern end of the alleged Post Dumpsite. Samples collected from PD001HP007 contained a concentration of 150 µg/L. No sample exceeded the RWQCB ESL in soil or groundwater.

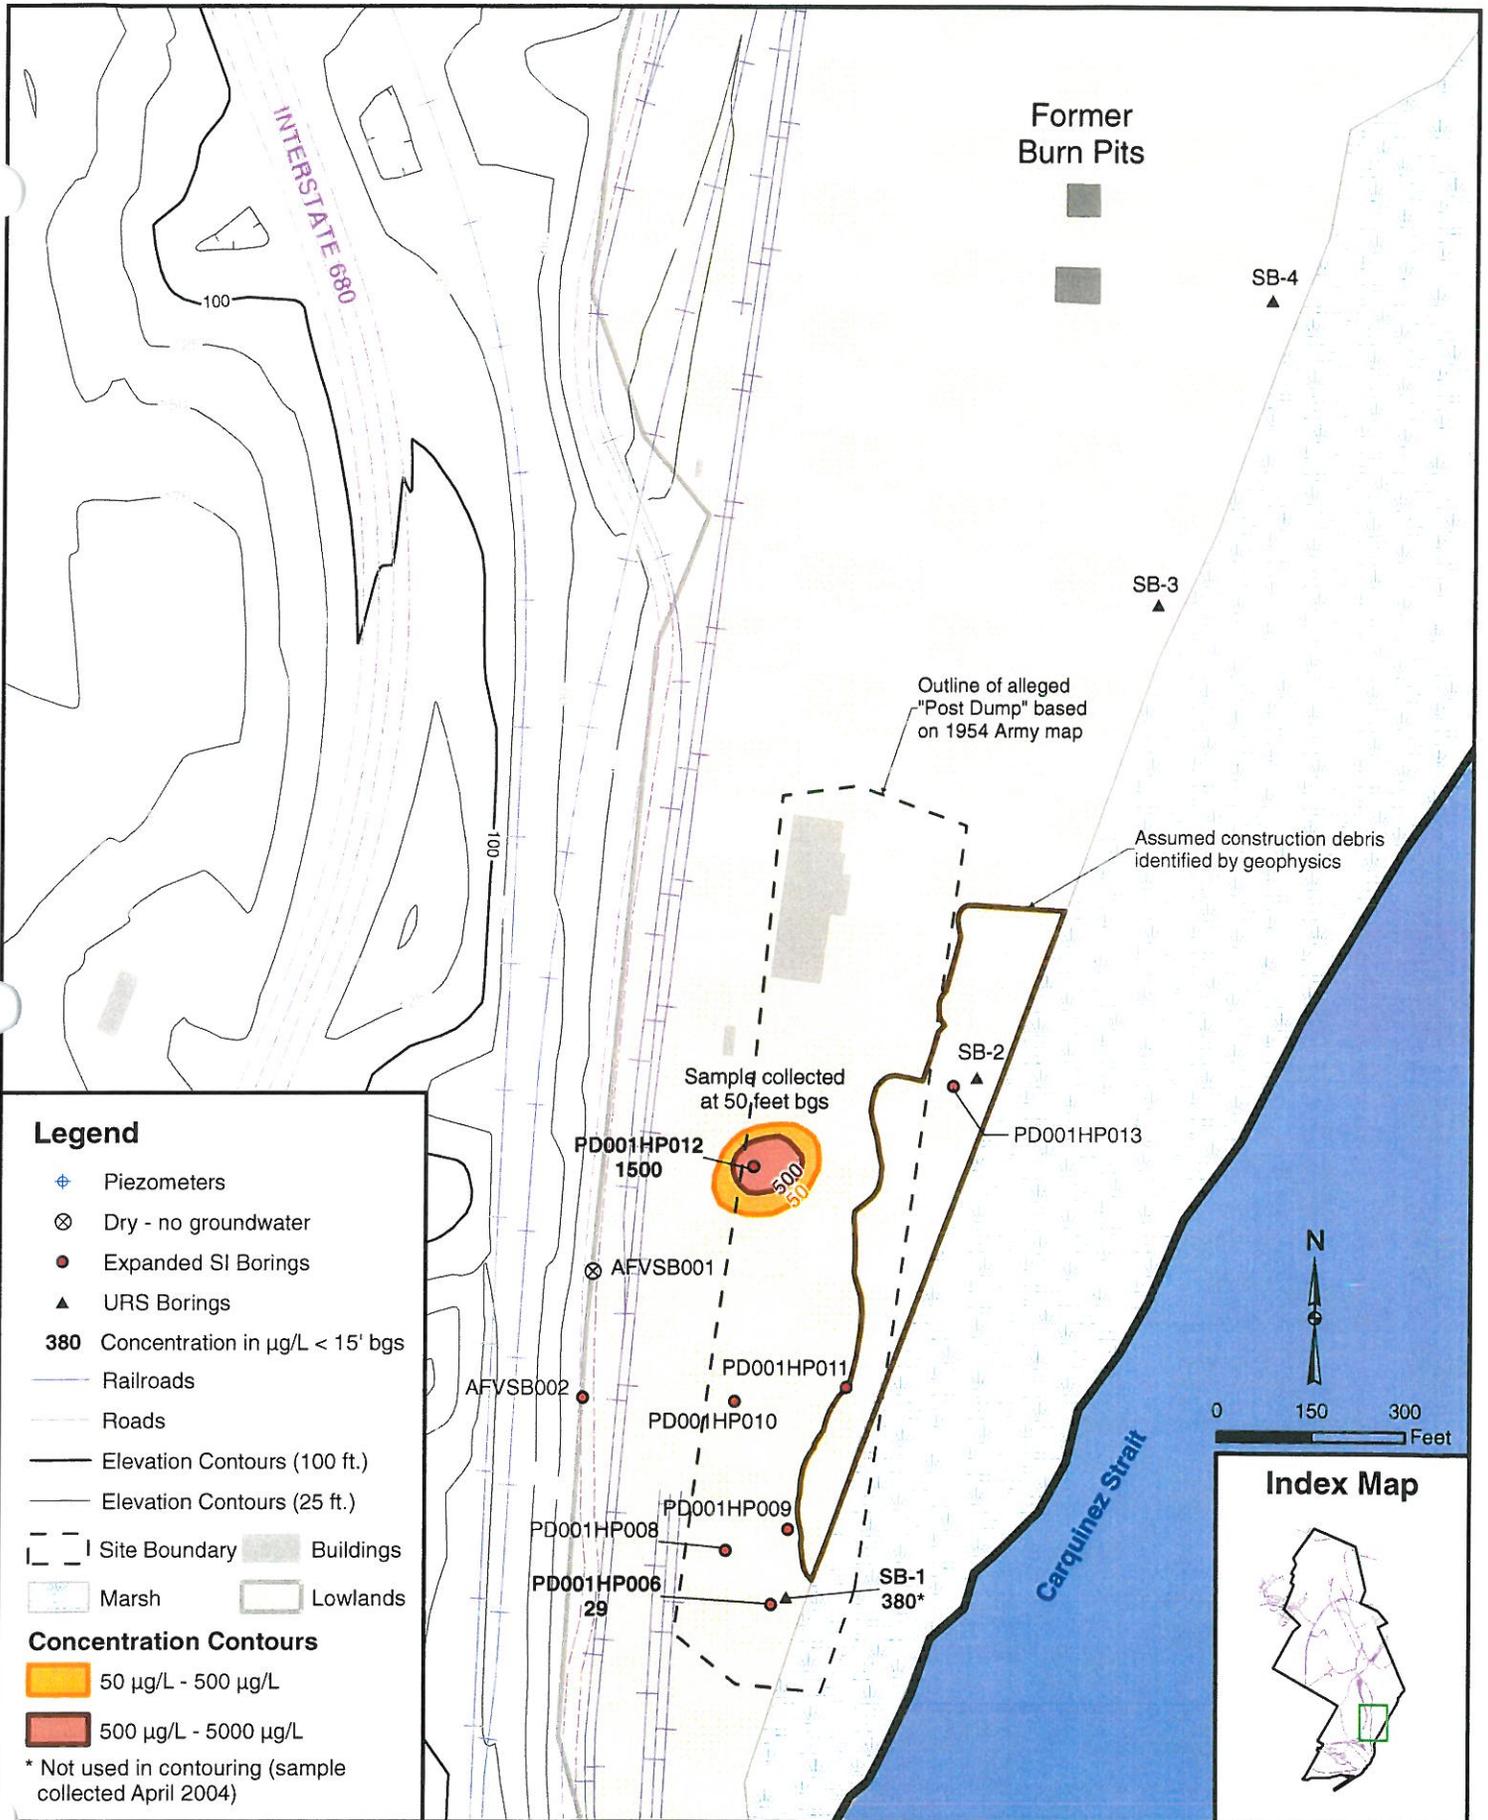
Figure 6-9

Petroleum hydrocarbons were also detected in soil and groundwater samples collected. Shown in Table 6-6, soil concentrations of gasoline, diesel fuel, and motor oil were all below their respective ESLs. Only one location PD001HP012 contained gasoline above the ESL in groundwater. The deep groundwater sample (50-55 feet bgs) contained 1,500 µg/L of gasoline, above the ESL of 500 µg/L and is shown on Figure 6-9.

TITLE: Gasoline Detected in Shallow and Deep Groundwater at the Alleged "Post Dump"
SITE: Benicia Arsenal, Benicia, California
