PROJECT NAME: Tourtelot Property

PROJECT NO.: 35734/04.02

APPENDIX C
SEISMIC REFRACTION SURVEY REPORT

Subject: Seismic Refraction Survey Report
Tourtelot Property
Benicia, California

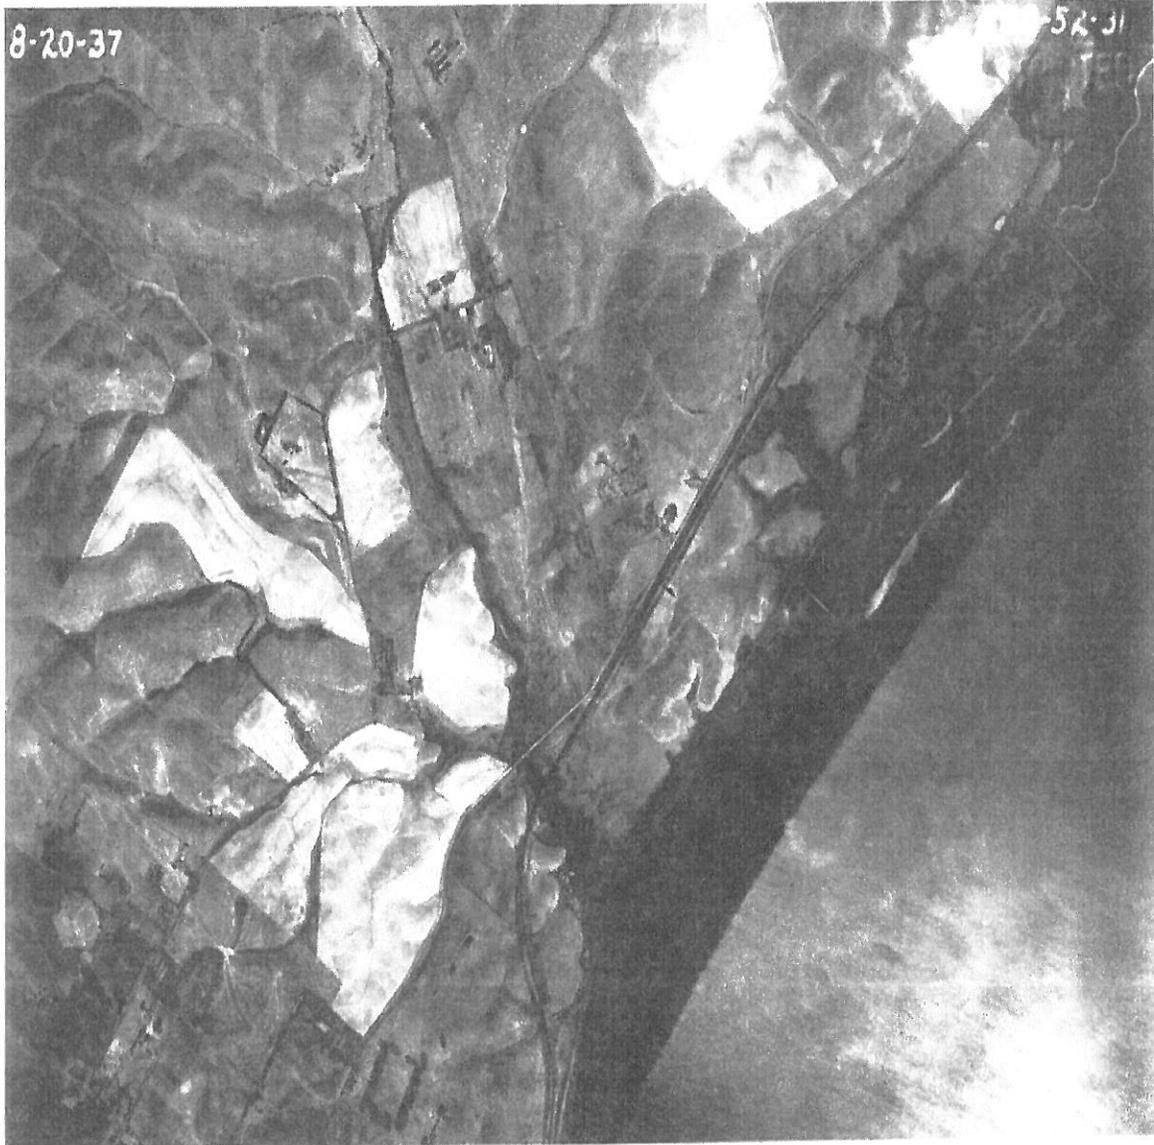
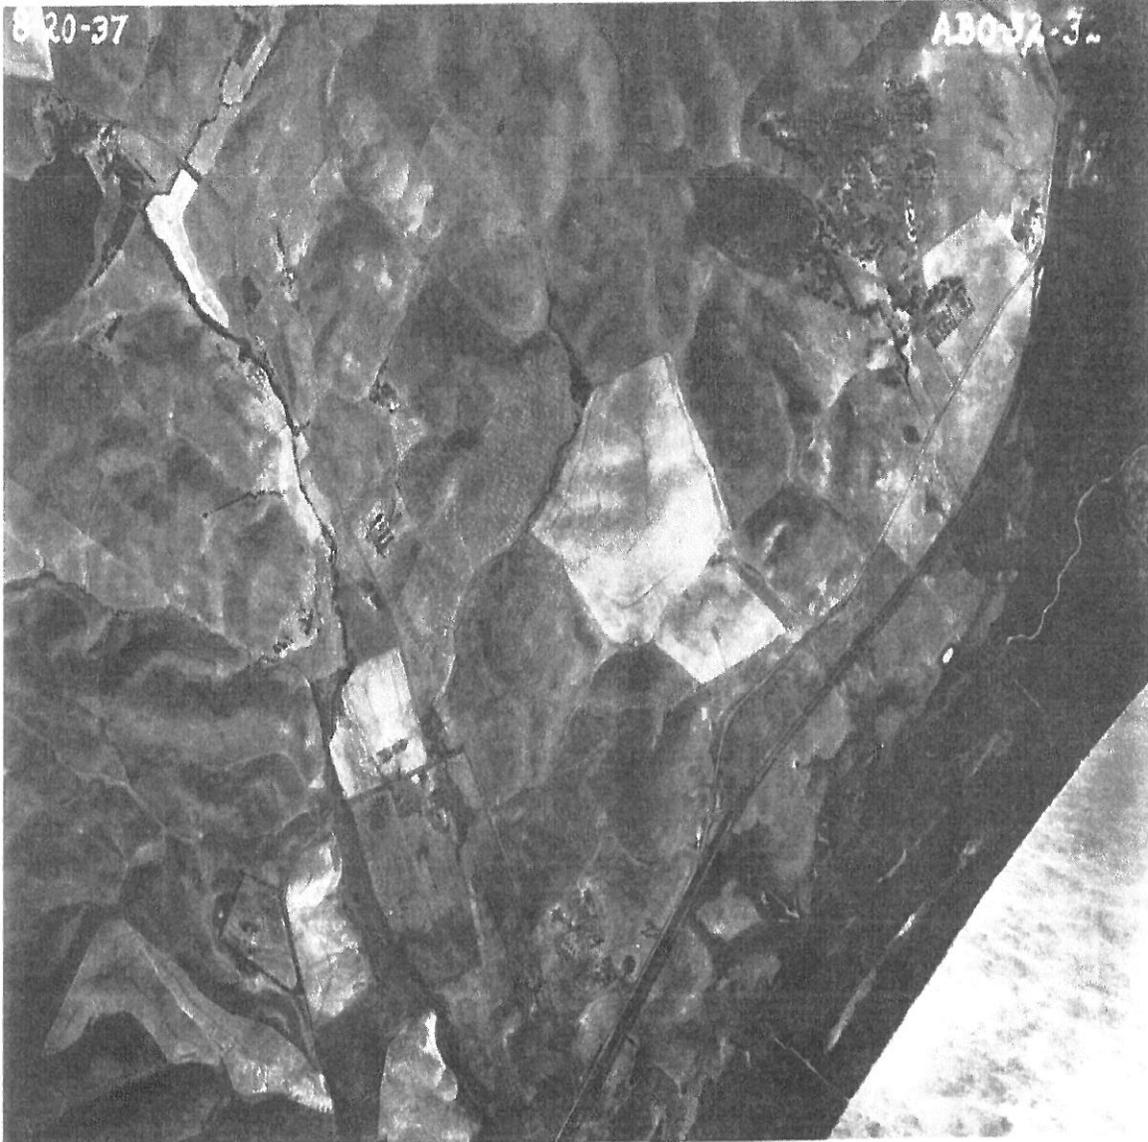
Figure 2. Photo Number ABO-52-31
Estimated Scale: 1:30,000

- **North Valley:** There is very little to be seen in terms of man-made features in the North Valley. A dirt road (possibly Midway Road) and a small structure appear at the base of the slope running northwest from the prominent east-west tree line on the southeastern boundary of the North Valley. An area of agriculture is noted northeast of the property; this field appears to be plowed. Neither the TNT Strips nor any buildings associated with the Howitzer Test Facility or Ammunition Renovation/Primer Destruction Site are visible within the North Valley, although the Project Site fence line is (faintly) visible. The North Valley Military Landfill is not visible. No evidence of grading activities is noted within the North Valley.

- **Ridge:** None of the features known to occur in the Ridge area, including the Dynamite Burn Site, roads, grading activities, and soil piles, were observed on the photographs.

- **South Valley:** A small stand of trees is noted to the southeast in the South Valley. Neither the Flare Site nor the Demolition Sites are visible in this photograph. Neither the McAllister Drive Land Bridge nor the housing tracts have been constructed in 1937. No grading activity is observed.

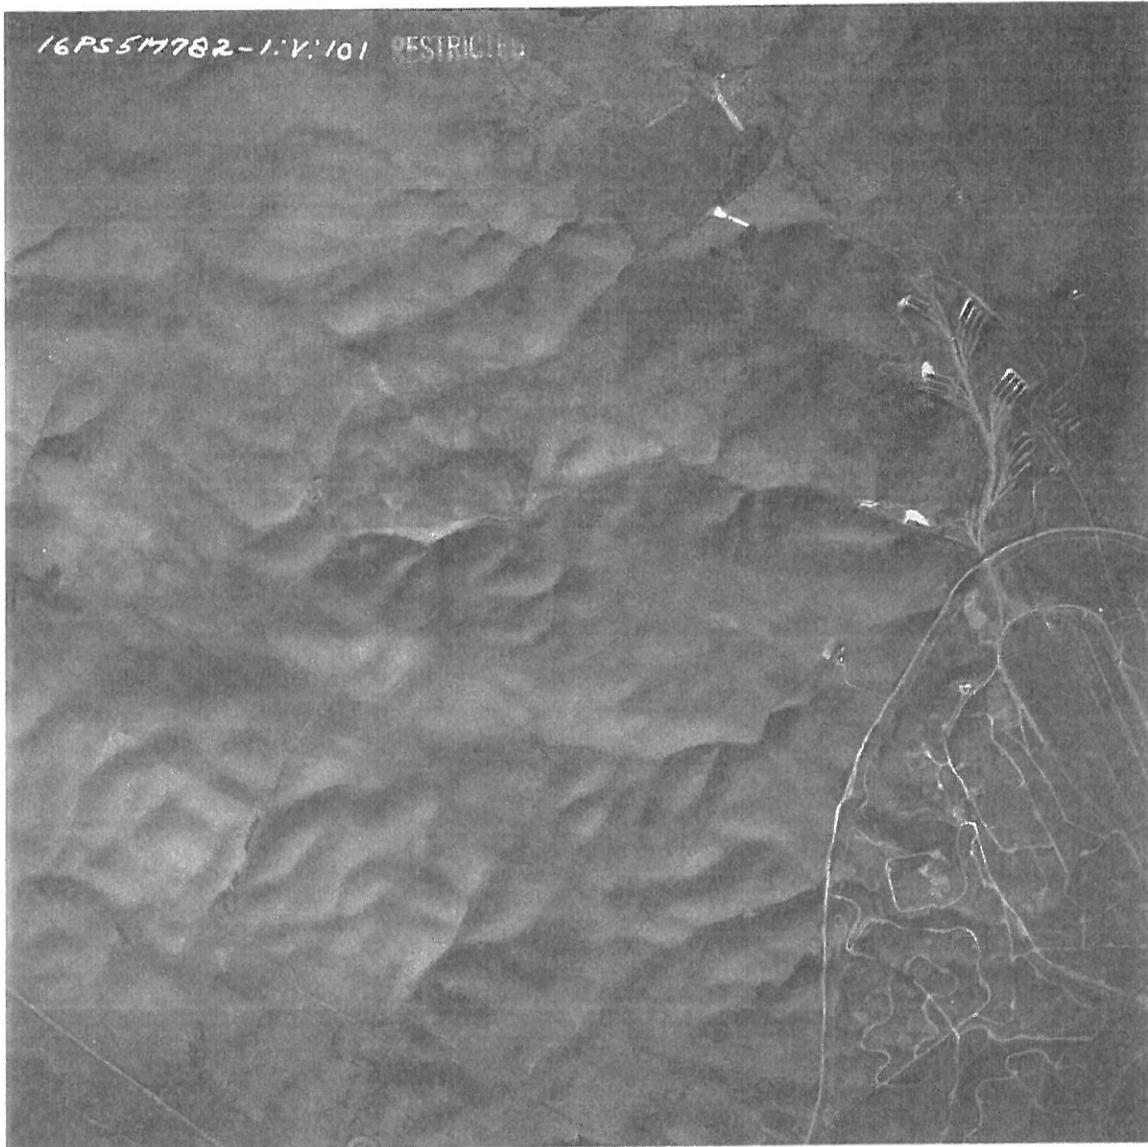
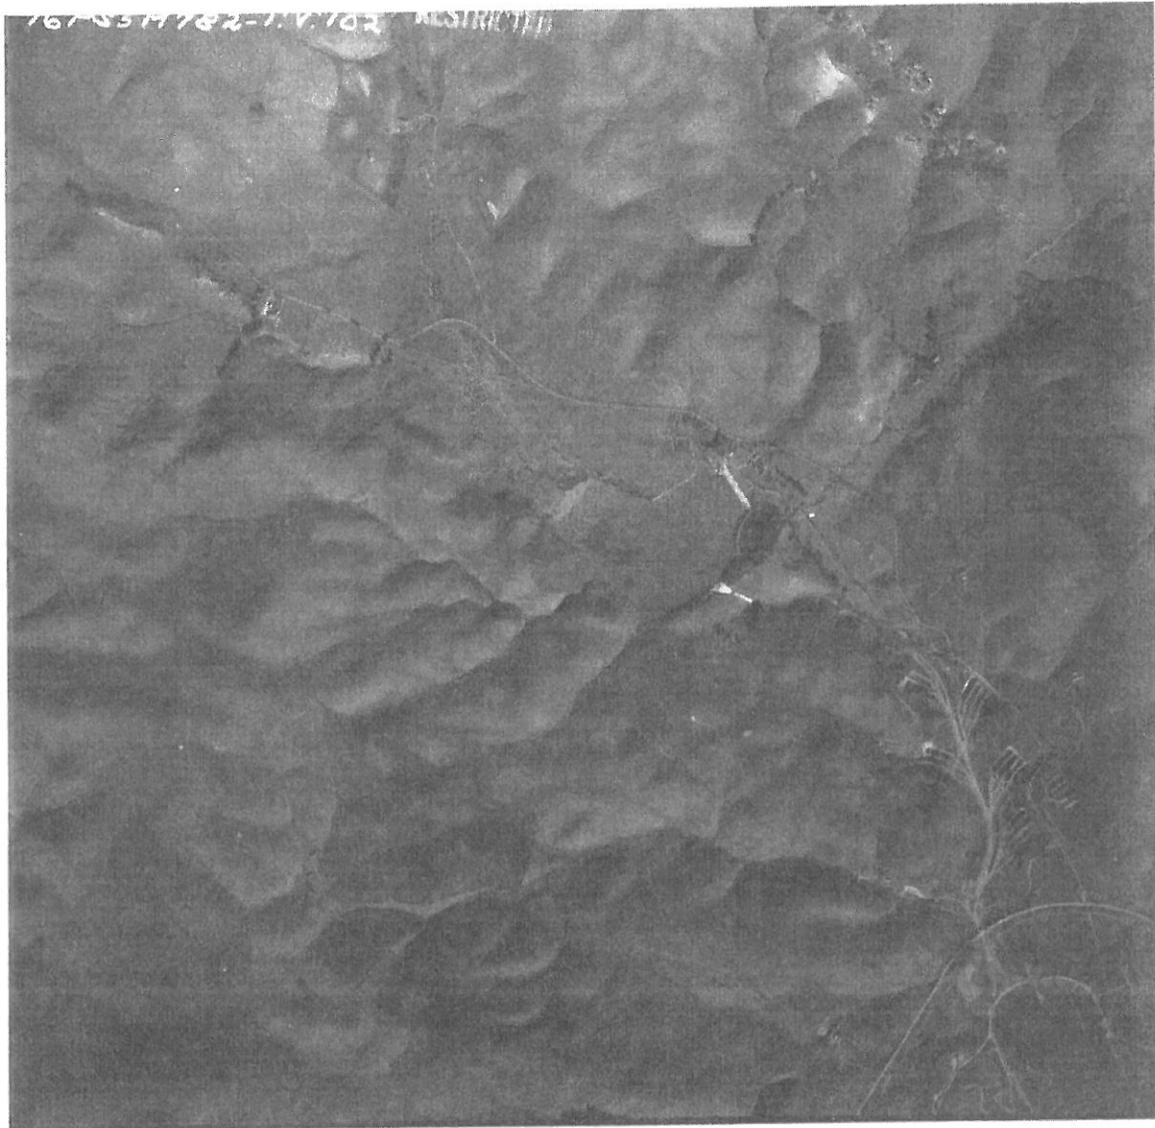
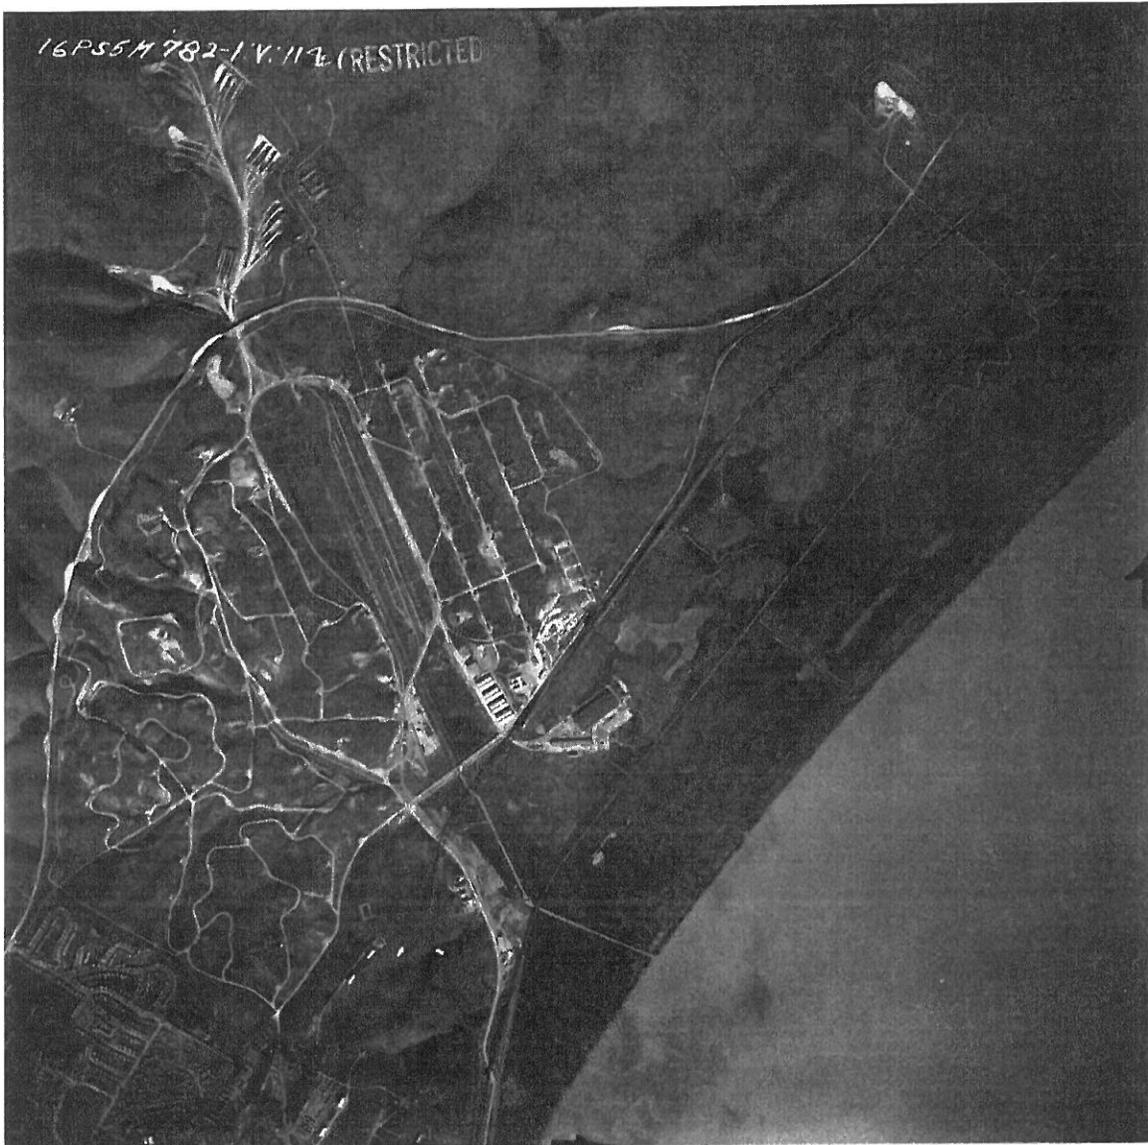
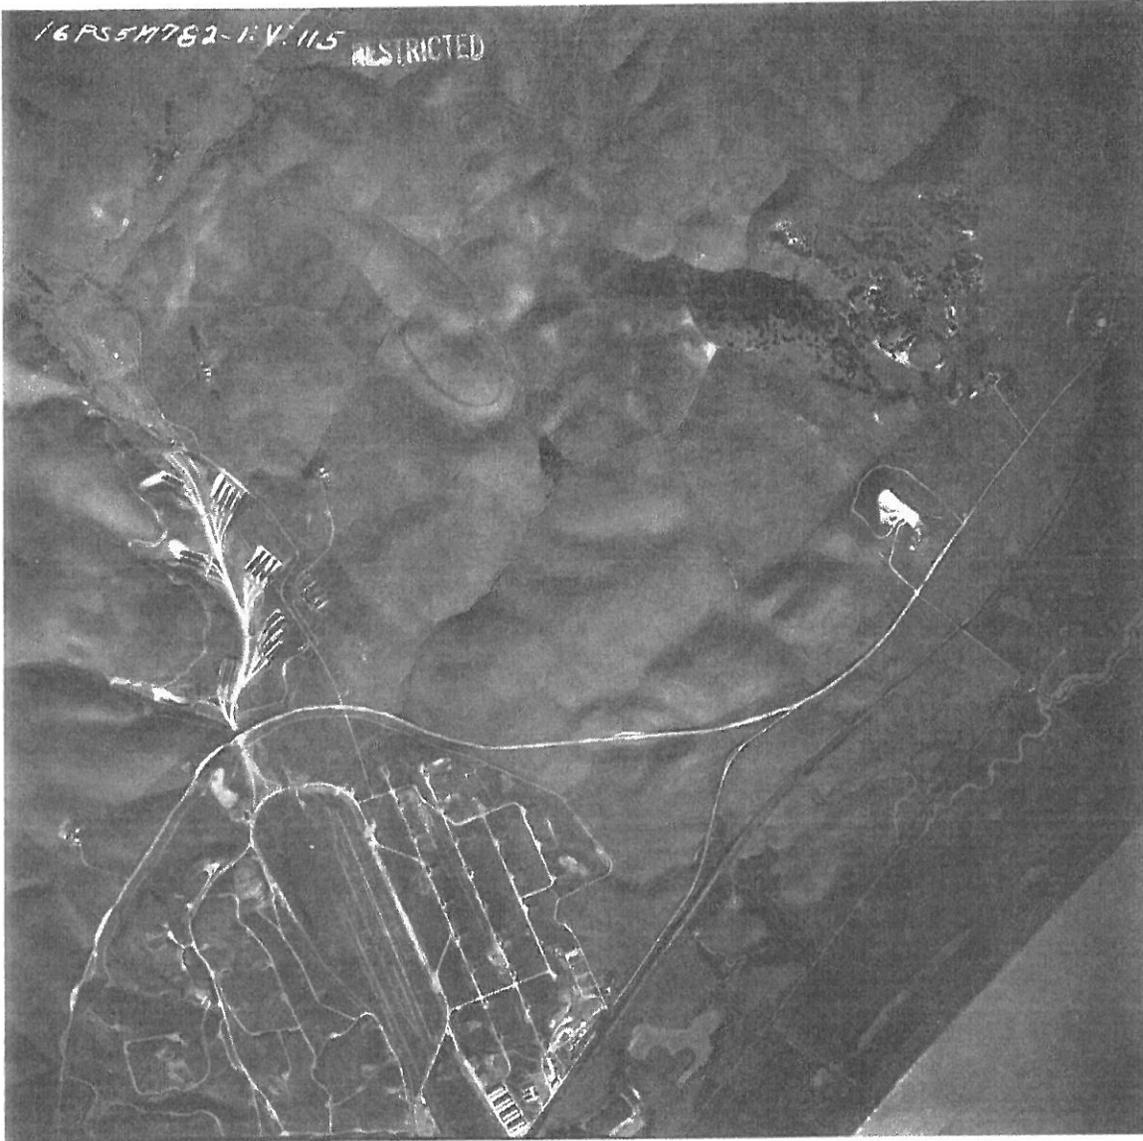
Figure 4. Photo Number 16PS514782-1:v:101
Estimated Scale: 1:30,000

- **Ridge:** The Dynamite Burn Site is not visible on any of these photographs. There is no ground disturbance or activity noted along the Ridge area in Photographs 114-115. No structures are visible.

- **South Valley:** There is no evidence of activity noted within the South Valley in these photographs. The Demolition Sites and Flare Site are not visible. An east-west-trending road that travels from the railroad spurs westward is visible. This road was not visible on the 1937 photograph. There is no evidence of grading or construction; the McAllister Drive Land Bridge had not been constructed in 1945.

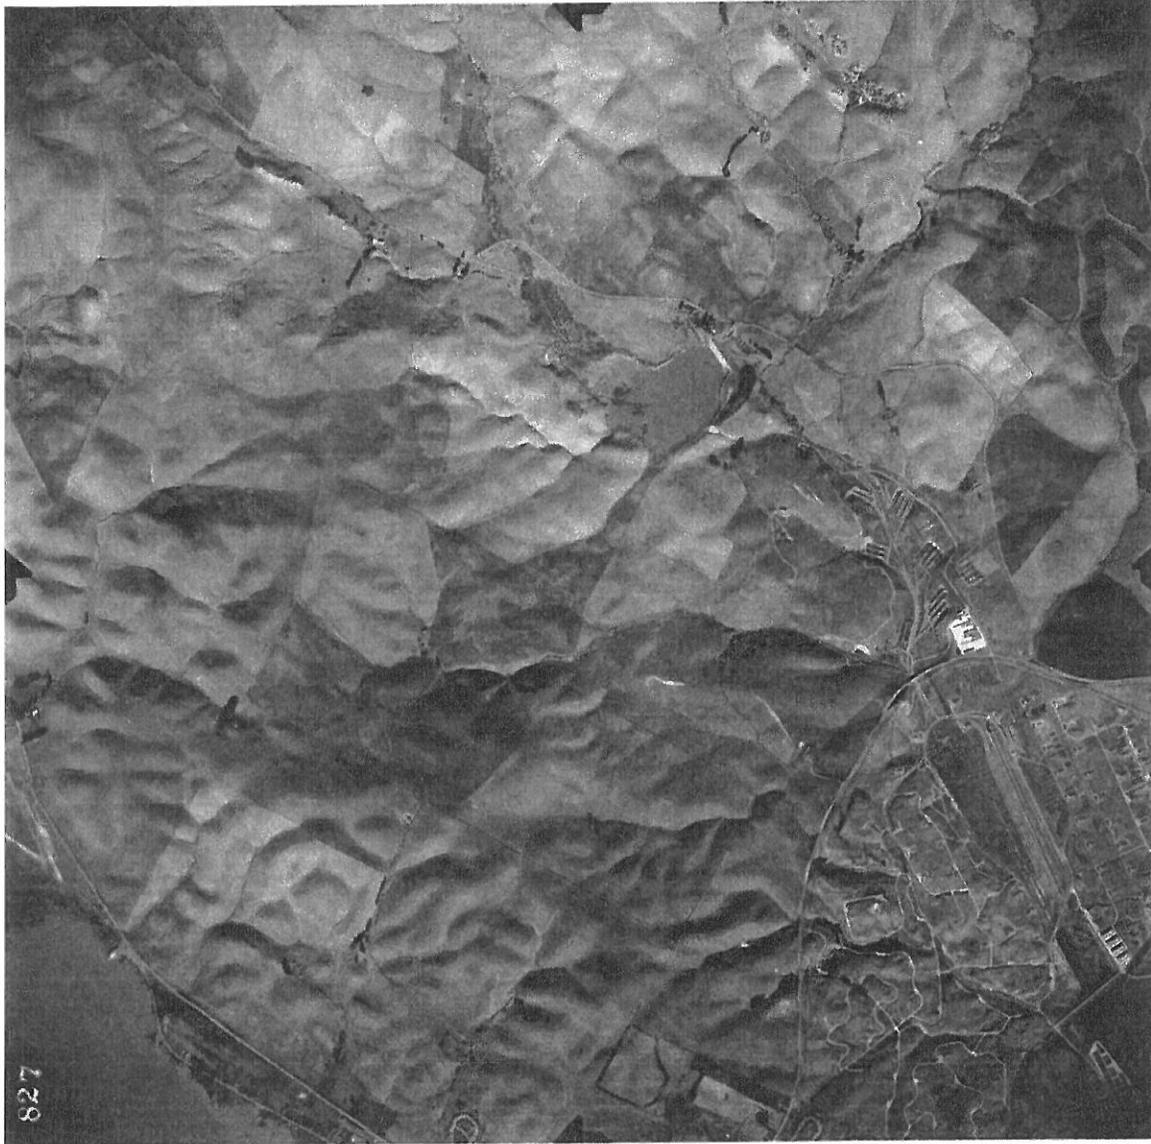
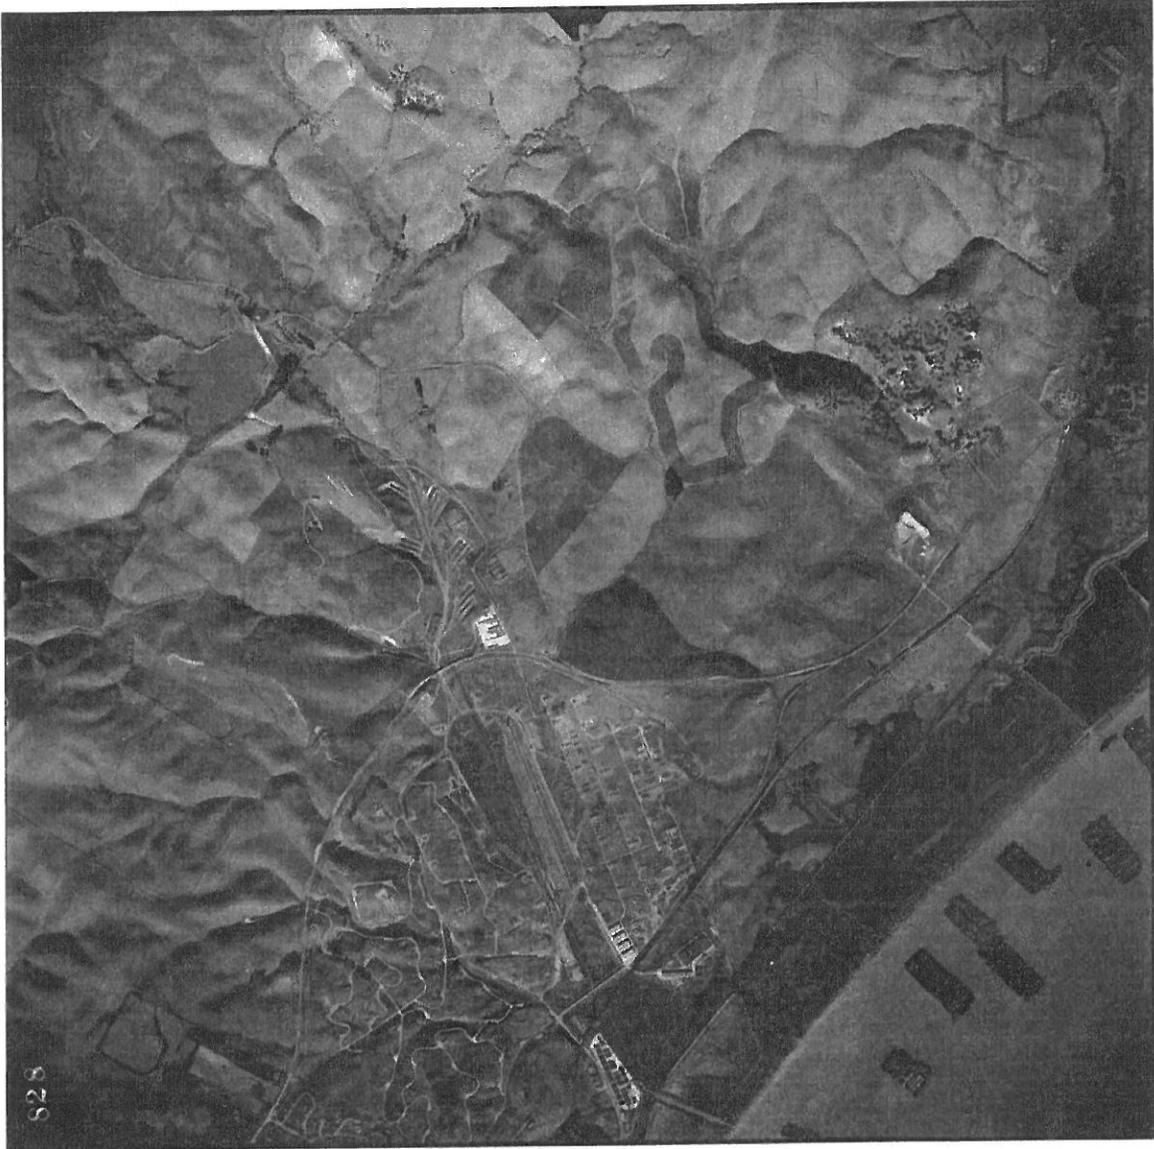
**Figure 8. Photo Number VVWZM7 AMS 1 DEC 47 43 (827)
Estimated Scale: 40,500**

- **Ridge:** The Dynamite Burn Site is not visible. On the south edge of the oval Ammunition Renovation/Primer Destruction Site is a dirt road running south-southwest toward the Ridge area; this road is shaped like a "J" and links the Dynamite Burn Site with the facilities in the North Valley. At the end of the "J" is a truck turnaround (the Dynamite Burn Site is to the north of this truck turnaround). There do not appear to be any buildings extant within or north of the truck turnaround, only a small stand of trees. The ground shows signs of disturbance with numerous vehicle tracks within the Dynamite Burn Site.

- **South Valley:** There are substantial changes to the South Valley visible since 1945. The Flare Site and Demolition Sites are visible on the north and south side of the valley. There is a dirt road leading to these areas through the valley. There is no evidence of grading activity noted in the South Valley. The McAllister Drive Land Bridge has not been constructed; no home construction has occurred.

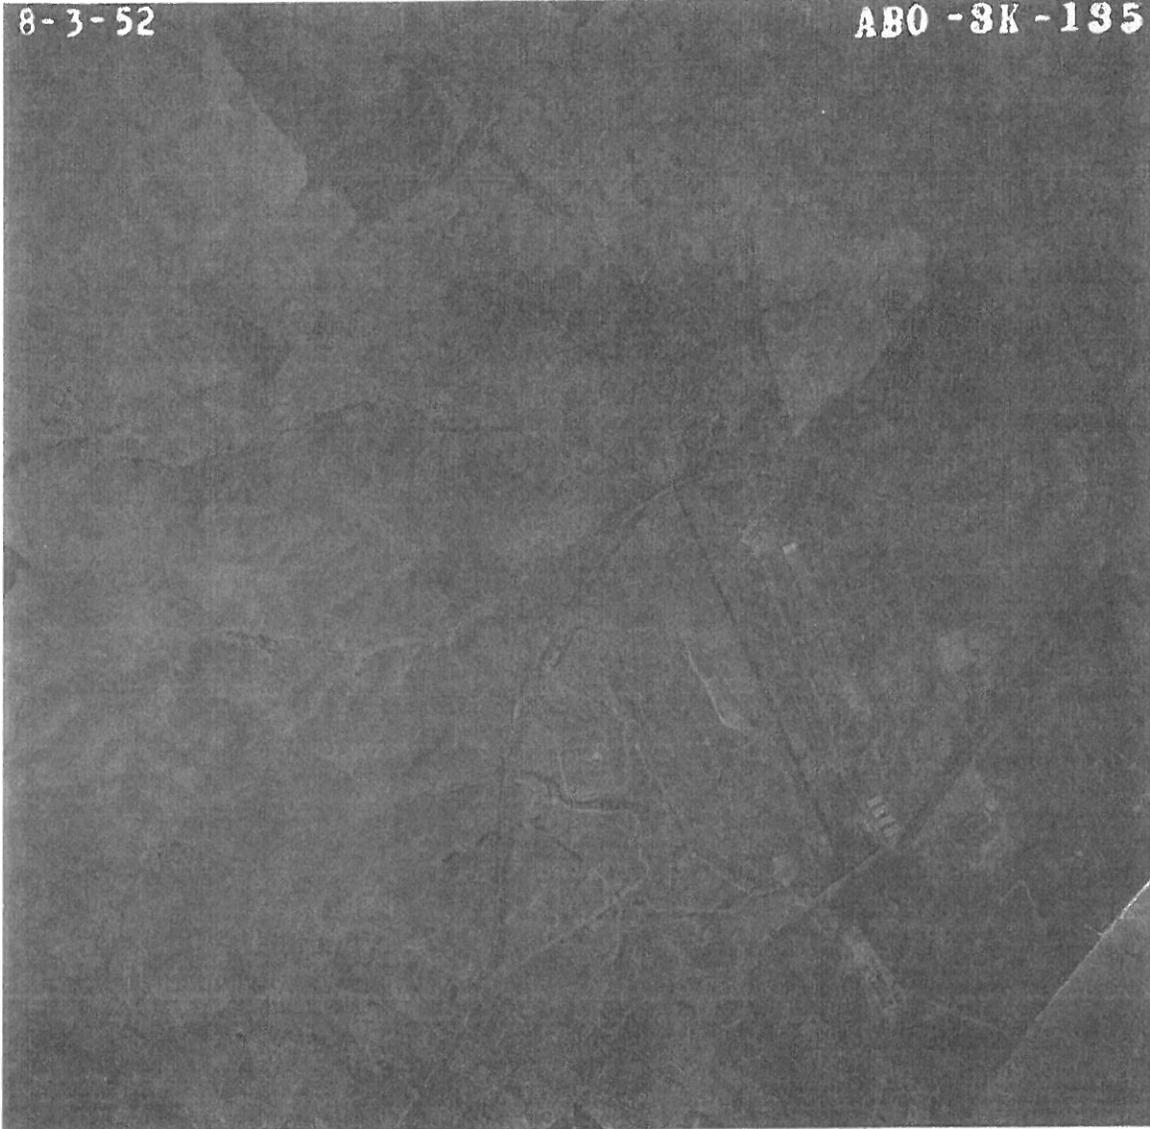
Figure 10. Photo Number ABO-3K 135
Estimated Scale: 1:30,000

- **North Valley:** There are only minor changes visible since 1947. All five TNT Strips, the Powder Loading Room (Building 183), and the Test Firing Butts (Building 182) in the Howitzer Test Facility are visible in the 1952 photograph. The ground disturbance between the TNT Strips noted in the 1947 photograph is no longer apparent. Midway Road and the prominent east-west-trending tree line are also visible. Although it appears that there is a small road leading to this location, neither Buildings 540 and 542 nor the Test Firing Tunnels (Building 181) in the Howitzer Test Facility are visible in these photographs. The North Valley Military Landfill, just east of the Test Firing Tunnel location, is faint. The Project Site Fence Line is faintly visible along the western boundary of the property. There is some ground disturbance noted in the Ammunition Renovation/Primer Destruction Site, although there do not appear to be any structures noted. No evidence of grading is visible.

- **Ridge:** There is evidence of the ground disturbance northwest of the Dynamite Burn Site that was also noted in the 1945 and 1947 photographs. A network of dirt roads converges on the Dynamite Burn Site from all directions. The "J"-shaped road links the Dynamite Burn Site to the facilities in the North Valley. Neither the soil/debris piles nor grading is visible along the Ridge.

- **South Valley:** The only activities visible in the South Valley are a few roads and a disturbed area extending west from the railroad tracks. This disturbed area lies along the southeastern border of the South Valley and the Project Site boundary. The major dirt road access extends westward from this area. Several other smaller roads/trails also cross the South Valley. Nothing is visible around the Flare Site/Demolition Sites except for the road leading to the area.

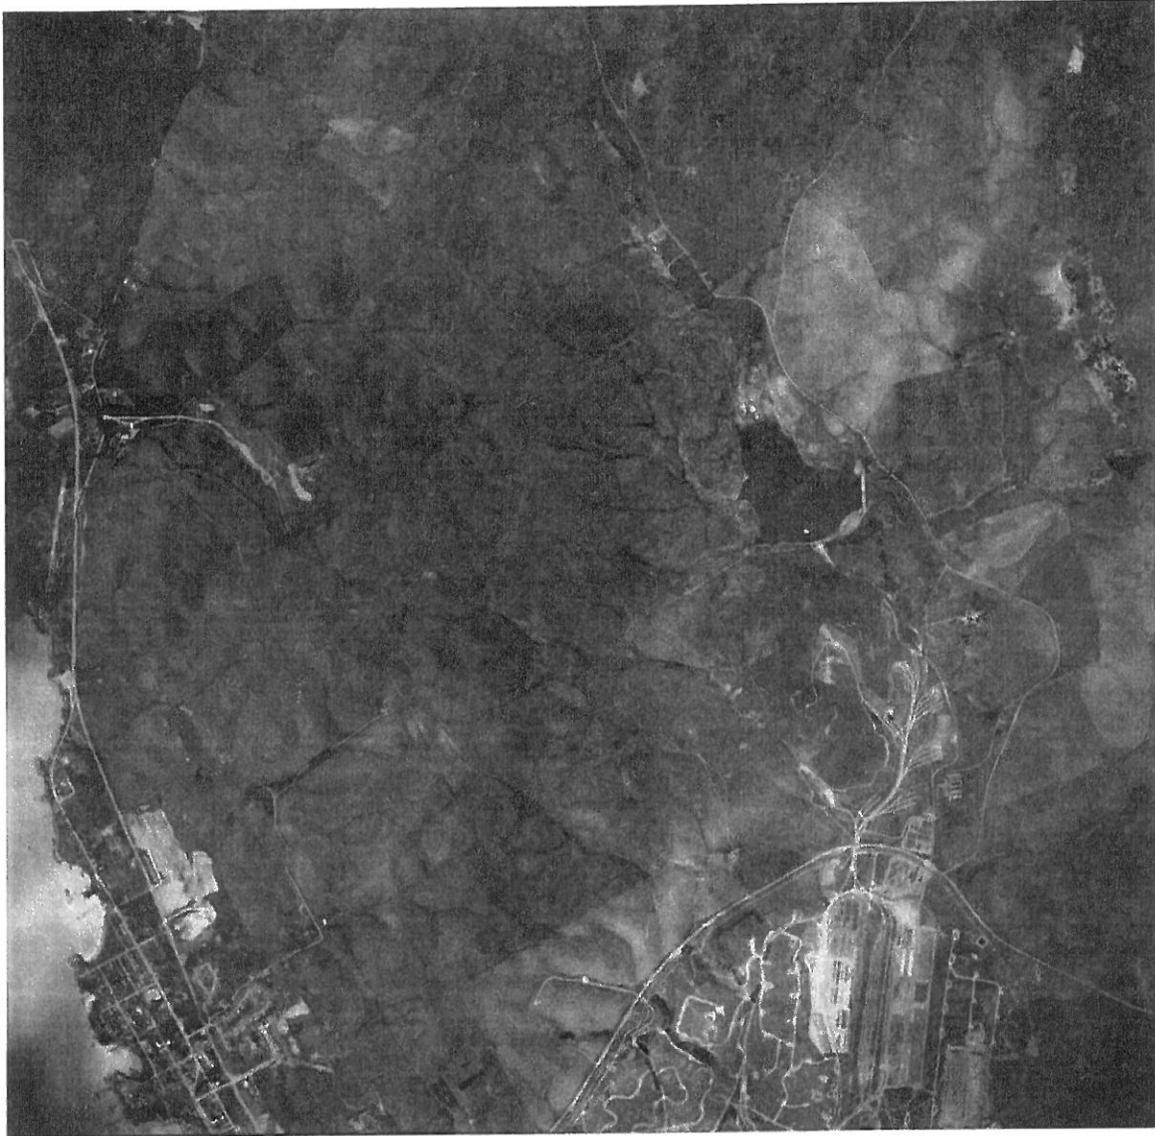
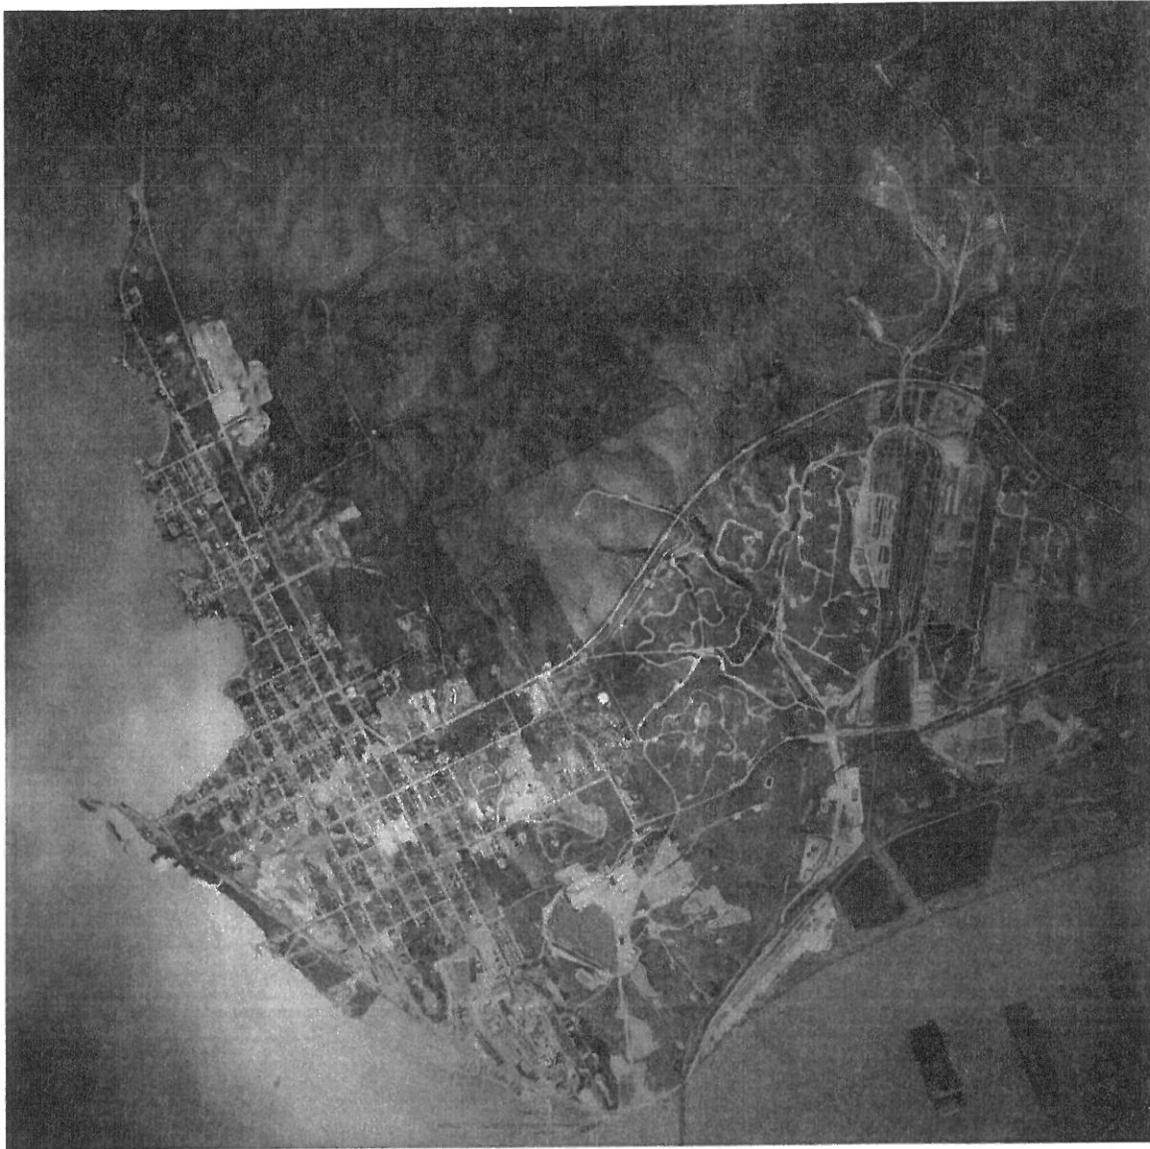
Figure 12. Photo Number 146 6inv
Estimated Scale: unknown

- **North Valley:** There are a few changes noted since the 1952 photograph. There appears to be an area of recent grading that appears lighter than the surrounding area in the Howitzer Test Facility area and the Ammunition Renovation/Primer Destruction Site not visible in previous photographs. Only the Powder Loading Room (Building 183) and the Test Firing Butts (Building 182) are visible. Midway Road and the prominent east-west-trending tree line are visible in these photographs. Four out of five of the TNT Strips are also visible; T3 is not visible. There is evidence of ground disturbance activity in the area surrounding the North Valley Military Landfill; none of the buildings associated with these areas (Buildings 540, and 542) are visible. The ground disturbance activities have produced scarring in this area that appears lighter than the surrounding area; these activities were not observed in previous photographs of the North Valley. None of the buildings associated with the Ammunition Renovation/Primer Destruction Site are visible in these photographs. The Project Site fence line is prominent along the west edges of the North Valley.

- **Ridge:** The Dynamite Burn Site is visible in these photographs. Light shaded areas suggest grading activities at the Dynamite Burn Site, as well as in the southern part of the Ridge area (i.e., toward the South Valley). South of the prominent east-west-trending tree line that borders the southeastern edge of the North Valley is a light-colored, depressed area that follows the natural relief of the topography. There is evidence of grading at the location of the soil/debris stockpiles. A few piles are noted as well; these piles were not observed in previous photographs of the ridge. The "J"-shaped road, which links the Dynamite Burn Site to the North Valley, is visible and extends toward the soil/debris stockpiles.

- **South Valley:** There is disturbance along the South Valley from the railroad tracks and westward. Most of this disturbance appears lighter than the surrounding area and includes the Flare Site and Demolition Sites. The Flare Site and all three Demolition Sites, which had not been observed in previous photographs, are now visible. There are a number of new roads throughout the South Valley that are visible as well. McAllister Drive Land Bridge has not yet been constructed, nor has any of the housing construction begun.

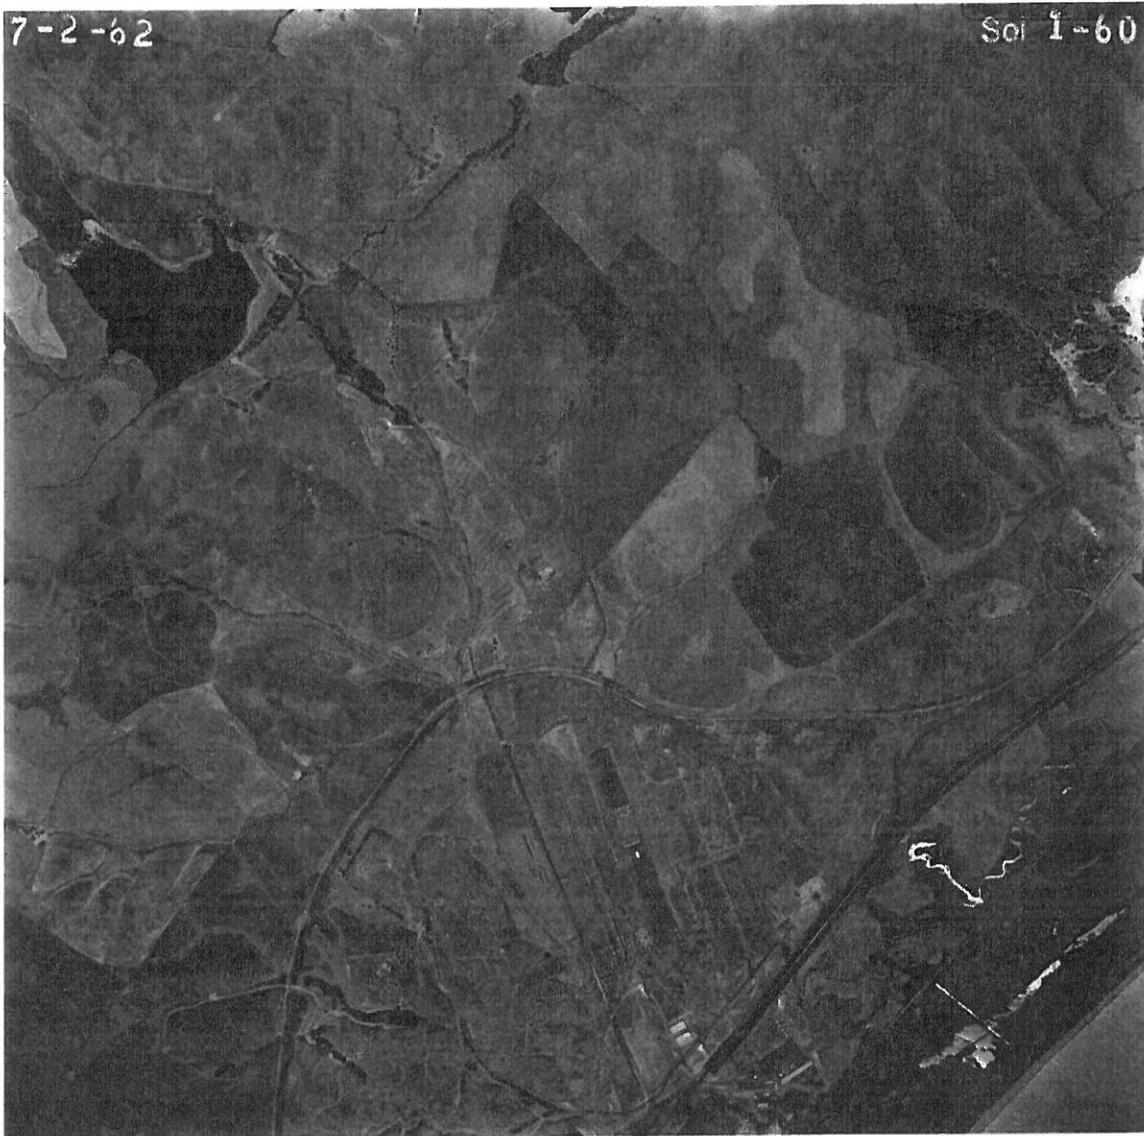
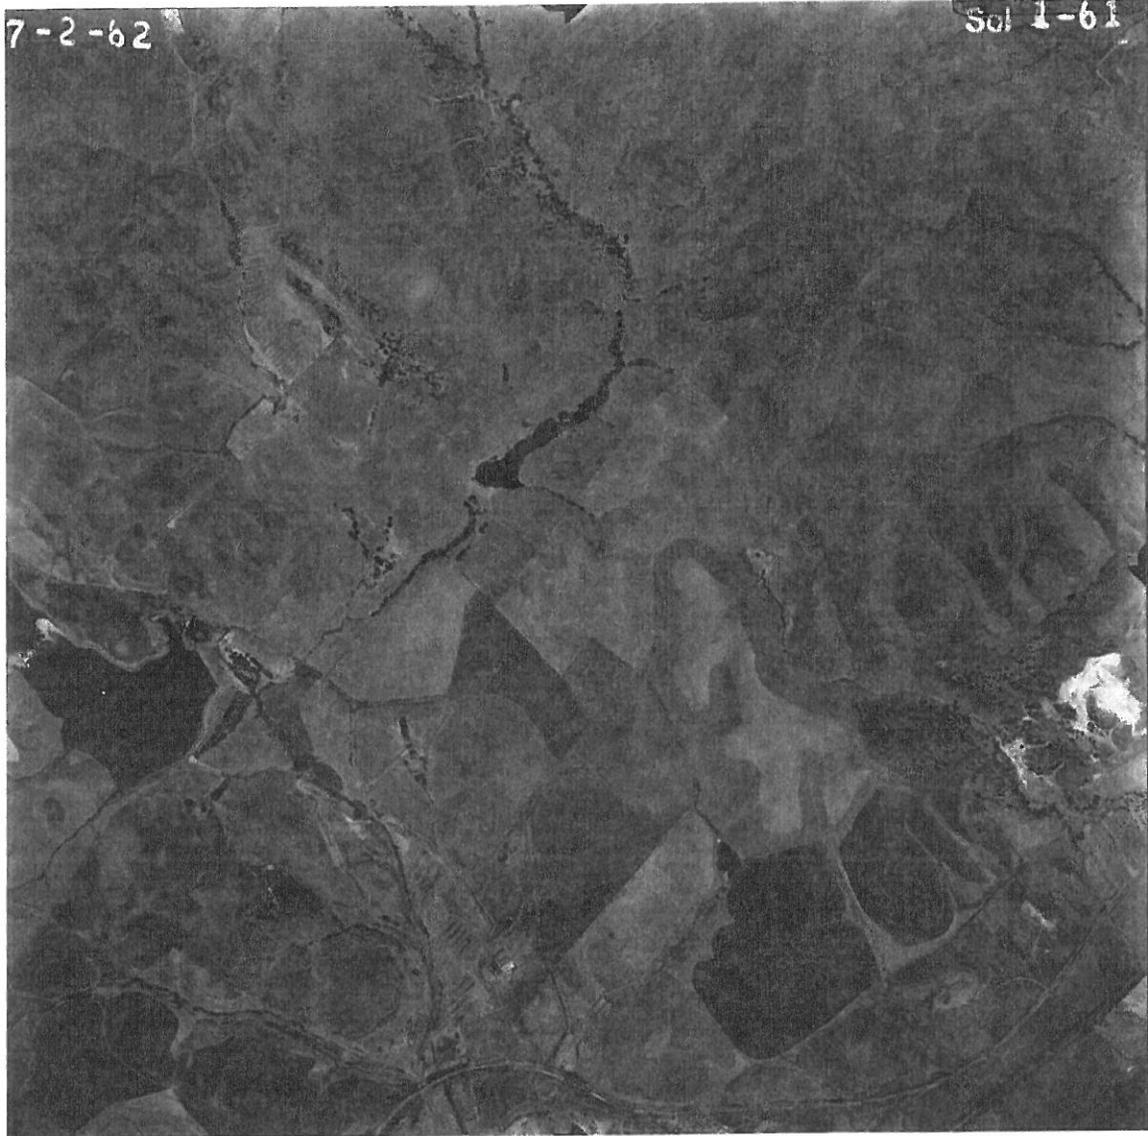
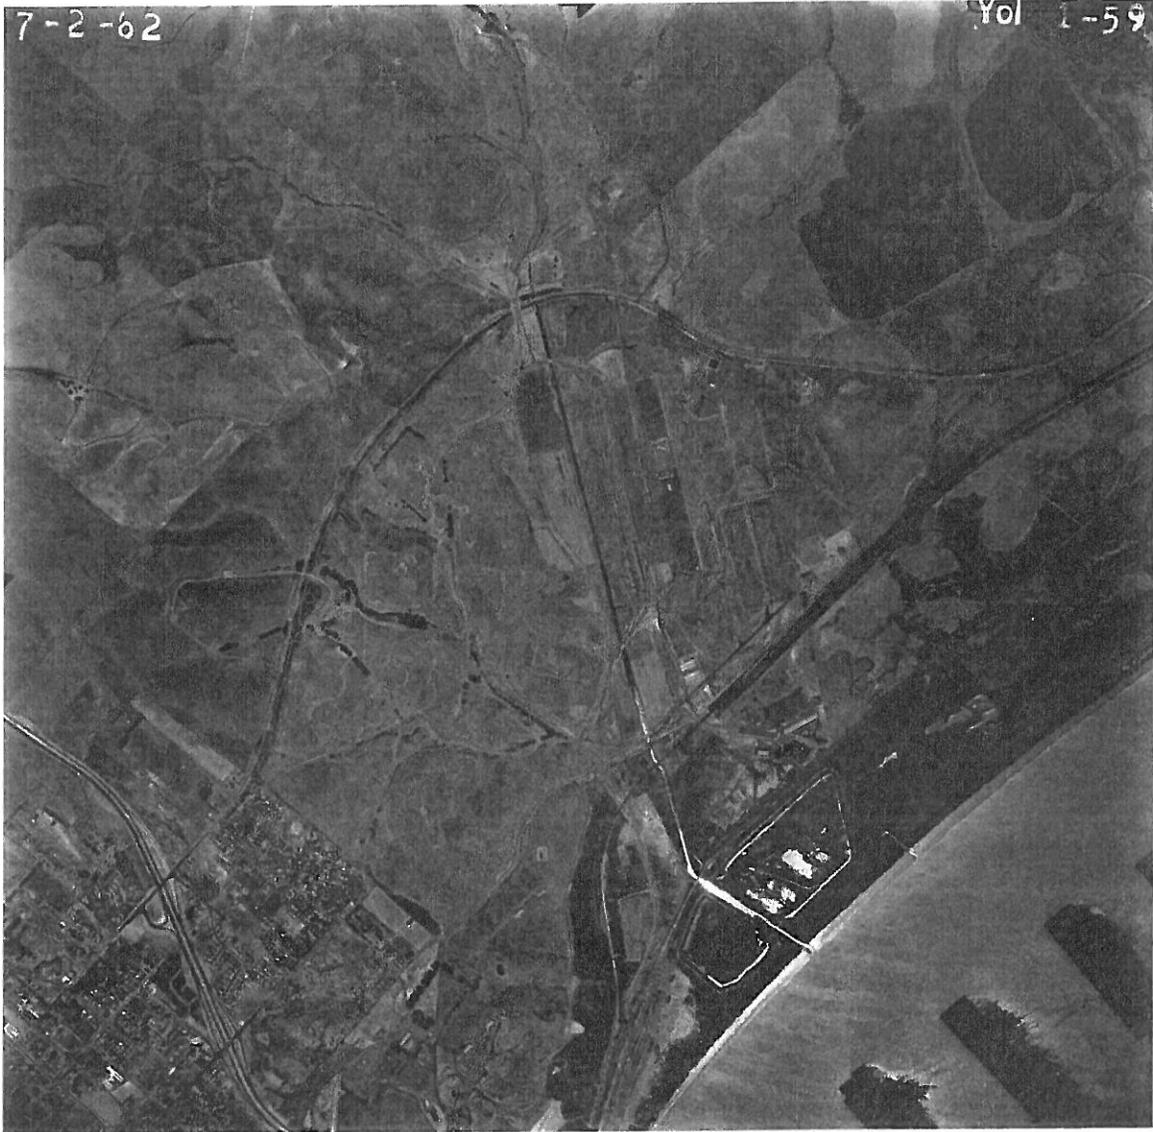
Figure 14. Photo Number SOL 1-60
Estimated Scale: 1:36,000

- **North Valley:** There are subtle changes to the North Valley since 1960. Four TNT Strips are visible; TNT Strip T3 is not visible. The Howitzer Test Facility is visible; the southern portion of this area appears to be surrounded by trees not noted in previous photographs. The Test Firing Tunnels (Building 181), the Test Firing Butts (Building 182), the squirrel cages, Buildings 540 and 542, the Powder Loading Room (Building 183), and other buildings associated with the Ammunition Renovation/Primer Destruction Site are visible. There is visible ground disturbance to the east and southeast of the Howitzer Test Facility, at the North Valley Military Landfill area. There appear to be a number of structures in the Ammunition Renovation/Primer Destruction Site; possible remnants of the squirrel cages (ca. 1945-1947). Both the Howitzer Test and the Ammunition Renovation/Primer Destruction Site appear to be contained inside of a fence, which is not noted in previous photographs. The Ammunition Renovation/Primer Destruction Site appears to be graded; both hilltops, as indicated by topographic maps, have been removed since 1937. Midway Road is visible. The Project Site fence line is visible along the western edge of North Valley. The prominent east-west tree line is visible. At the northeastern corner of the Project Site is a light-colored area that contrasts with the surrounding area just east of the TNT Strips.

- **Ridge:** The "J"-shaped road traveling south from the Howitzer Test Facility to the Ridge is faintly visible. The Dynamite Burn Site is visible at the end of the "J"-shaped road in these photographs. Some disturbance is shown along the Ridge, including a dirt road visible running south from the edge of the prominent east-west tree line in the southeastern portion of the North Valley toward the South Valley. A darker area that contrasts with the surrounding lighter vegetation of the area is noted along the east edge of the Ridge; this darker area was not apparent in any prior photographs. No

soil/debris piles are visible; however, this location has been disturbed by grading activities, as noted in photographs from 1945 and 1960.

- **South Valley:** No evidence of activity is noted in the South Valley area since 1960; faint traces of the Flare Site and the Demolition Sites are visible. Roads leading to these areas are faint. McAllister Drive Land Bridge has not yet been constructed, nor has any of the housing construction begun.
