PROJECT NAME: Tourtelot Property

PROJECT NO.: 35734/04.02

APPENDIX C
SEISMIC REFRACTION SURVEY REPORT

Subject: Seismic Refraction Survey Report
Tourtelot Property
Benicia, California

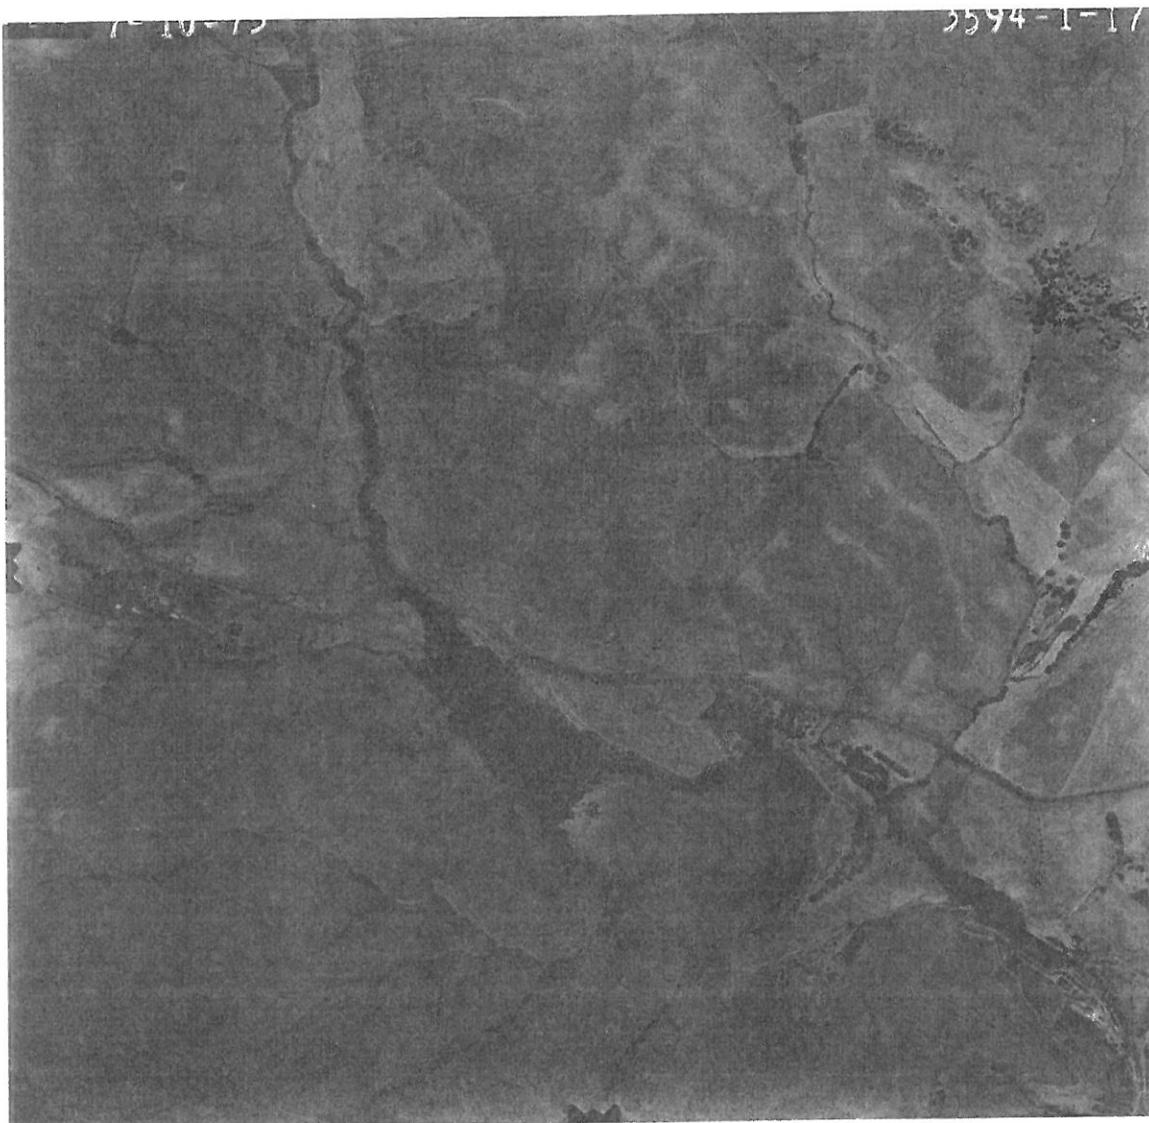
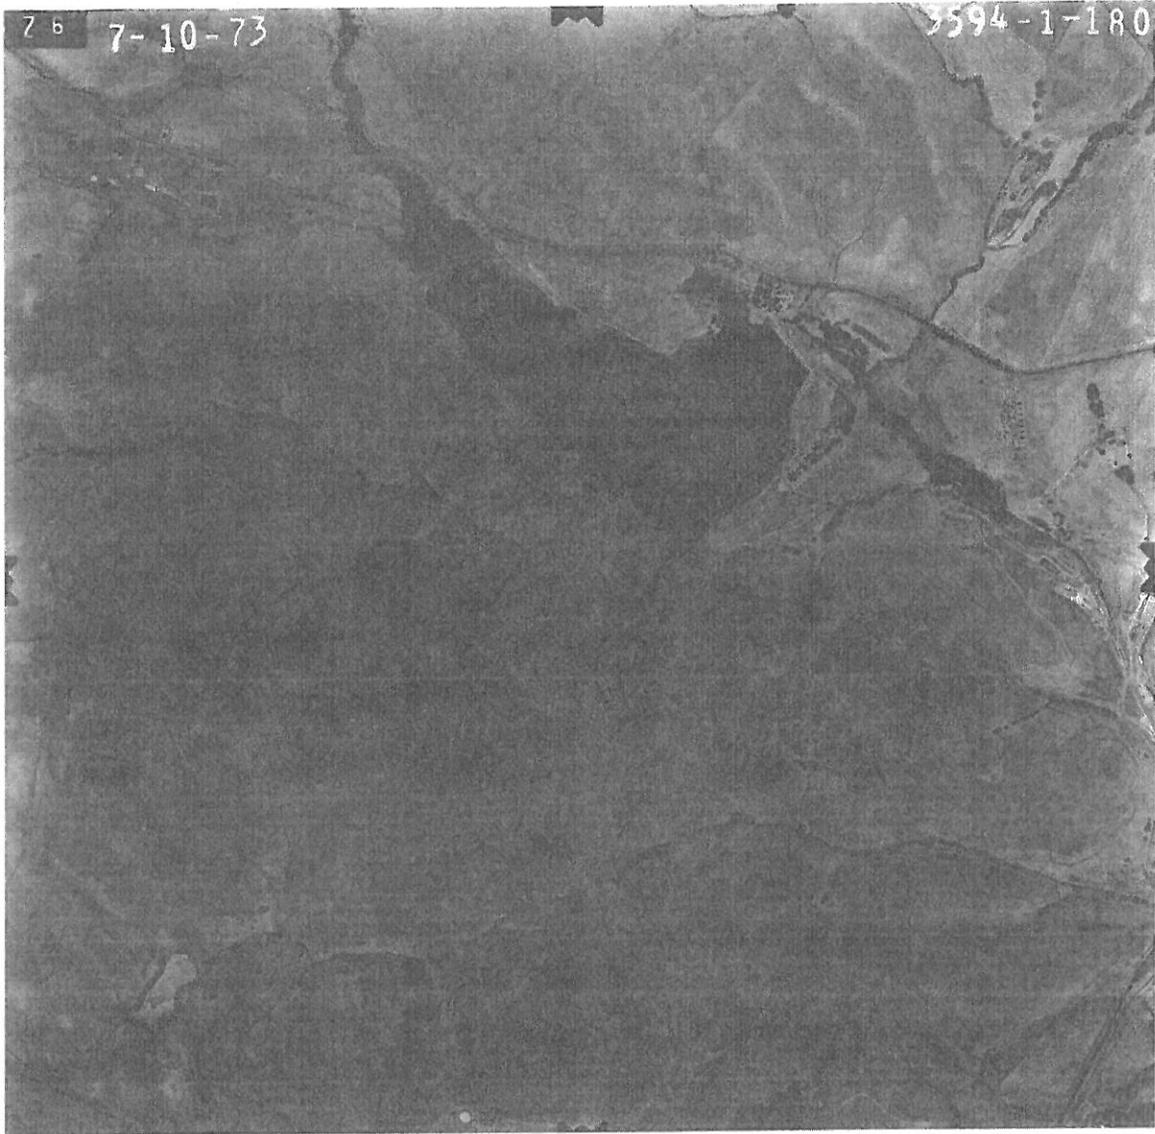
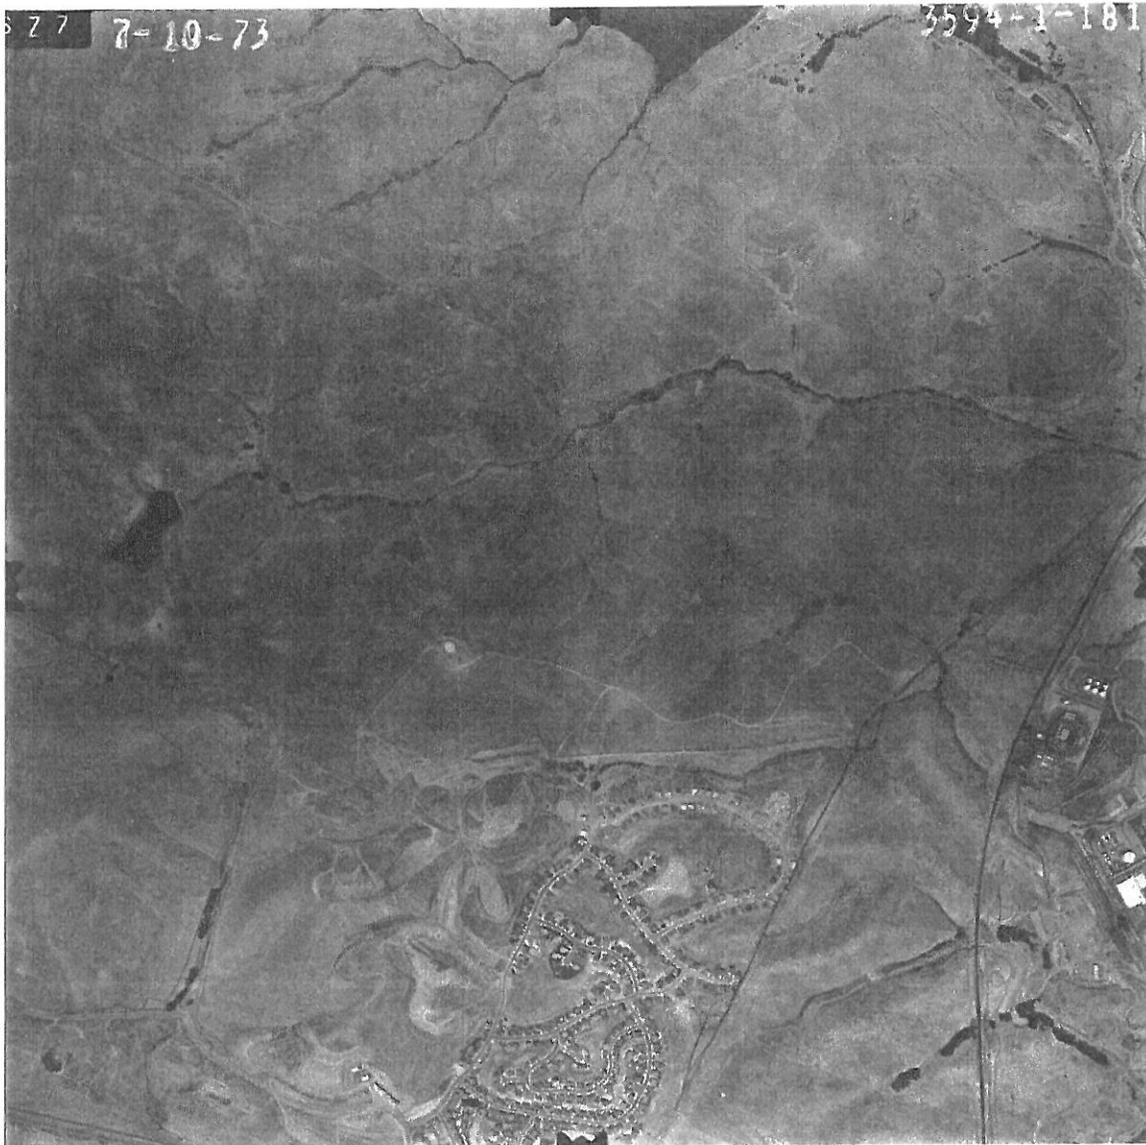
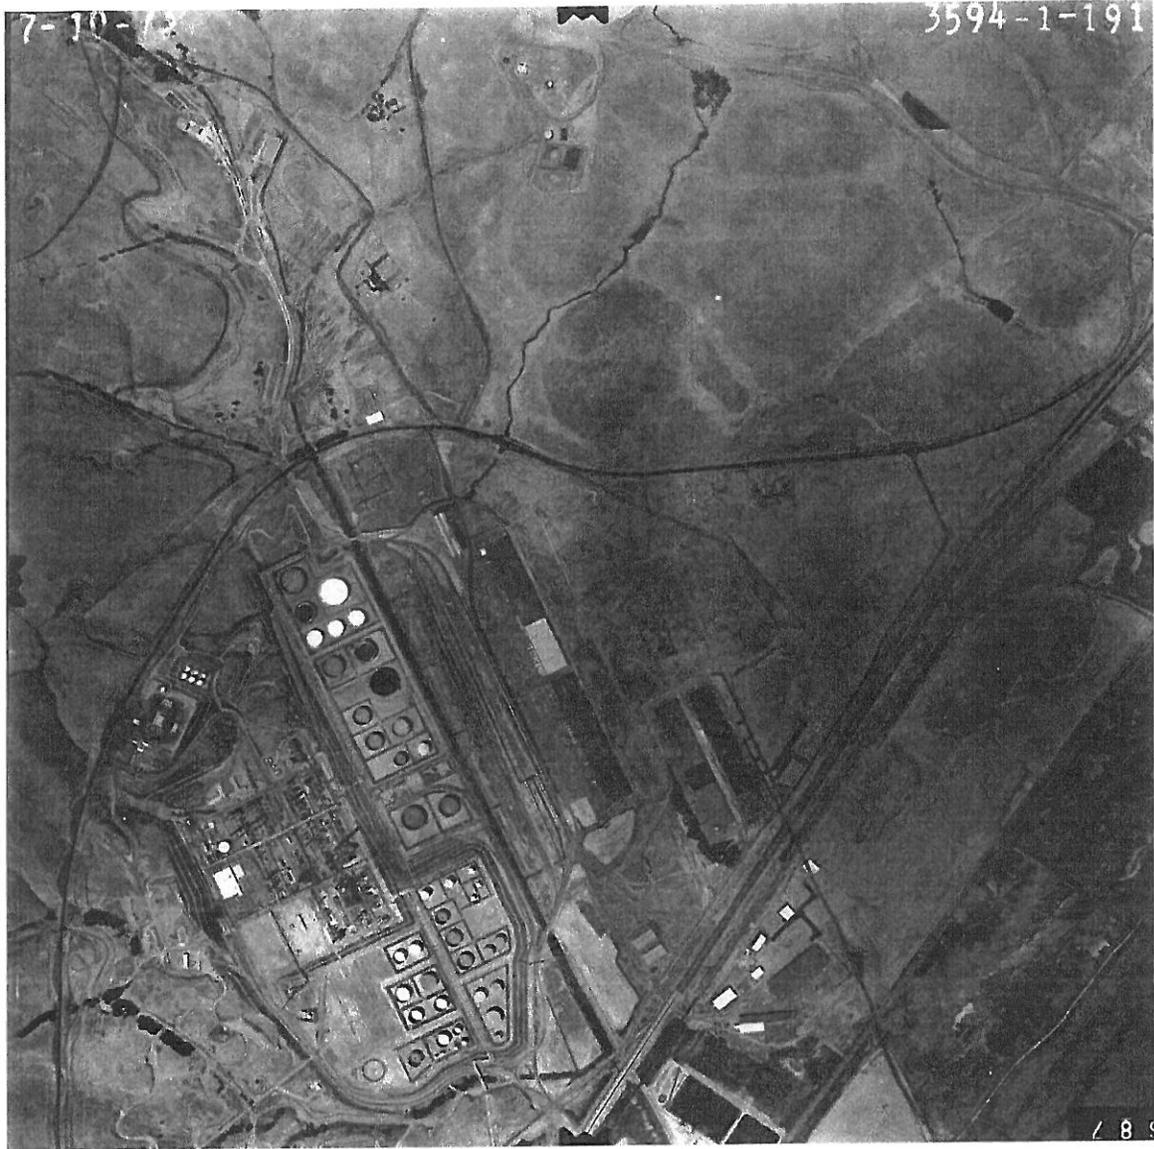
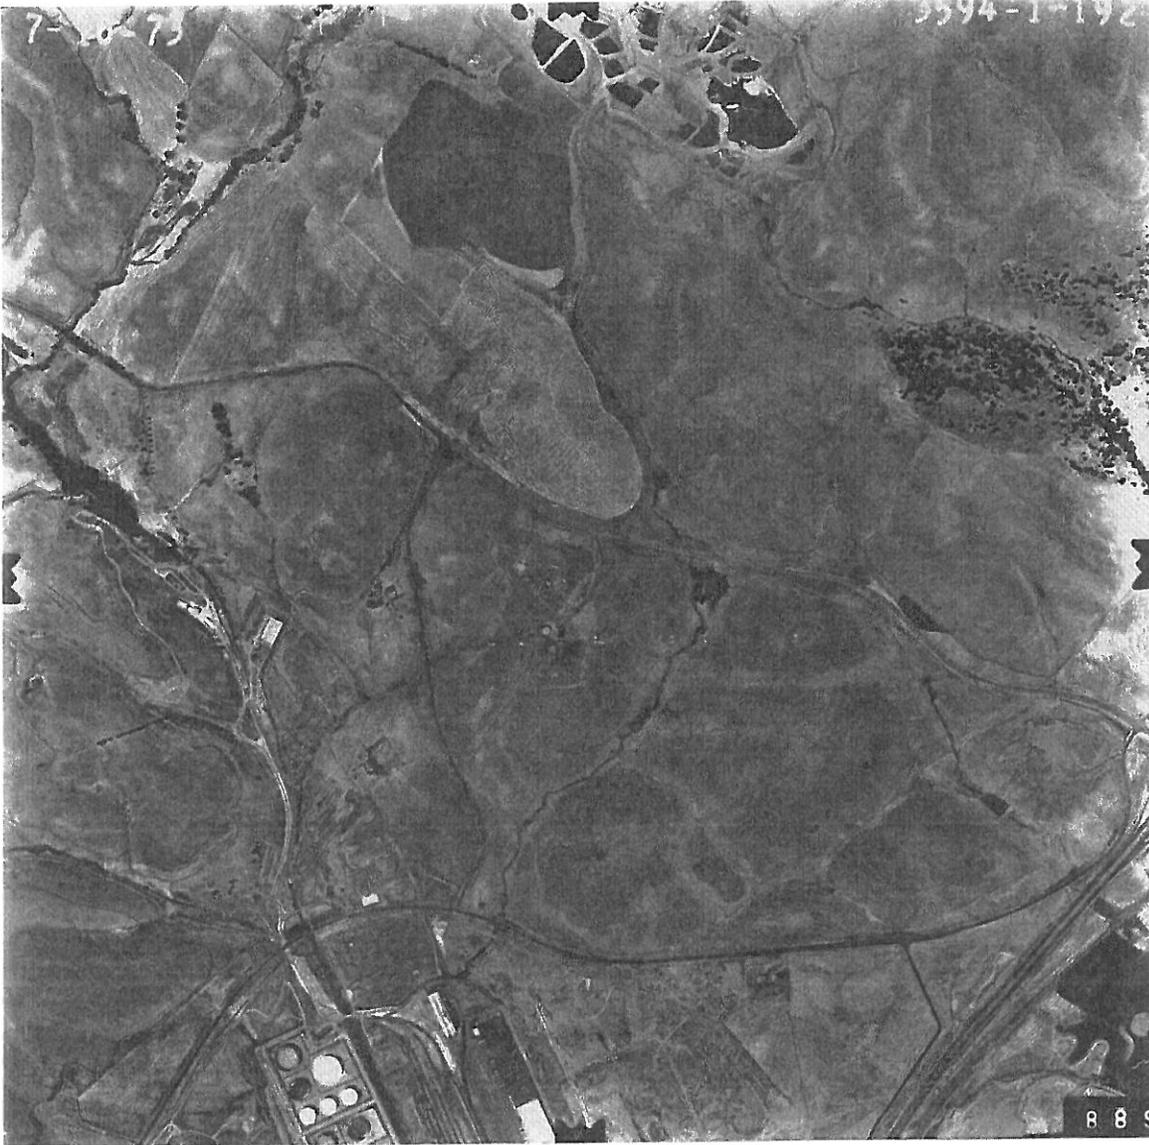
Figure 17. Photo Number 3594-1-179
Estimated Scale: 1:36,000

- **North Valley:** All five TNT Strips are visible; there appears to be a sixth TNT Strip as well between TNT Strips between T3 and T4. This additional TNT Strip was not observed on previous photographs. Within the Howitzer Test Facility remains just one visible large building (Building 182, the Test Firing Butts). The Test Firing Tunnels (Building 181), the Powder Loading Room (Building 183), Buildings 540 and 542, and buildings associated with the Ammunition Renovation/Primer Destruction Site are not visible in these photographs. There is a building visible south of the TNT Strips; this building was not observed on previous photographs. Midway Road, a dirt road, runs from this building south, first curving west, then east around the base of a small knoll, then west again. It continues southwest until it intersects an asphalt road that runs along the perimeter of the property. The prominent east-west-trending tree line has extended to the west since 1962, intersecting the Ridge at the Dynamite Burn Site.

- **Ridge:** The "J"-shaped road traveling southwest from the North Valley to the Dynamite Burn Site is visible. The Dynamite Burn Site is fainter than in previous photographs. There is a dirt road running southwest from the, traveling southwest to a point where it meets the asphalt road, in the South Valley, parallel to the property fence line; this road was noted in the 1960-62 photographs. The disturbance noted in 1962 south-southeast of the tree line/Dynamite Burn Site is visible; however, no soil/debris piles are visible on the west edge of the Ridge.

- **South Valley:** There are minor changes to the South Valley since 1962. The Flare Site and Demolition Sites are not visible in the photographs from 1973, although the dirt roads leading to these areas appear graded. In Photograph 192, there are some graded roads visible from the tree line, traveling a half-moon shape to the south edge of the property; these roads extend toward the Flare Site and Demolition Sites. No other evidence of grading is noted on these photographs. The McAllister Drive Land Bridge is not present, and no construction of housing occurs within the property boundary.

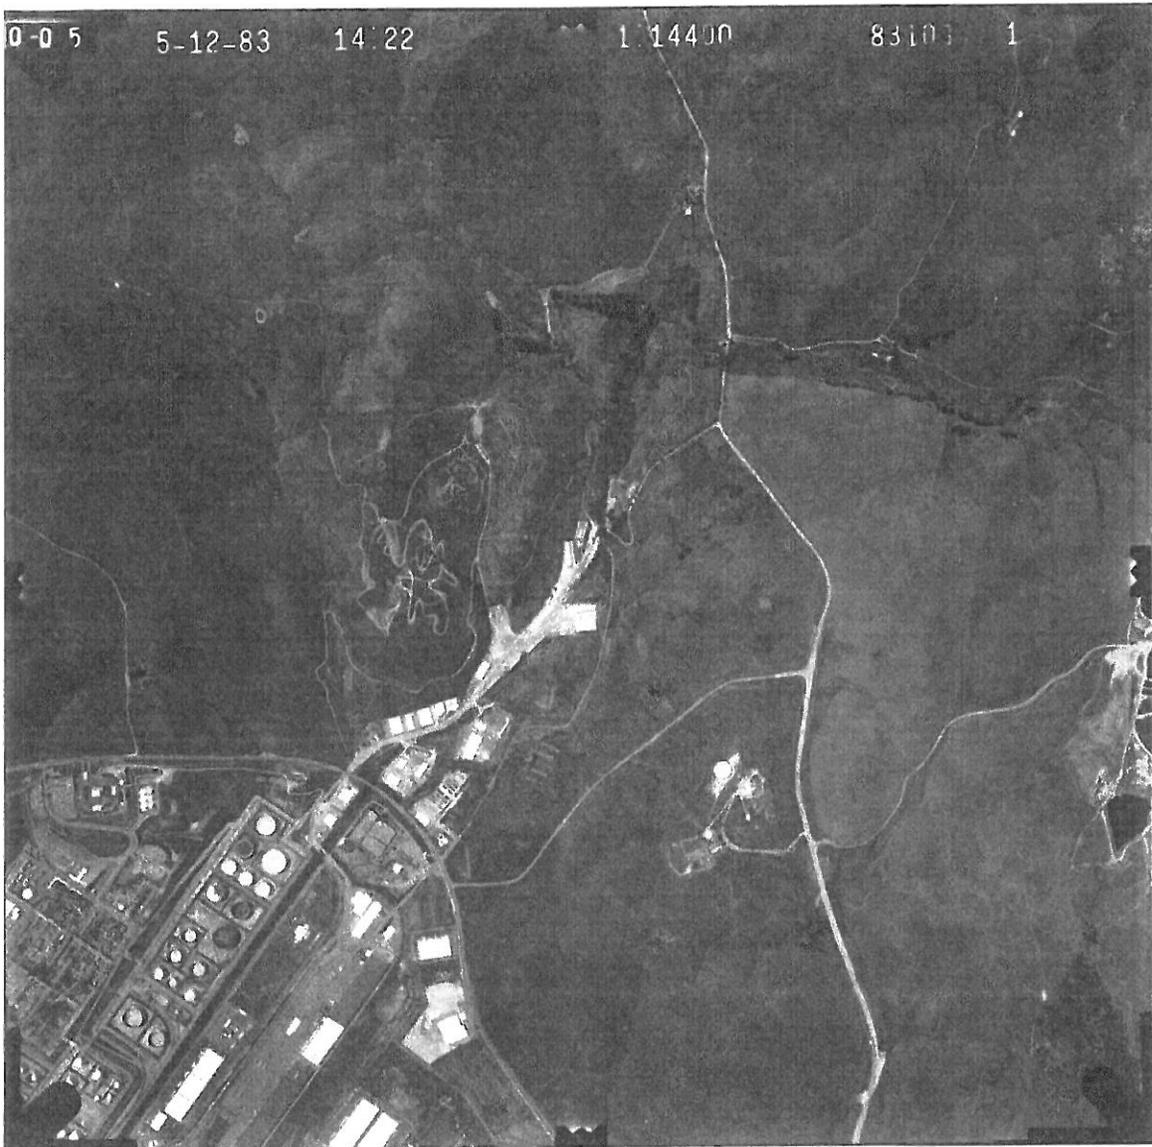
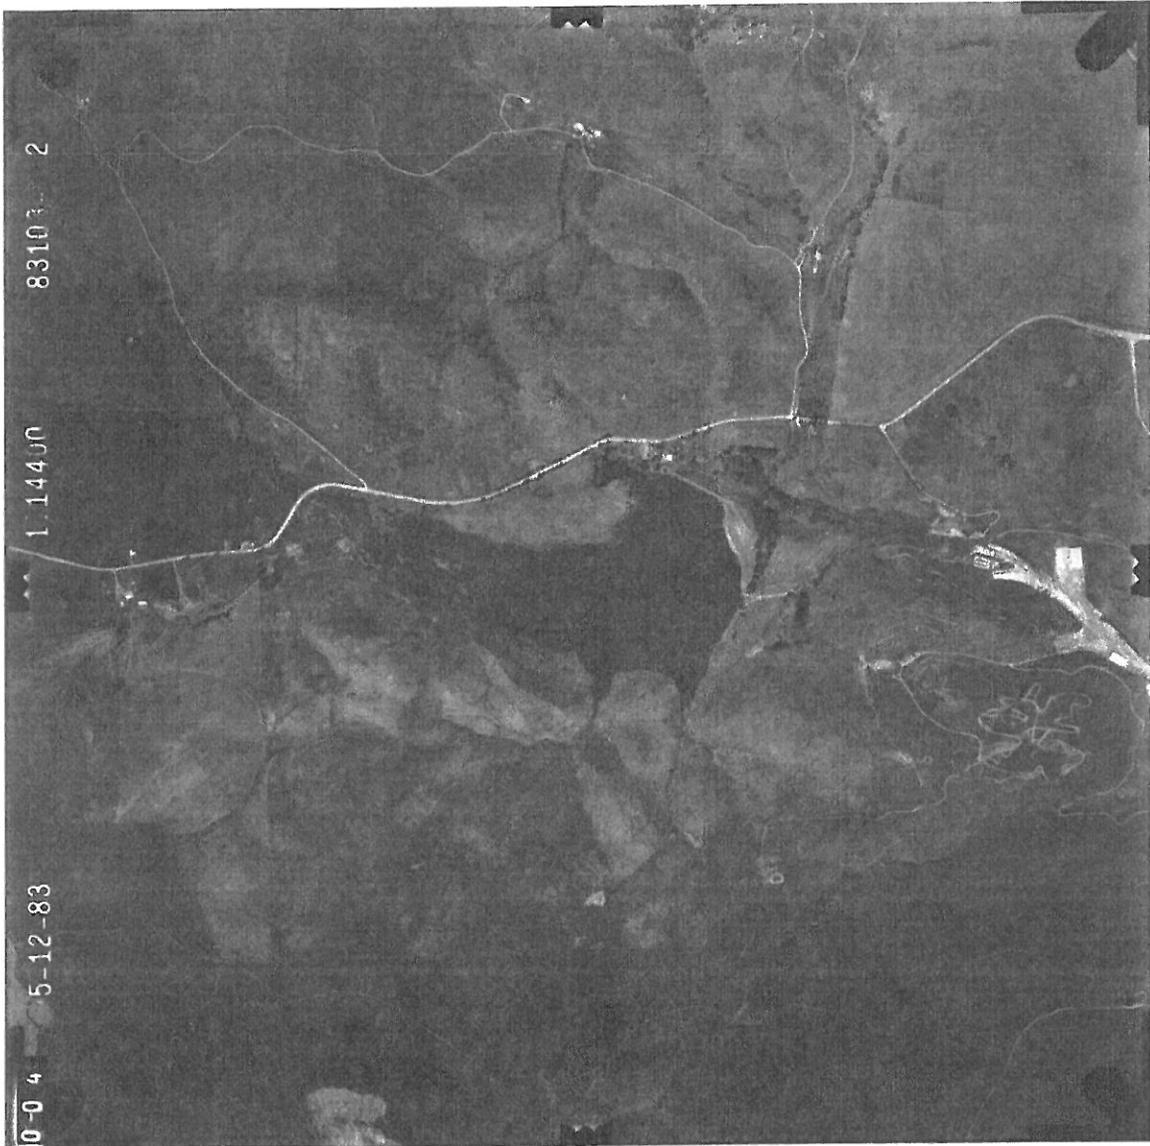
Figure 22. Photo Number 83103-1
Estimated Scale: 1:21,600

- **North Valley:** There are minor changes to the North Valley since 1973. The Project Site fence line is very faint. Five TNT Strips are visible. There is ground disturbance visible within the Ammunition Renovation/Primer Destruction Site that was not observed in previous photographs. The ground disturbance appears to be from off-highway recreational vehicles. There are three structures in the northern half of the Howitzer Test Facility that include the Test Firing Butts (Building 182), the Powder Loading Room (Building 183), and the remnants of the squirrel cages (1945-47); disturbance is also noted in the middle of this area. Buildings 540 and 542, and the various buildings associated with the Ammunition Renovation/Primer Destruction Site are not visible in these photographs, nor were they seen in the 1973 photographs. Building 181 (Test Firing Tunnels) appears with the north-facing side as an east-west-trending linear feature. A dirt road lies between the buildings in the northern half of the Howitzer Test Facility. This road appears to be graded to the east and southeast of Building 181. The North Valley Military Landfill area is faintly visible, although a network of dirt roads traverses the area. Much of the Ammunition Renovation/Primer Destruction Site is graded as well. Midway Road is still visible.

- **Ridge:** There are minor changes to the Ridge since 1973. The Dynamite Burn Site is visible, surrounded by a number of dirt roads and trails, similar to areas that have been used by off-highway recreational vehicles. These roads or trails are not as numerous in the 1973 photographs. No soil/debris stockpiles are visible. Only a portion of the "J"-shaped road remains visible.

- **South Valley:** There are minor changes to the South Valley since 1973. From the Ridge area to the south and southeastward, there are a number of dirt roads and trails, and residual surface scarred areas previously observed to have some ground disturbance (especially around Demolition Site #1, the Flare Site, and other Demolition Sites). Several of these roads were observed in the 1973 photographs. The McAllister Drive Land Bridge is not present, and no construction of housing occurs within the property boundary.

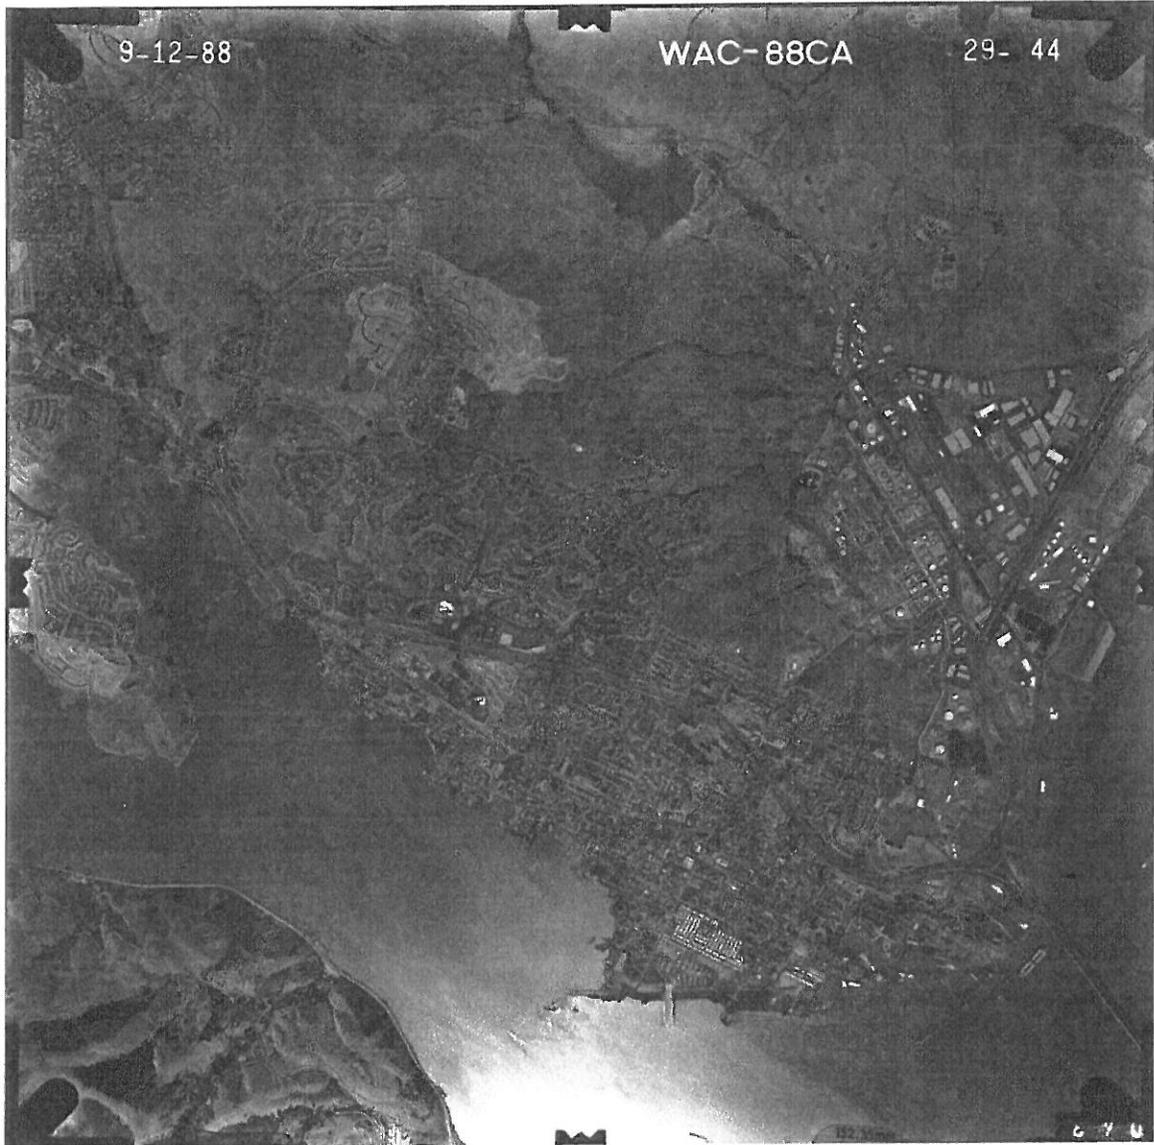
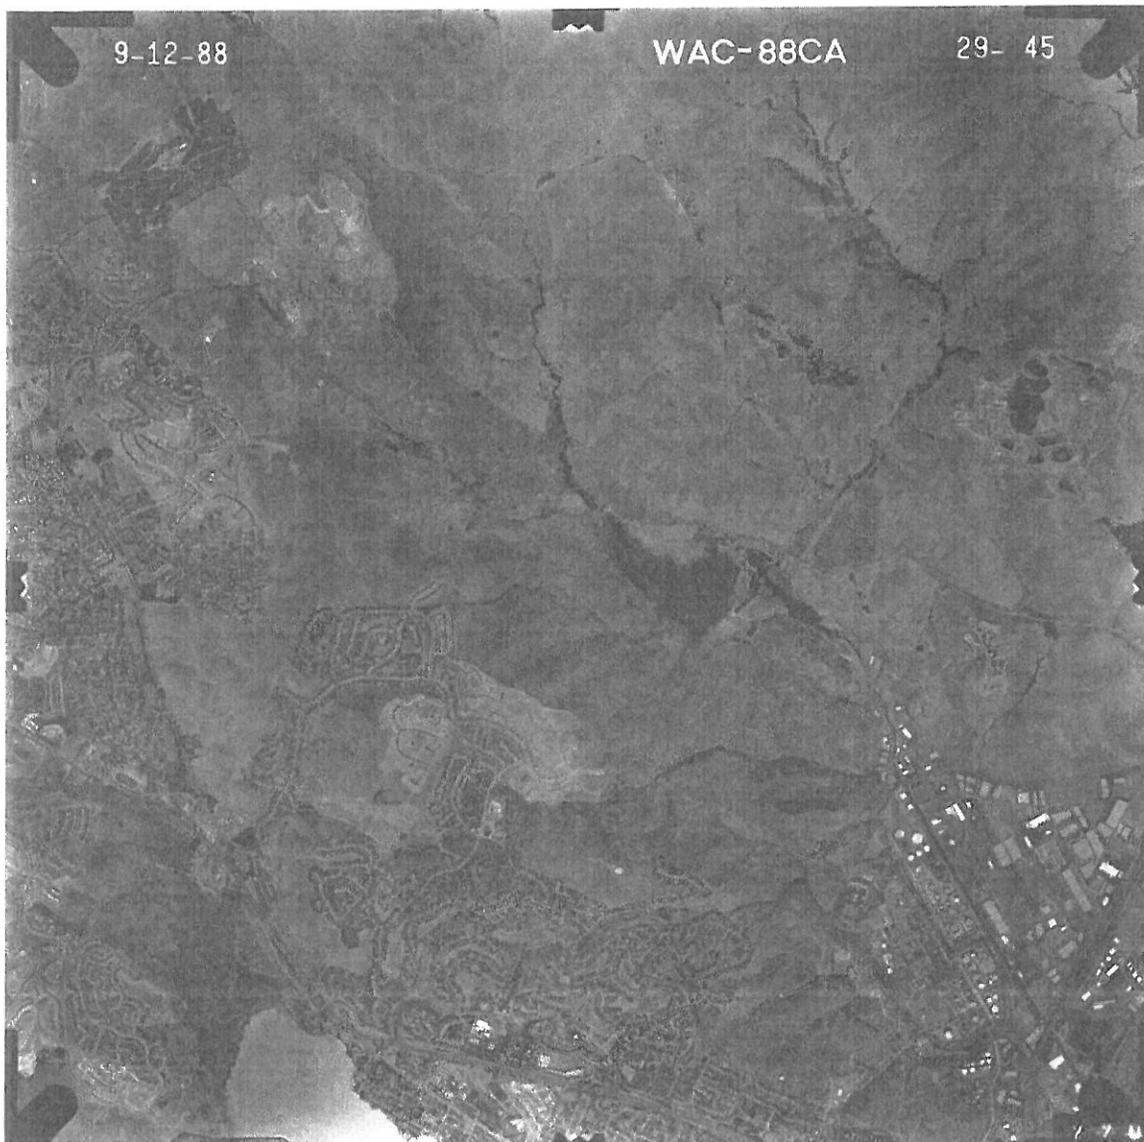
Figure 24. Photo Number WAC-88CA 29-44
Estimated Scale: unknown

- **Ridge:** There are only minor changes to the Ridge since 1983. The Dynamite Burn Site is visible. There are several dirt roads/trails present throughout the Ridge area. Only a portion of the "J"-shaped road is visible. No soil/debris piles are visible. There is a small, cleared area visible on the western edge of the Ridge.

- **South Valley:** There are very few changes to the South Valley since 1983. The Flare Site and Demolition Sites are extremely faint in these photographs. Several roads, including the one used to access the Flare Site and Demolition Sites, are observed throughout the South Valley. Many of these roads had been observed in the South Valley since 1973. No evidence of grading is noted. The McAllister Drive Land Bridge is not visible, nor are the housing tracts to the immediate south. Some housing is noted to the far west and southwest of the property boundary.

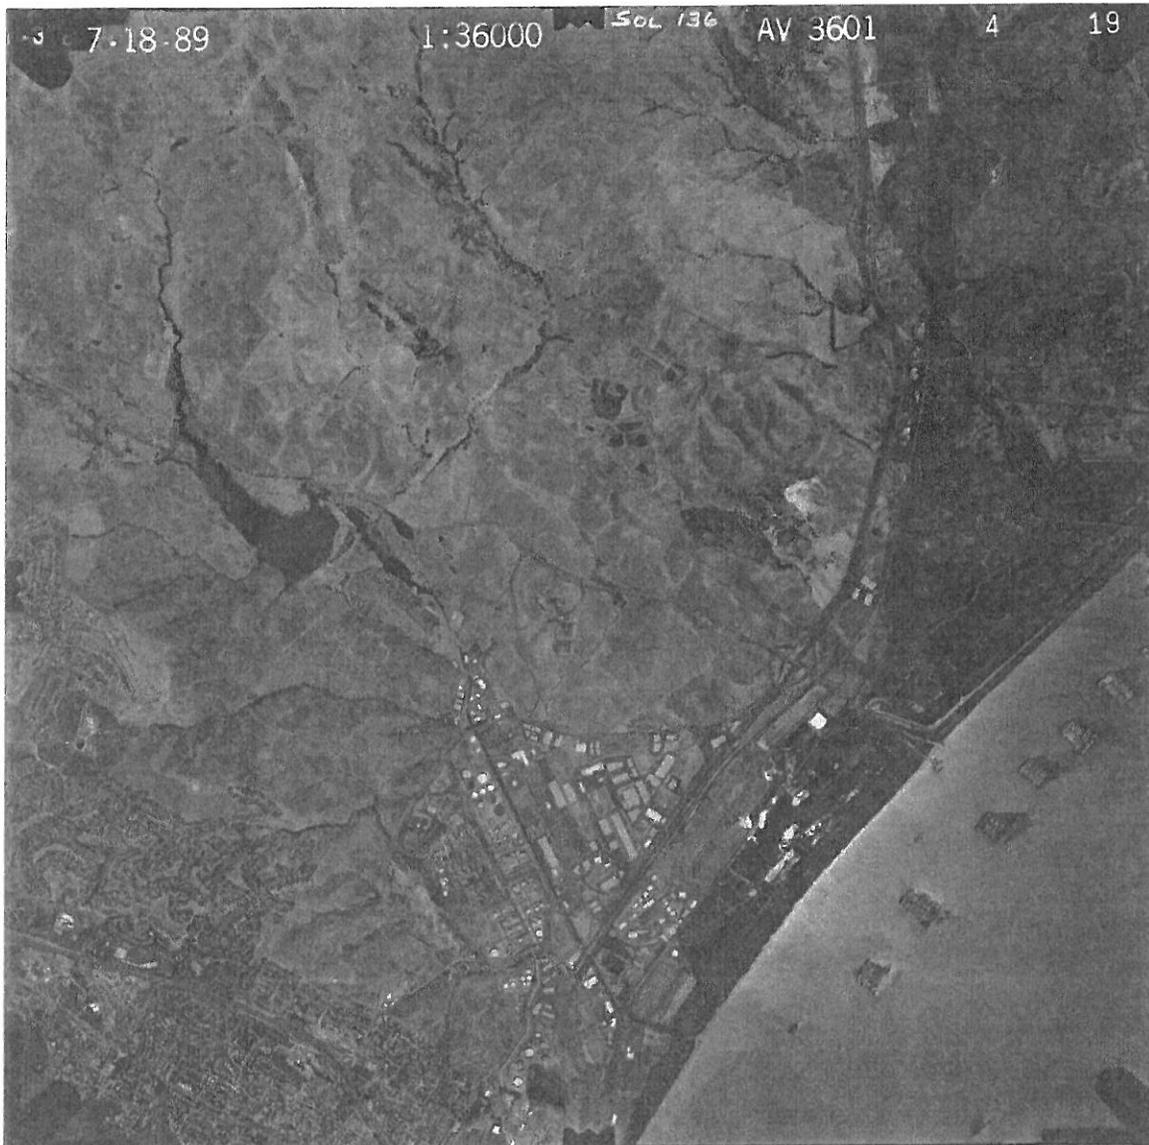
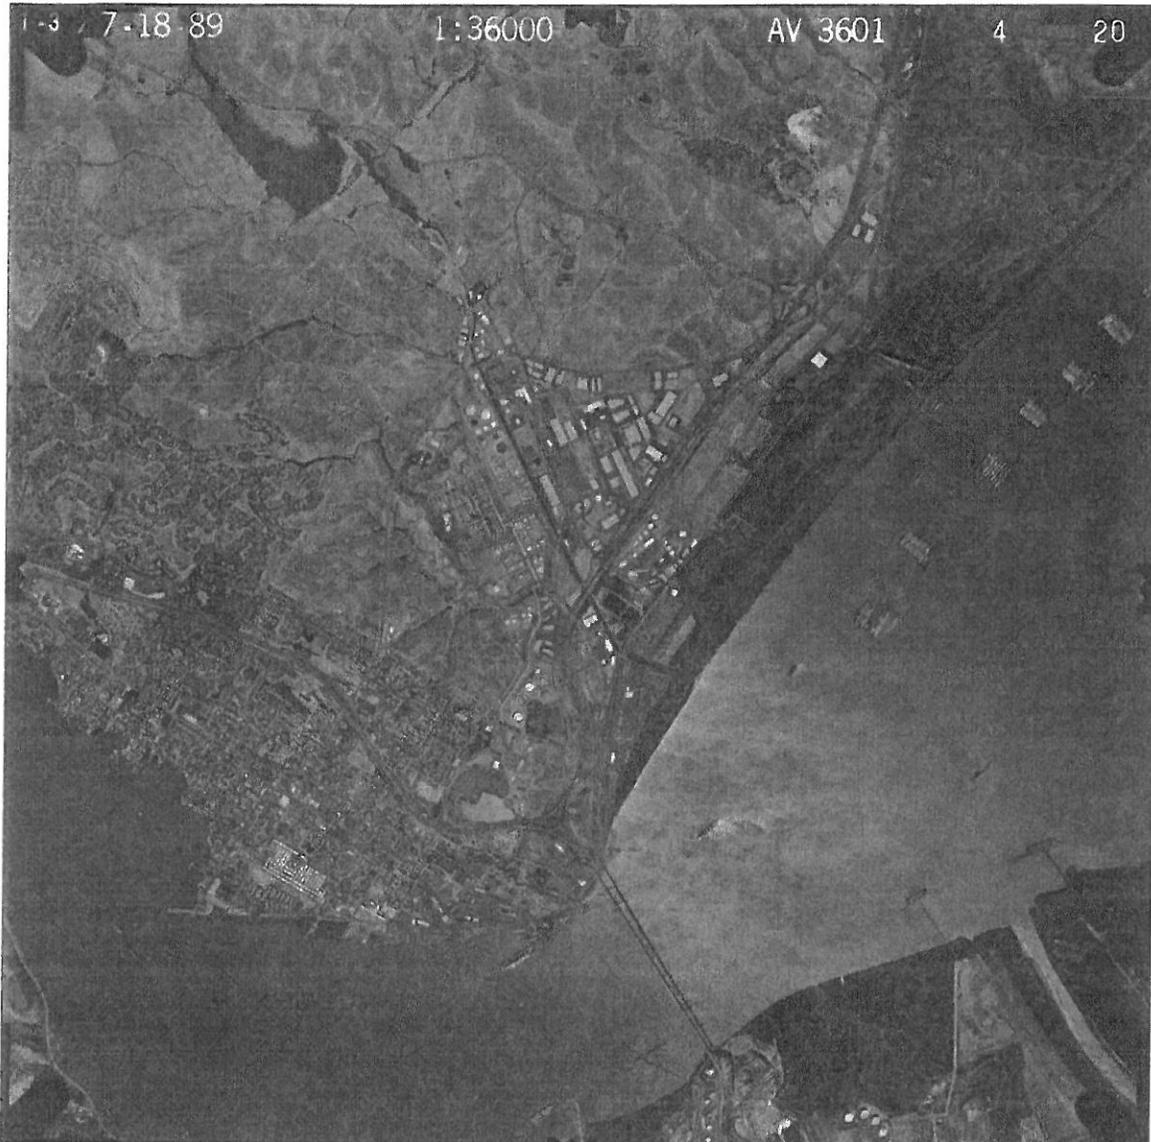
Figure 26. Photo Number SOL 136 AV 3601 4 19
Estimated Scale: 1:54,000

The Project Site is situated in the southwestern quarter of Photograph SOL 136 AV 3601 4 19 and in the northwestern quarter of Photograph AV 36014 20. Lake Herman is visible to the northwest of the Project Site in both photographs. Very little of the railroad tracks is visible to the east. Most of the spurs have been replaced with warehouses and other structures. Tanks and buildings are still present on the Exxon Oil Company property, which lies to the southeast of the Project Site. More housing tracts are being constructed to the west and southwest of the property. The entire southern portions of the Former Benicia Arsenal have been developed. Suisun Bay is visible in the southeastern corner of both photographs. A number of boats and/or ships appear to be docked in Suisun Bay.

- **North Valley:** Only minor changes to the North Valley are observed in photographs since 1988. It appears that very little of the Howitzer Test Facility remains, and faint ground disturbance is visible at the Ammunition Renovation/Primer Destruction Site. The Powder Loading Room (Building 183), Test Firing Butts (Building 182), and Test Firing Tunnels (Building 181) are faintly visible. The TNT Strips are faintly visible. The North Valley Military Landfill is faint. There is no evidence of grading activity near the landfill or west of the Ammunition Renovation/Primer Destruction Site. The prominent east-west-trending tree line remains visible. It appears that the Project Site boundary fence line has been replaced with a dirt road; this appearance is especially strong along the western edge. Midway Road is faintly visible.

- **Ridge:** The Dynamite Burn Site is visible but is fainter than in previous photographs. A prominent east-west-trending road extends to the "J"-shaped road. There is a small area of disturbance in the area of the soil/debris piles; no piles are visible, however. There are a number of dirt roads present throughout the Ridge.

- **South Valley:** There is faint evidence of the Flare Site and Demolition Sites visible in the South Valley. The dirt road leading to these areas is also faint, as are other roads throughout the South Valley. The McAllister Drive Land Bridge is not visible. The only housing tracts noted are outside of the Project Site to the west and southwest.

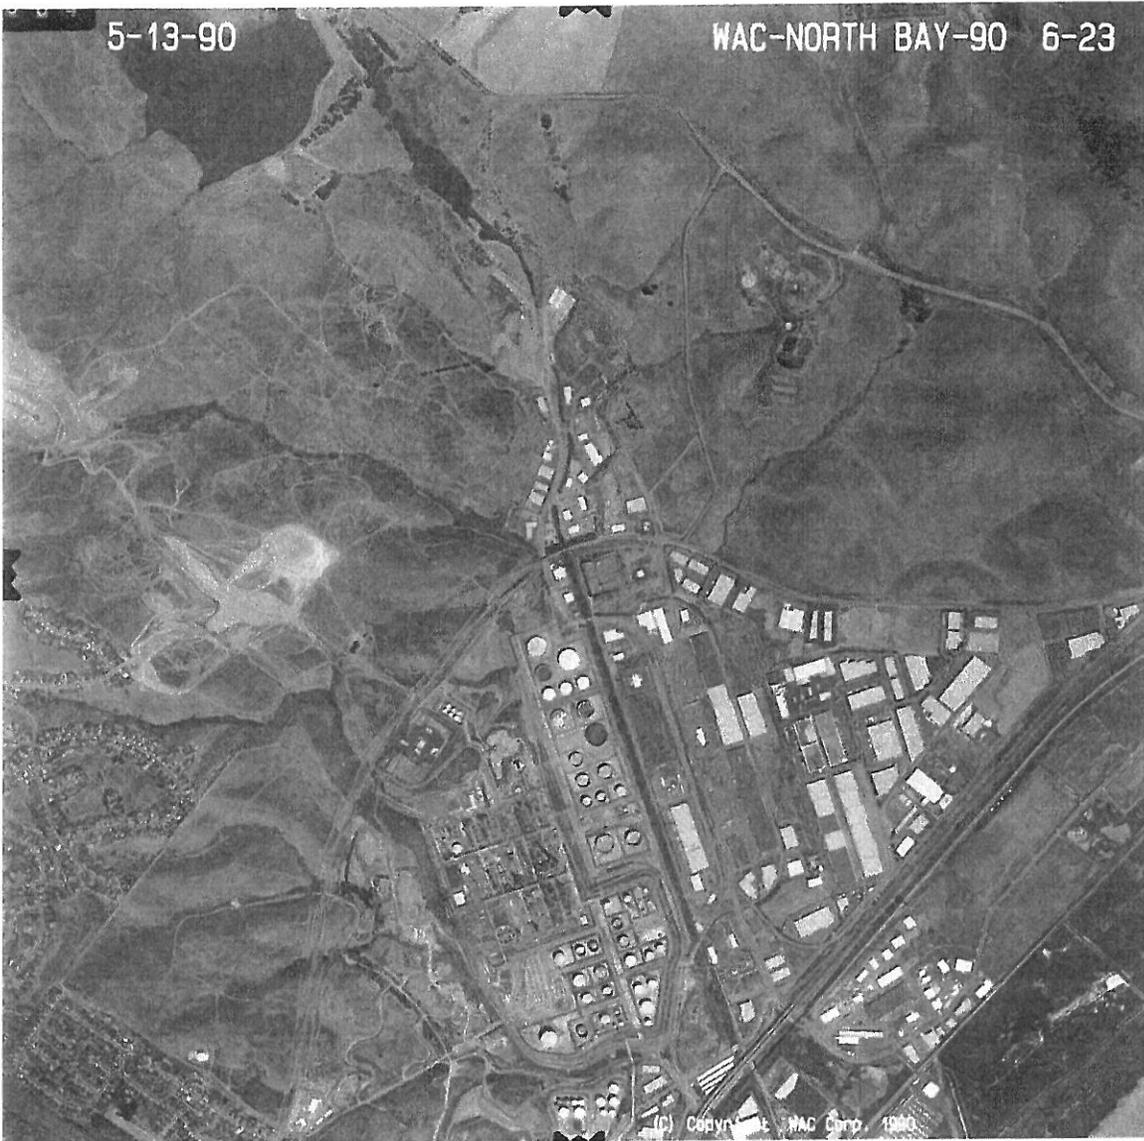
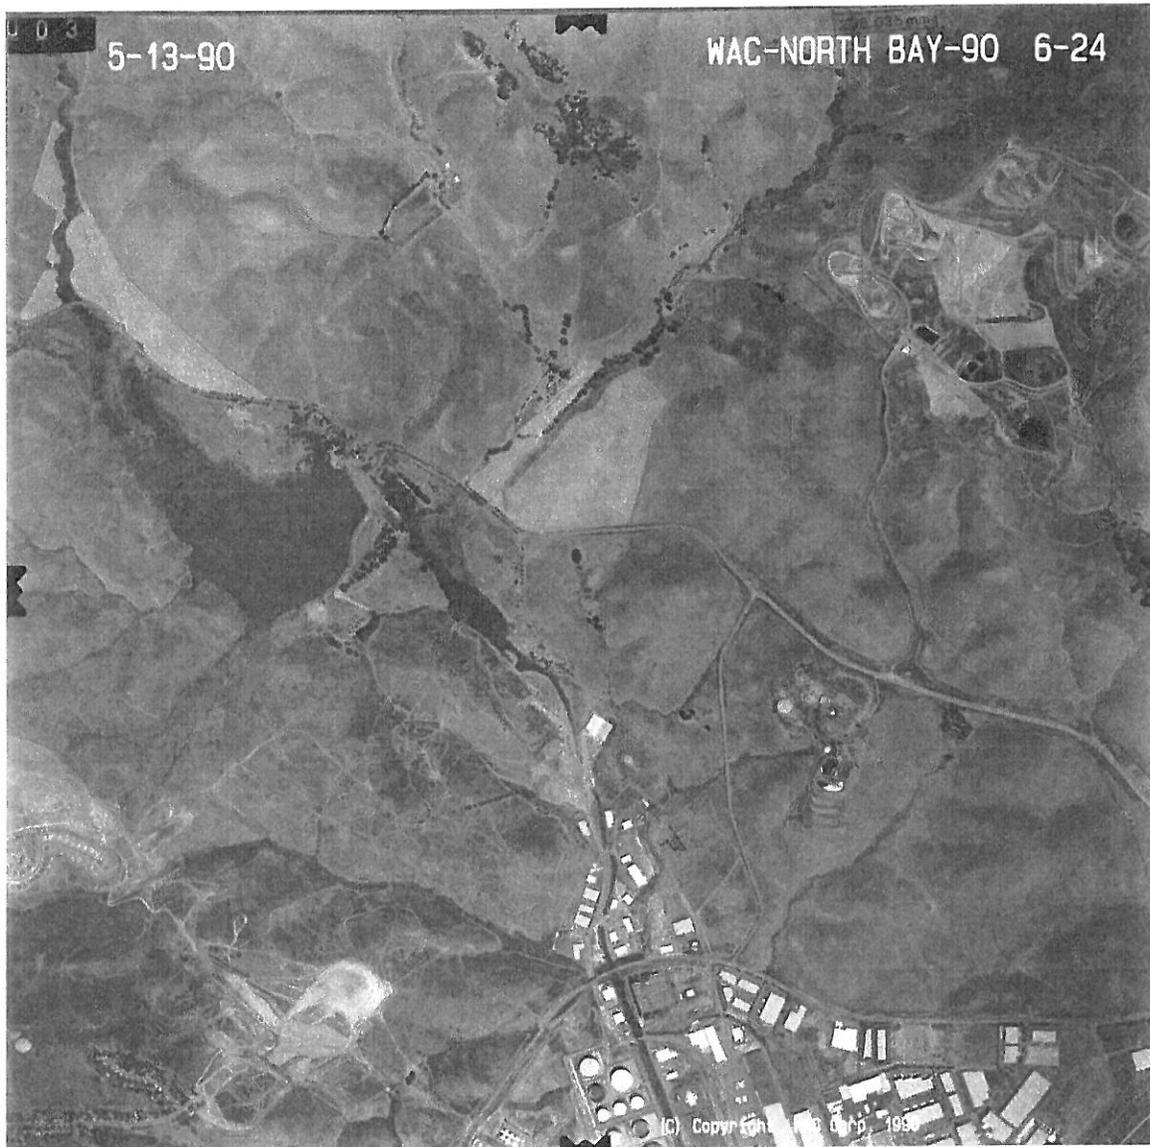
Figure 28. Photo Number WAC-North Bay 90 6-23
Estimated Scale: unknown

- **Ridge:** Only a few changes are noted along the Ridge since 1989. The tree line noted in the North Valley is visible, and extends into the Ridge area. The "J"-shaped road leading to the Dynamite Burn Site and the property fence road are visible. A small building is observed south of the approximate middle of the tree line; the building is unidentified and had not been noted in previous photographs of the Ridge. There is a substantial number of dirt roads and trails along the Ridge from off-highway recreational vehicles. A dirt road extends from the Ridge to the west of the South Valley at Kearny Street. The soil/debris piles are not visible, but there are roads throughout this area.

- **South Valley:** Since 1989, there are a few changes noted in the South Valley. There are still a number of roads and trails throughout the South Valley. The Flare Site and Demolition Sites are not visible due to the large number of roads/trails (including the original road that was used to access these sites) that cross the area. It appears that construction of the McAllister Drive Land Bridge has begun on the southern edge of the South Valley. Grading activities are noted south of the South Valley as well. Housing has been constructed to the west and southwest of the Project Site.

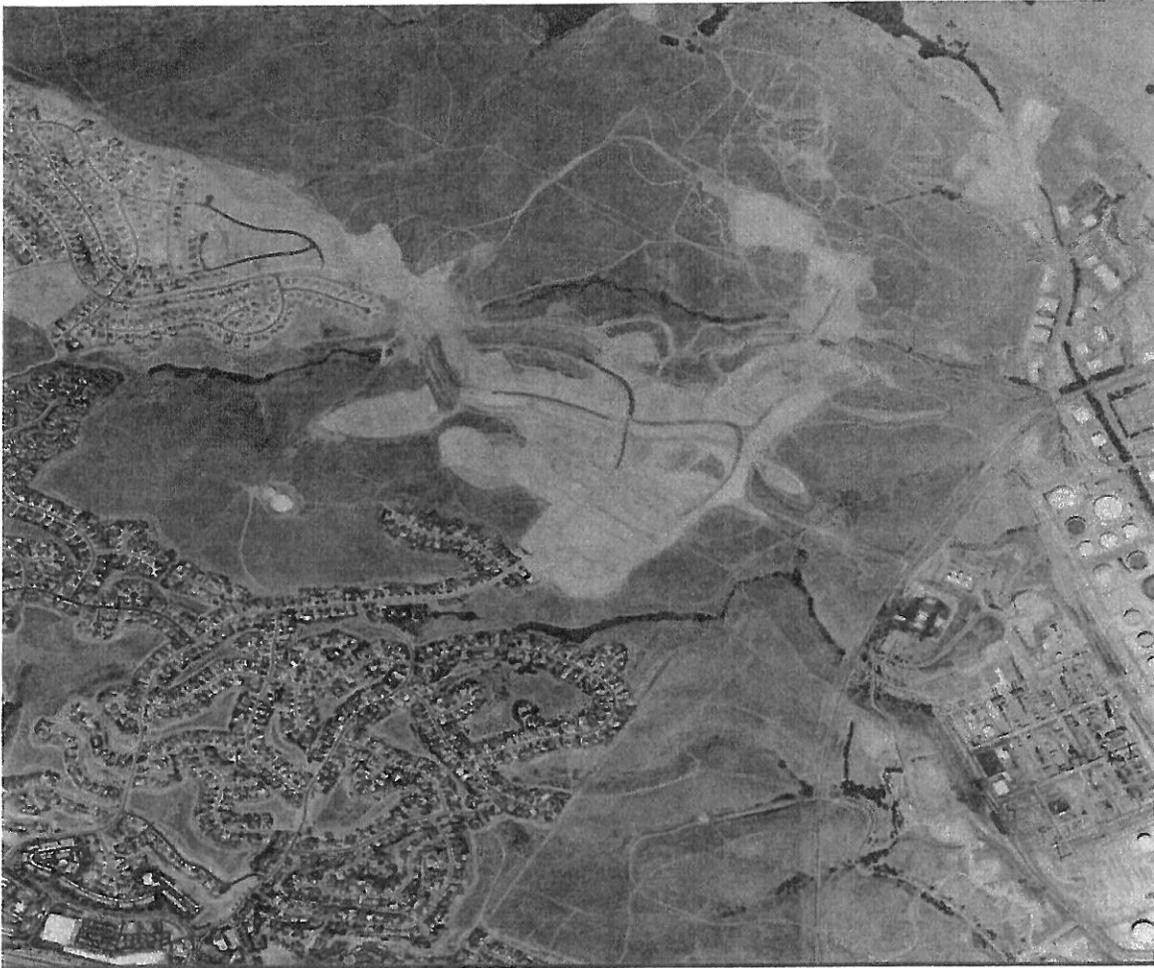
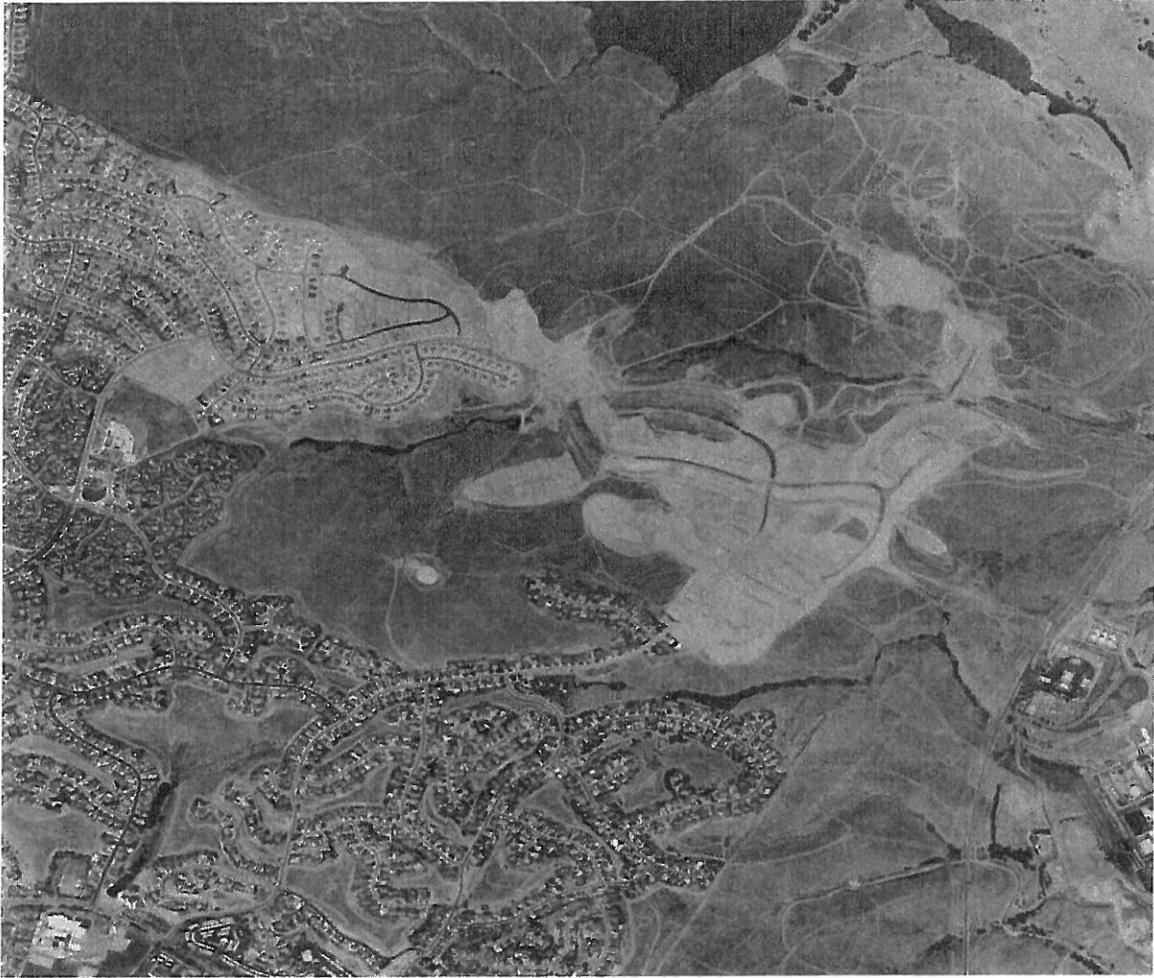
**Figure 30. Photo Number (not labeled with ID numbers)
Estimated Scale: 1:23,400**

- **North Valley:** There are a few changes noted in the North Valley since May 1990. The TNT Strips are not visible. Several off-highway recreational vehicle dirt roads/trails traverse the area. Only outlines of the Ammunition Renovation/Primer Destruction Site are visible. The North Valley Military Landfill is not distinguishable, since the area is inundated with off-highway recreational vehicle roads and trails. A dirt road has replaced the fence line on the western edge of the property. There is some grading activity visible at the sites associated with the former structures; none of the buildings associated with the Howitzer Test Facility or the Ammunition Renovation/Primer Destruction Site were observed. The east-west-trending tree line is still prominent. Midway Road is very faint and is surrounded by a number of additional roads.

- **Ridge:** Since May 1990, there are only minor changes noted along the Ridge. The Dynamite Burn Site is graded with visible changes to the elevation along the top of the Ridge. More dirt road/trails are apparent throughout the Ridge; these are straighter and wider than in previous photographs. There are a number of soil/debris piles evident on the western edge of the Ridge. The "J"-shaped road is mostly graded over, and additional dirt roads appear in that area.

- **South Valley:** The most changes noted in the September 1990 photographs are those in the South Valley. Grading activities are identified to the south, southwest, and west edges of the property, including Demolition Sites #1 and #2, and westward. The McAllister Drive Land Bridge that connects the southern portion of the South Valley to the Ridge area has been constructed. A road network covers the entire South Valley area. The Flare Site, Demolition Sites, and the road used to access them are no longer apparent due to grading activities throughout the South Valley, including an east-west-trending run-off control ditch along the south side of the valley. Graded pads being prepared for development are also visible.
