PROJECT NAME: Tourtelot Property

PROJECT NO.: 35734/04.02

APPENDIX C
SEISMIC REFRACTION SURVEY REPORT

Subject: Seismic Refraction Survey Report
Tourtelot Property
Benicia, California

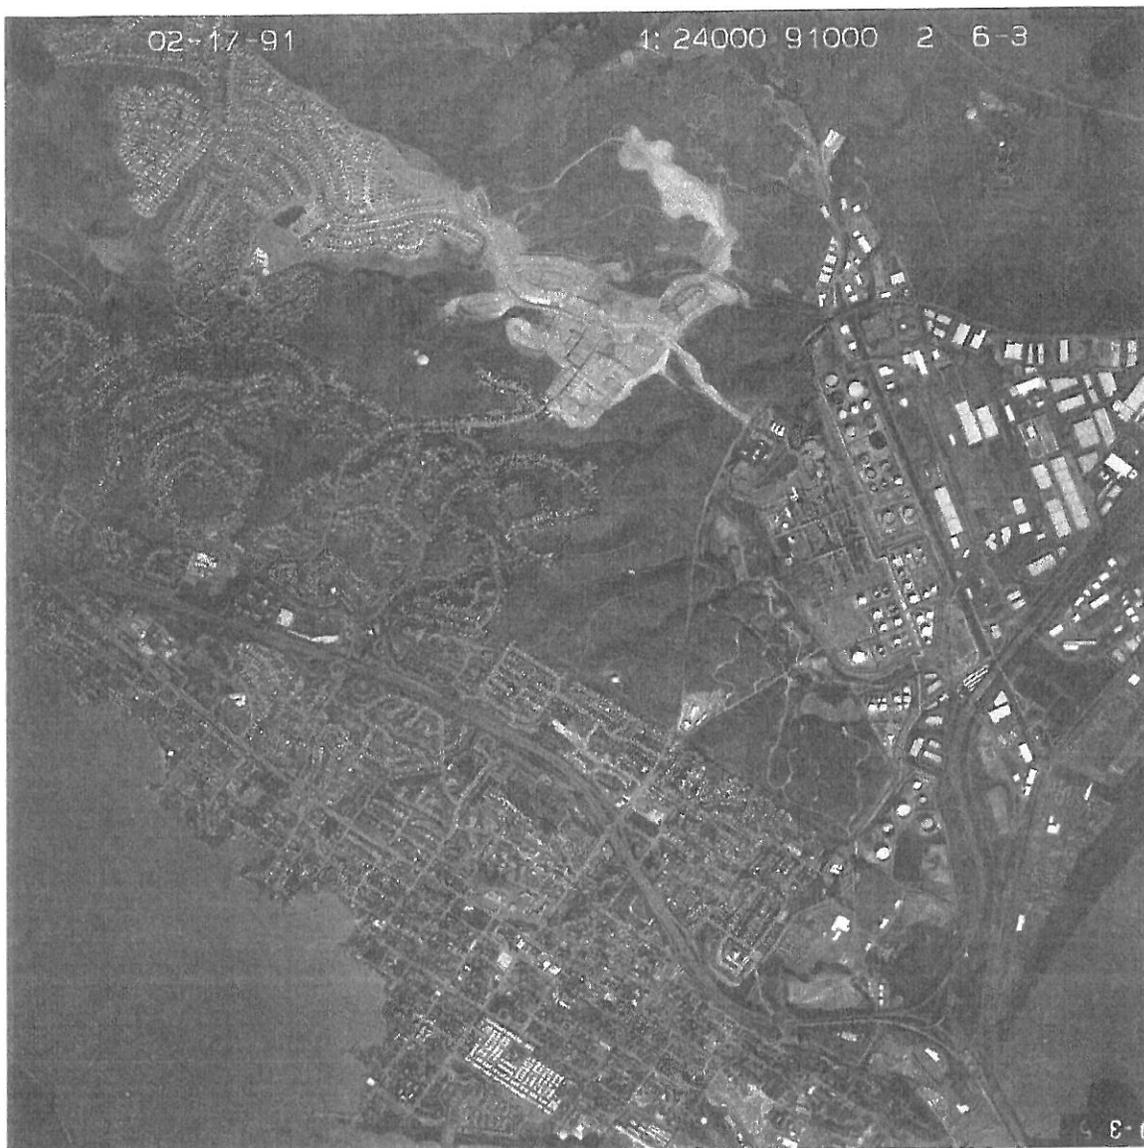
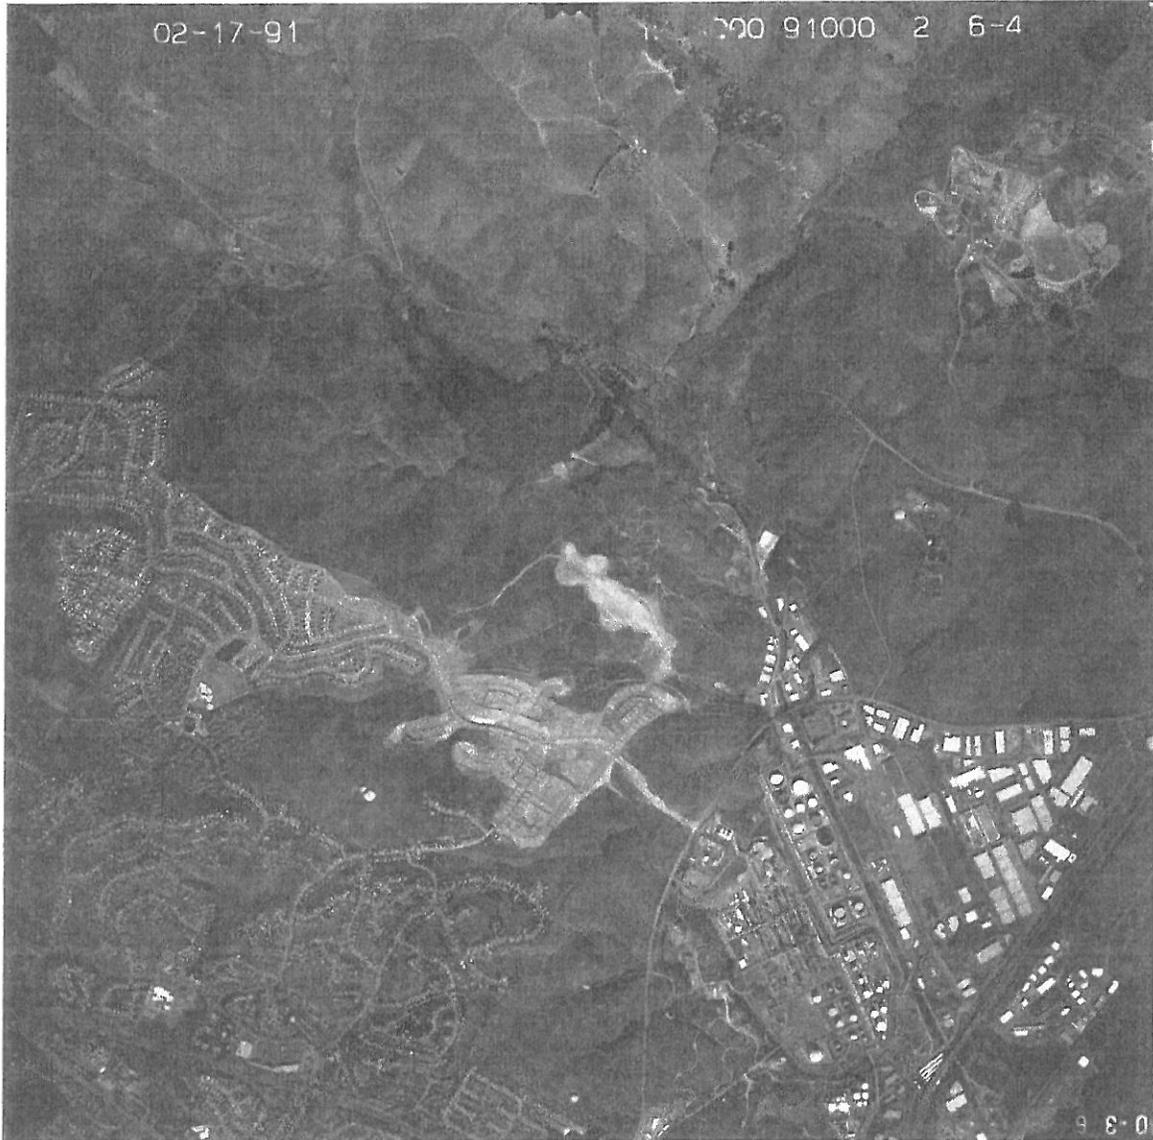
Figure 32. Photo Number 91000 2 6-3
Estimated Scale: 1:36,000

The Project Site is noted in the northern half of Photograph 91000 2 6-3 and in the center of Photograph 91000 2 6-4. Railroad tracks and spurs are no longer visible. Warehouses are situated to the east of the Project Site. Tanks and buildings are present on the Exxon Oil Company property, which lies to the southeast of the Project Site. More housing tracts are being constructed to the south and west of the property. Housing tracts are now present to the south of the property in the Former Benicia Arsenal. The Suisun Bay is visible in Photograph 91000 2 6-3.

- **North Valley:** Since September 1990, there have been a few changes to the North Valley. The property fence line is extremely faint. The tree line is still prominent. East of the Howitzer Test Facility, there is a disturbed area in the shape of a circled figure eight. This circled figure eight was not observed in any of the previous photographs. Portions of Buildings 181, 182, 540, and 542 are visible as well. The buildings associated with the Ammunition Renovation/Primer Destruction Site are not visible. Portions of the TNT Strips are visible to the northeast of these buildings. An outline of the Ammunition Renovation/Primer Demolition Site is visible, mainly by the cleared area. Grading west and southwest of the Howitzer Test Facility is noted, as are soil/debris piles on the western side of the property. The location of the North Valley Military Landfill is not visible. Midway Road is faintly visible. Several other roads cross the North Valley.

- **Ridge:** There are many dirt trails/roads throughout the Project Site; several of these were noted in previous photographs. The grading along the Ridge was expanded to include additional adjacent areas to the west and north of the previous grading. The graded areas appear lighter than the surrounding area, and several soil piles are noted. The "J"-shaped road and the Dynamite Burn Site are no longer visible by grading activities. This grading was noted as early as May 1990.

- **South Valley:** There are fewer changes to the South Valley than in the previous photographs. Grading for housing and the east-west-trending run-off control ditch is noted on the south and southwest throughout the South Valley. Roads leading to the Flare Site and Demolition Sites appear to have been graded. The McAllister Drive Land Bridge is complete.

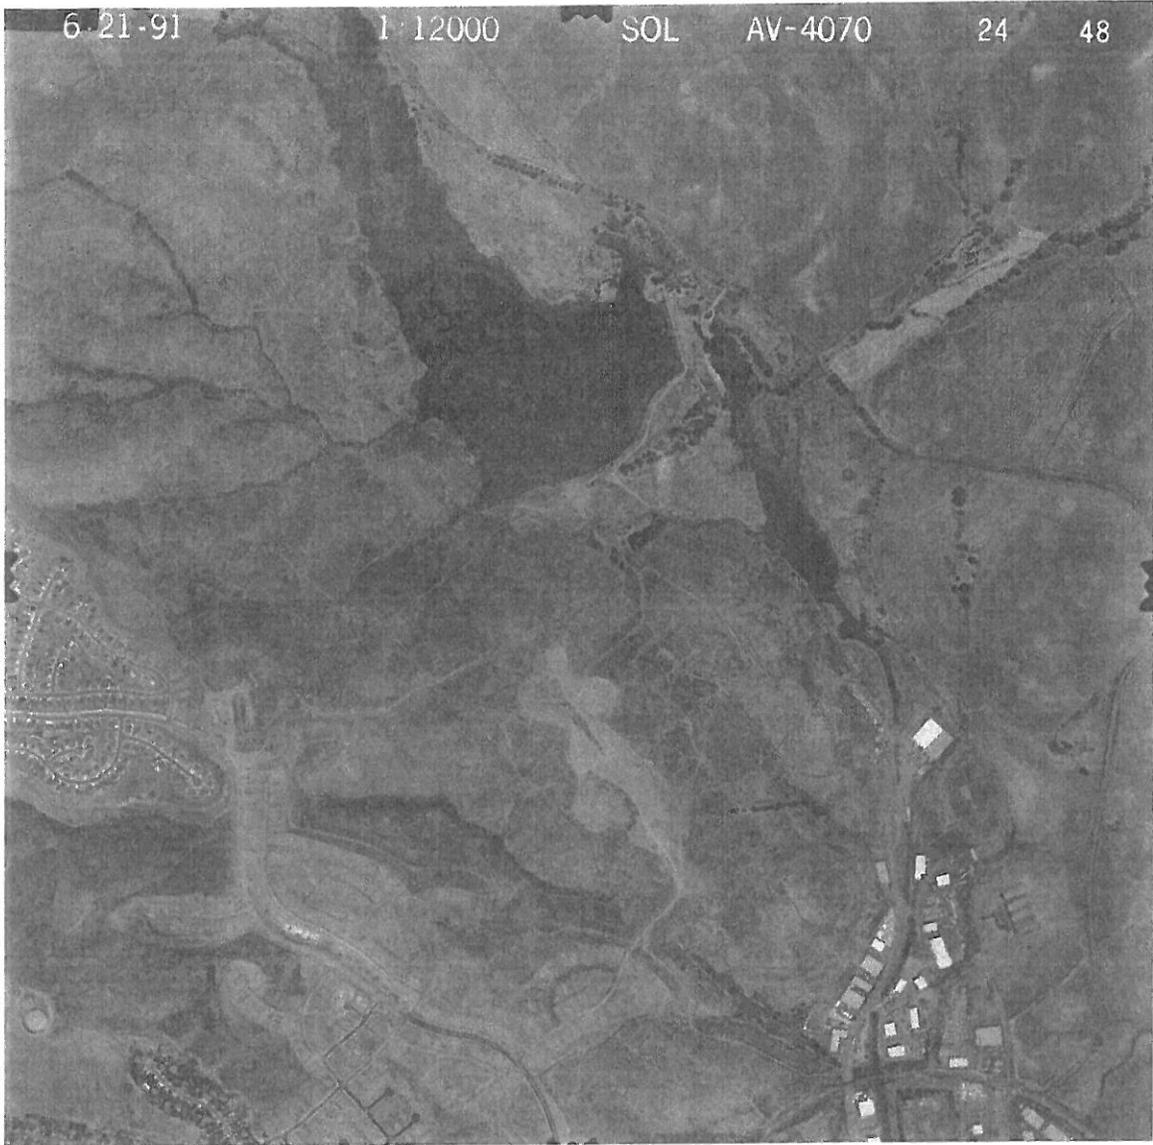
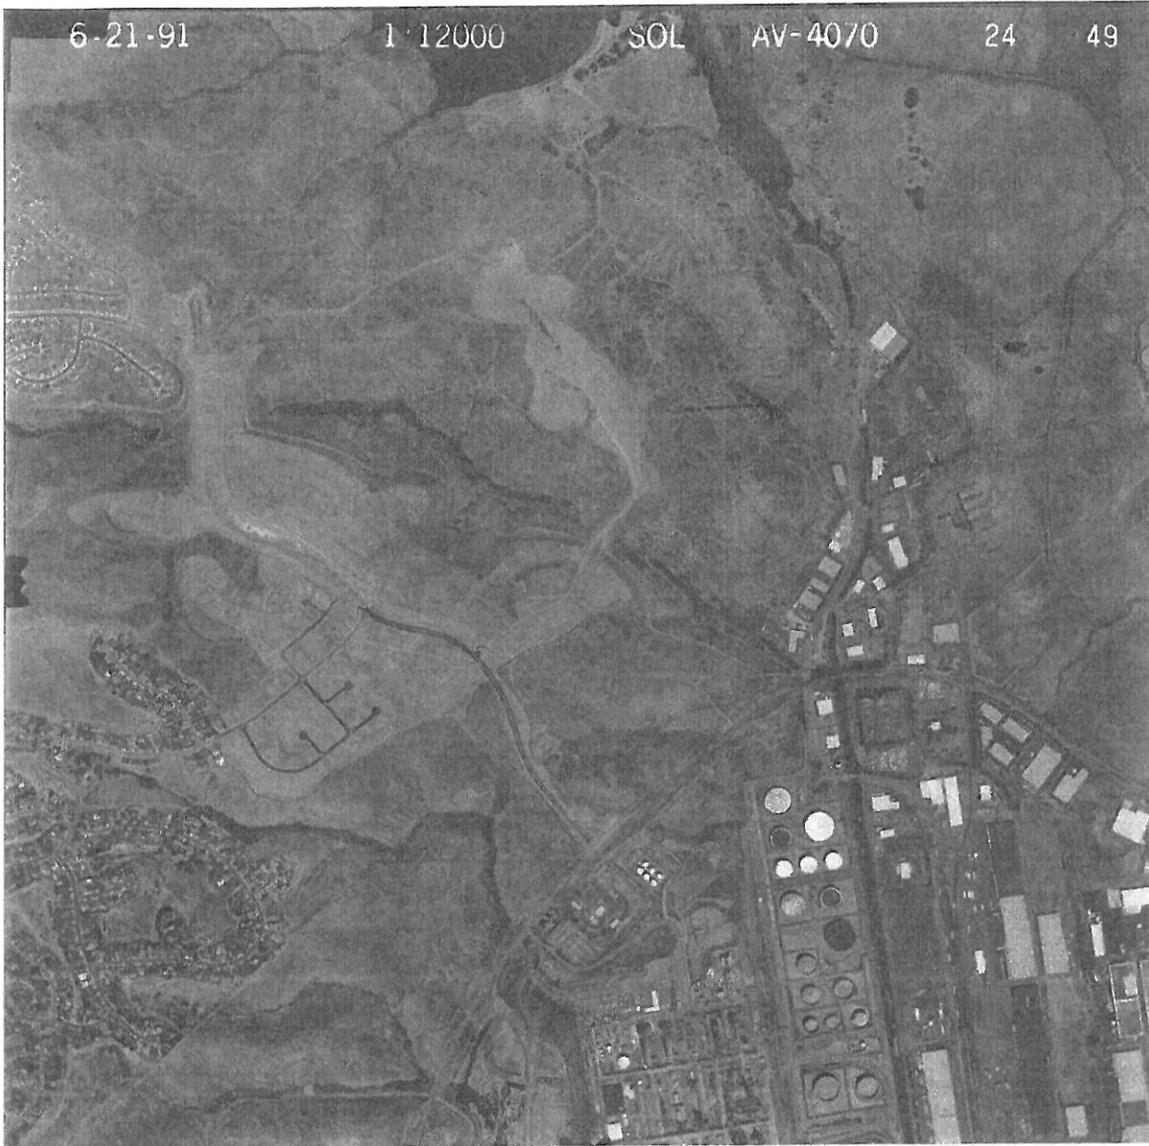
Figure 34. Photo Number SOL AV-4070 24 48
Estimated Scale: 1:18,000

- **North Valley:** This photograph is similar to the February 17, 1991, photograph, except that the circled figure-eight shaped dirt road/trail is no longer visible. The TNT Strips are visible. There has been grading to the west and southwest of the Howitzer Test Facility. Grading had been noted since September 1990. Dirt/debris piles are identified on the western edge and in the south-central portion of the property. A number of dirt trails are evident in the North Valley. These trails had been observed in previous photographs of the North Valley. The Test Firing Butts (Building 182), Buildings 540, 541, Powder Loading Room (Building 183), and Test Tunnels (Building 181) are visible. The buildings at the Ammunition Renovation/Primer Destruction Site are visible. Midway Road is visible; however, the North Valley Military Landfill is not visible. The fenceline is visible.

- **Ridge:** Only minor changes are noted along the Ridge since February 1991. The Dynamite Burn Site is not visible in the June 1991 photographs. Soil/debris stockpiles are present on the Ridge. The "J"-shaped road is not visible. Grading has occurred along the western edge of the Ridge and southward toward the South Valley.

- **South Valley:** There are little to no changes observed in photographs of the South Valley since February 1991. The run-off control ditch for the residential development along the south side of the South Valley is visible. The Flare Site and Demolition Sites are not visible. The McAllister Drive Land Bridge is visible in this area. Housing tract lots are graded to the south and west of the property; however, there are none within the property.

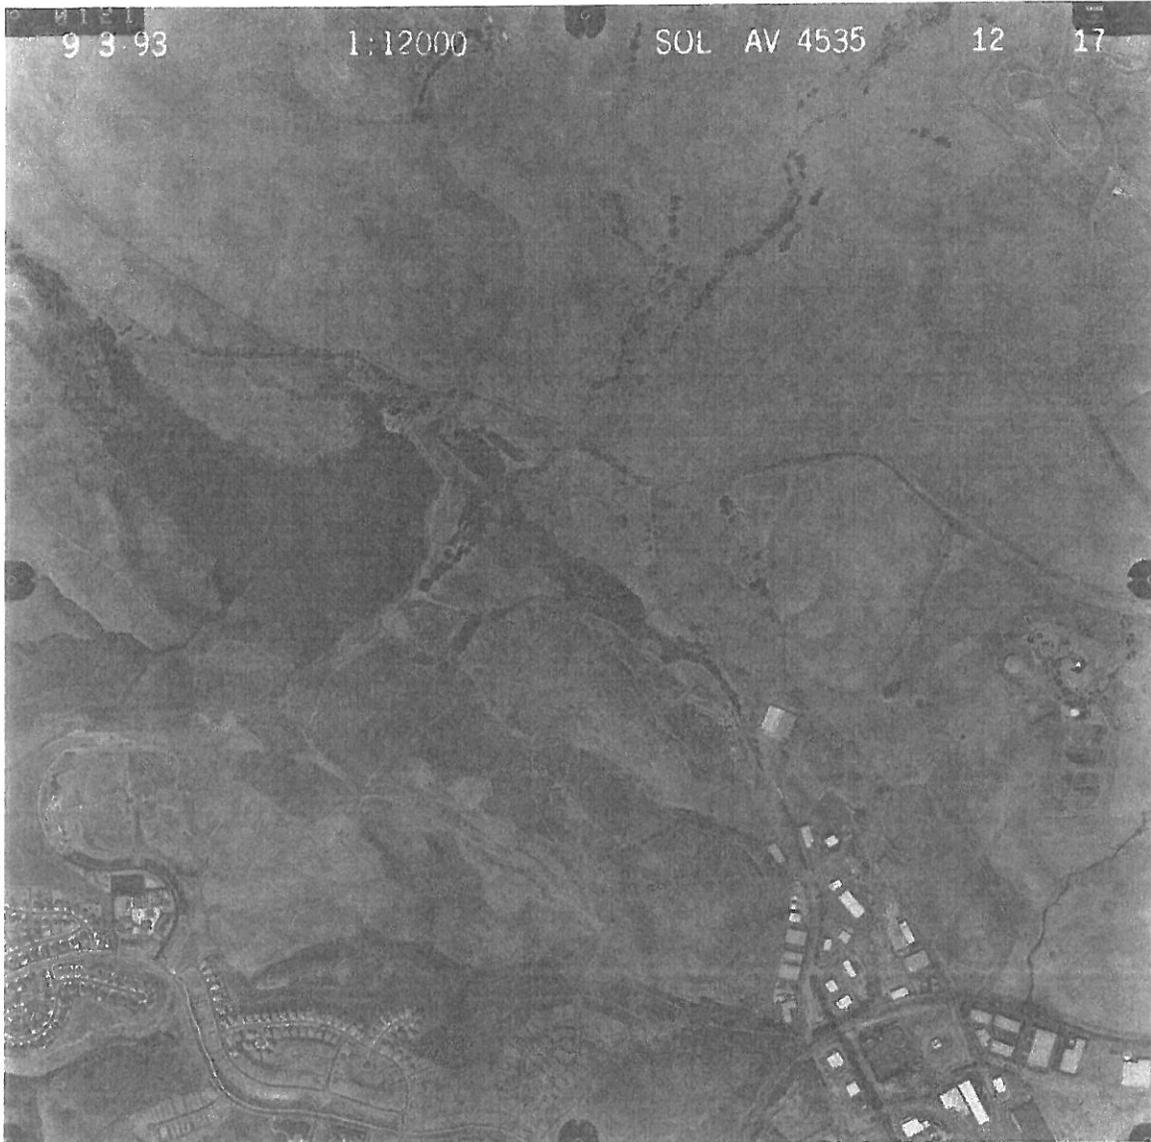
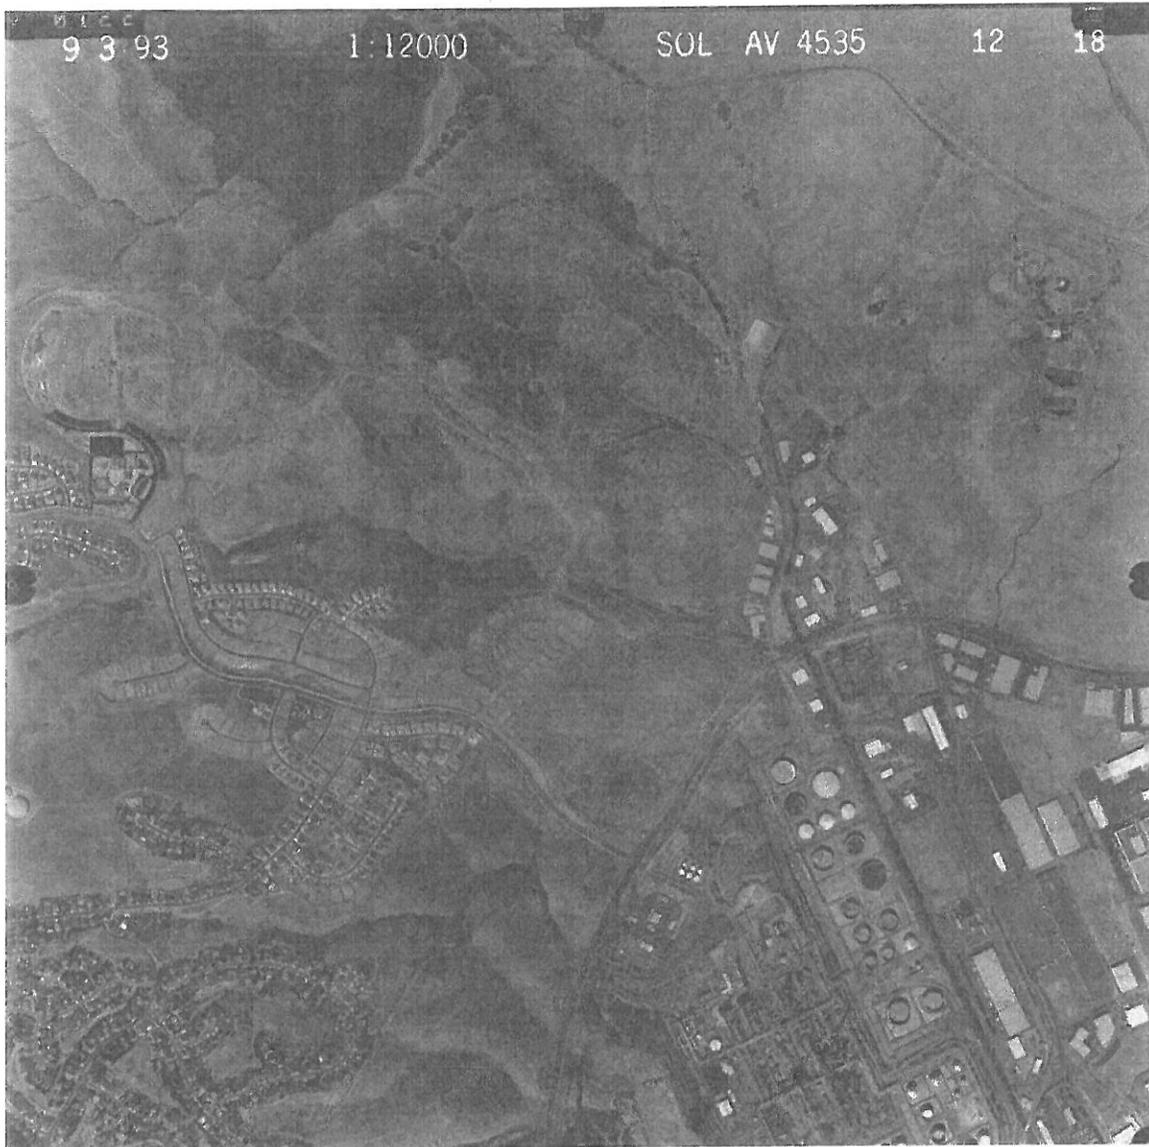
Figure 36. Photo Number SOL AV-4535 12 17
Estimated Scale: 1:18,000

- **Ridge:** There are significant changes to the Ridge since 1991. Grading since 1990 has removed visible signs of the Dynamite Burn Site. There are several soil/debris stockpiles on the Ridge. The "J"-shaped road is no longer visible. There is a small, square area that appears to be a type of fenced enclosure on the southwestern edge of the westernmost portion of the graded area (soil/debris piles); this square area was not observed on previous photographs. South of the square enclosure is a dark, contrasting, circular area in a gully leading into the South Valley.

- **South Valley:** Only a few changes are noted along the South Valley since 1991. Grading is visible throughout the South Valley in 1993. The Flare Site and Demolition Sites are faintly visible, and the road leading to these areas is faintly visible. The run-off control ditch along the south side of the South Valley is visible. The McAllister Drive Land Bridge is visible in these photographs.

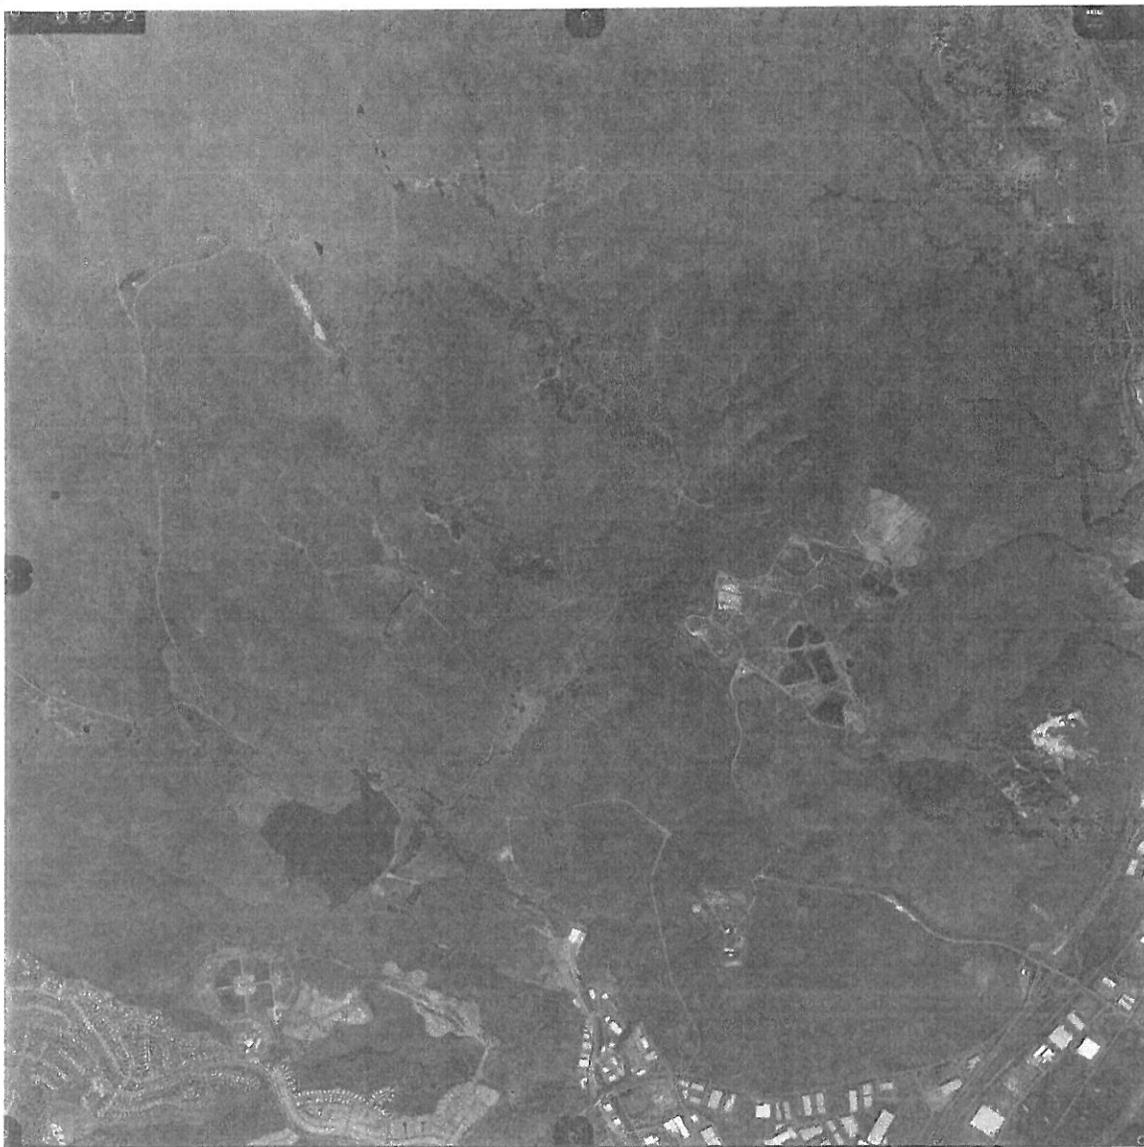
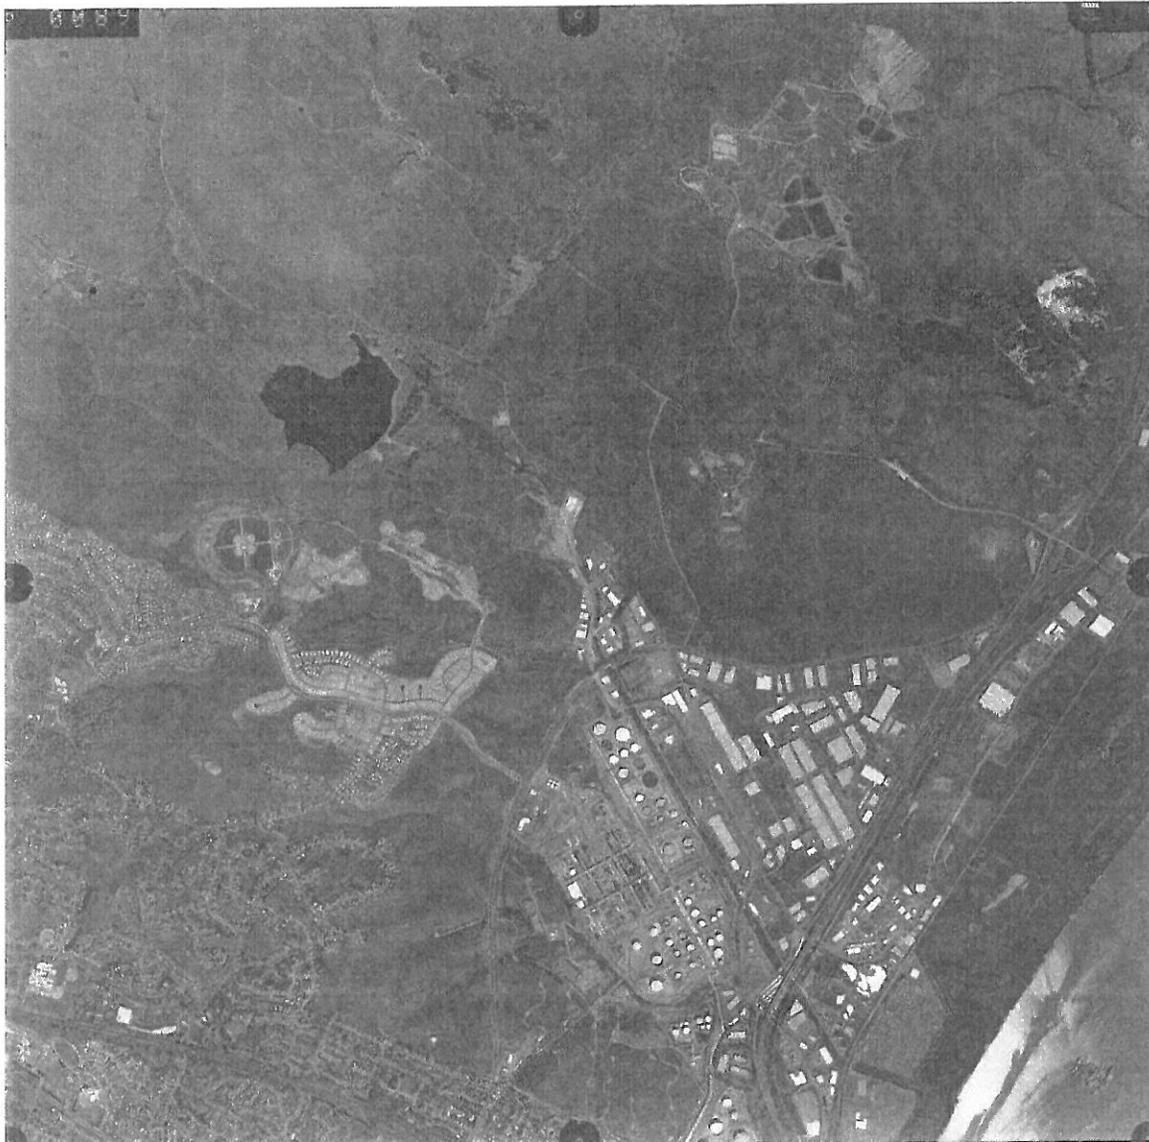
Figure 38. Photo Number SOL AV-5140 33 30
Estimated Scale: 1:36,000

- **North Valley:** Not much change is noted in the North Valley since 1993. Five TNT Strips are visible. Portions of the Howitzer Test Facility, including the Test Firing Butts (Building 182), and the Test Tunnel (Building 181), are still visible; however, the Powder Loading Room (Building 182), and Buildings 540 and 542 are not visible. The Ammunition Renovation/Primer Destruction Site and its associated buildings are not visible. Midway Road is visible; however, the North Valley Military Landfill is not visible. There is grading to the southwest of the Howitzer Test Facility. There is a clearly defined road traveling west-east-southeast between the housing areas at the southern end of the property near Kearny Street. The grading had been noted in previous photographs, while the road was not. There appear to be fewer dirt trails south of the TNT Strips than in previous photographs because more vegetation cover has overgrown the disturbed areas.

- **Ridge:** There are several changes to the Ridge observed in the 1996 photographs. Grading has removed signs of the Dynamite Burn Site. Several soil/debris piles are visible. The "J"-shaped road is not visible on these photographs. The square area noted on the 1993 photographs is visible; but the dark, contrasting, circular area is not.

- **South Valley:** There are a few changes to the South Valley since 1993. Neither the Flare Site nor Demolition Sites #1 and #2 are visible, but Demolition Site #3 is visible. The McAllister Drive Land Bridge is visible. The run-off control ditch is visible, and previously graded areas have a greater amount of vegetative cover.

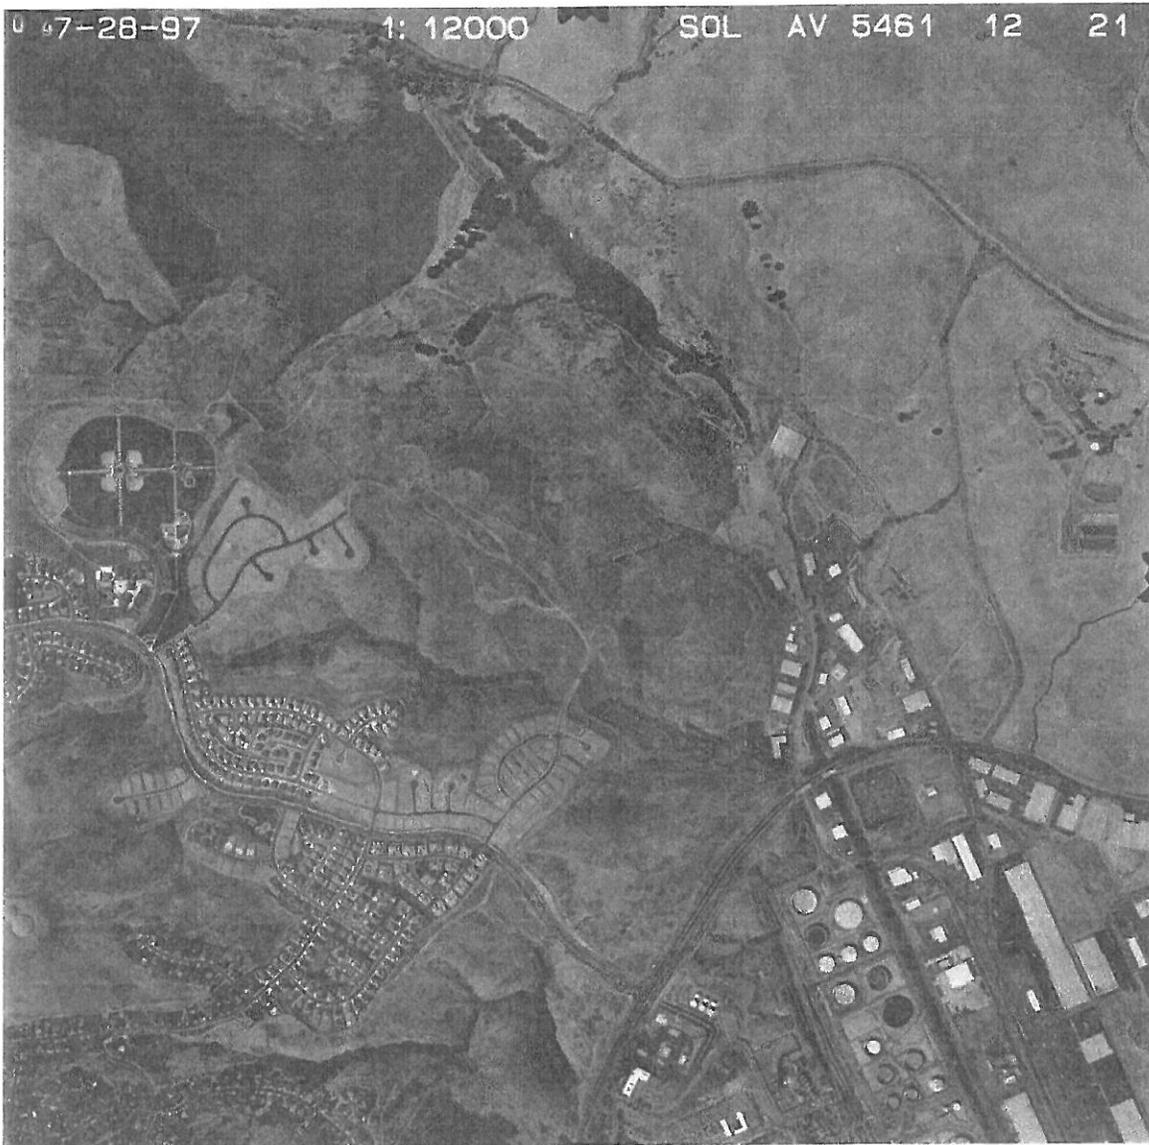
Figure 40. Photo Number SOL AV 5461 12 21
Estimated Scale: 1:18,000

- **Ridge:** This is the most recent aerial photograph of the Ridge analyzed. There are a number of dirt/debris piles visible on the western edge of the Project Site along the Ridge. The area also contains the square, enclosed area, as noted previously. The dark, contrasting, circular area reappears in the same area as it was in 1993. The "J"-shaped road is not visible. Graded areas show signs of increased vegetative cover in those areas.

- **South Valley:** The 1997 photograph is the most recent aerial photograph of the South Valley analyzed. Construction activities south of the South Valley are observed in the photographs. The Flare Site and Demolition Sites are not visible, and vegetation is more dense than in previous photographs. There is less grading evident along the South Valley than previously noted. The McAllister Drive Land Bridge and adjacent road are visible and appear to be paved. The road leading south from the Ridge through the South Valley toward the housing complexes has also been paved.
