TOURTELOT CLEANUP PROJECT

TOURTELOT PROJECT ANNUAL INSPECTION AND REPORT FORM

Benicia, California

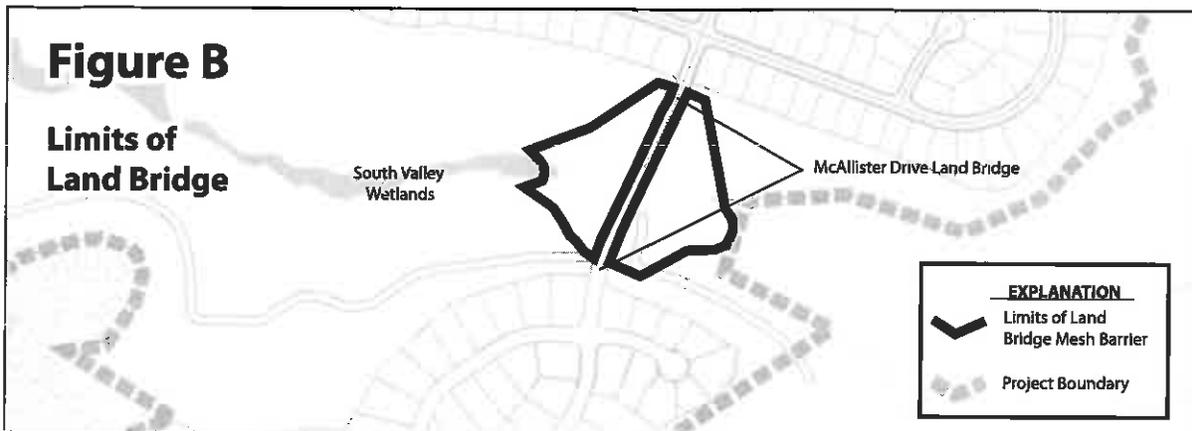
LAND BRIDGE MESH BARRIER

The Land Bridge Mesh Barrier has lifted along the Northerly limits. While the area that is lifting has lifted quite a bit, it does not appear to having an overall effect on the barrier remaining securely in place. Append C has photos. On a scale of 1-10 (10 being the worst), how significant is the damage?

3-4

As mentioned above, the edges beginning to lift "up" may affect the overall hold down strength of the mesh barrier.

The best way to describe the affected area would be an area running the length of the perimeter of the mesh barrier is no longer held down by pins.

No repair is recommended for the mesh barrier, only monitoring. The vegetation has become an effective long-term hold down for the barrier.
