**Appendix A Slope Stability and Erosion Areas**

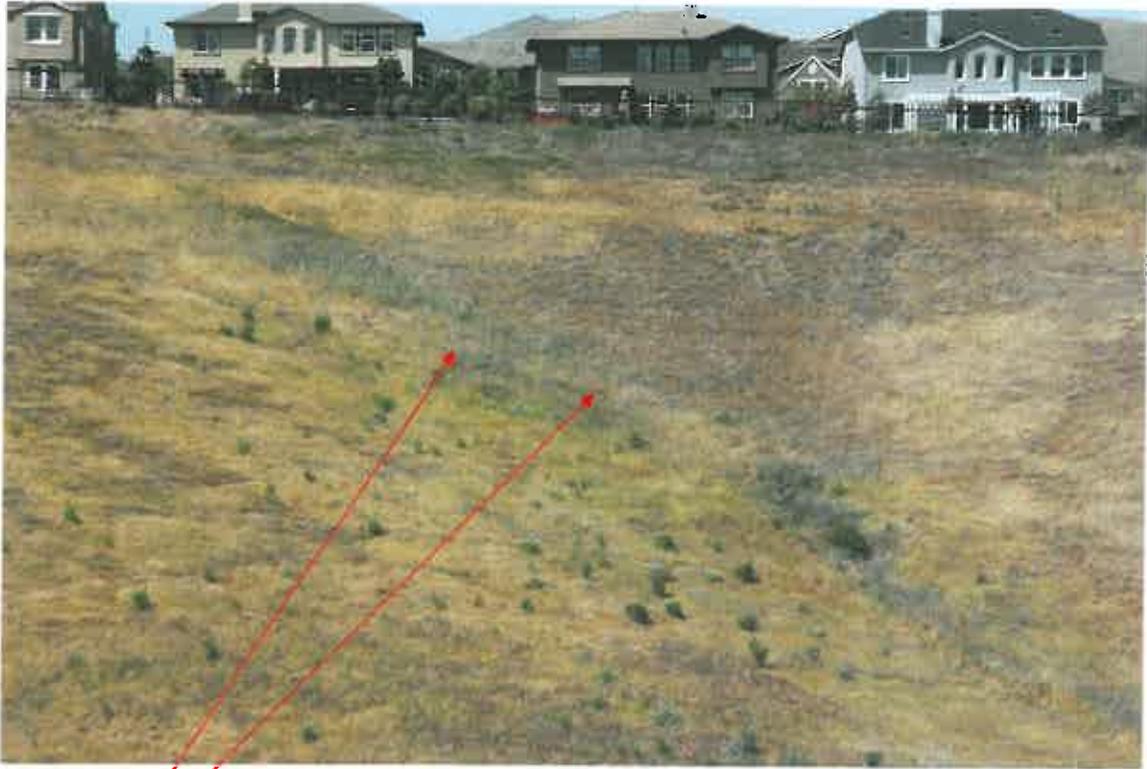
**Slump in Area H May 12, 2008 Unchanged from 2008**

**Line of slump found in 2007, no change detected**

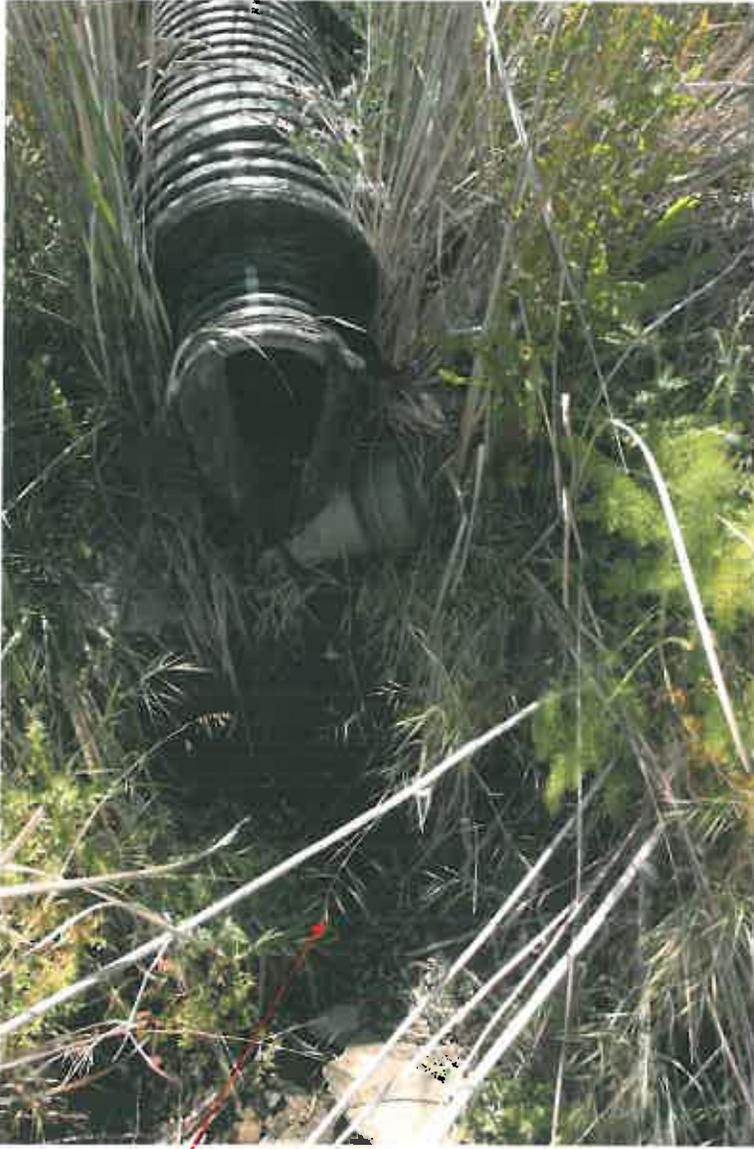
Erosion Damage at Station S5      May 12, 2008

**Note erosion at drain outlet that has eroded the slop bank at location of Staion S5 marker**

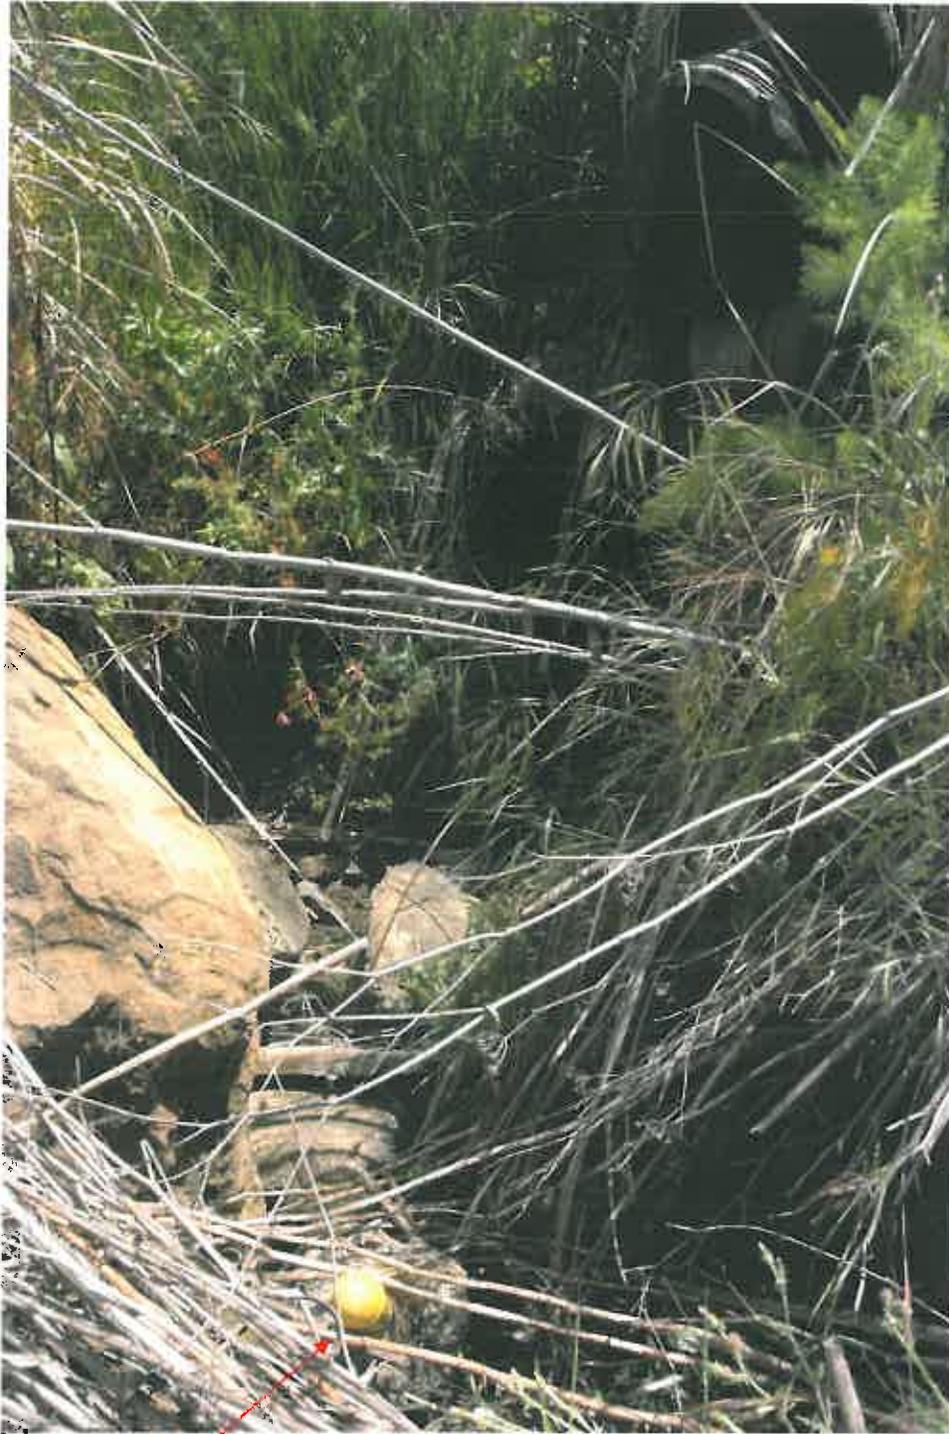
Note erosion undermining and displacement of Station S5 marker
