TOURTELOT CLEANUP PROJECT

TOURTELOT PROJECT ANNUAL INSPECTION AND REPORT FORM

Benicia, California

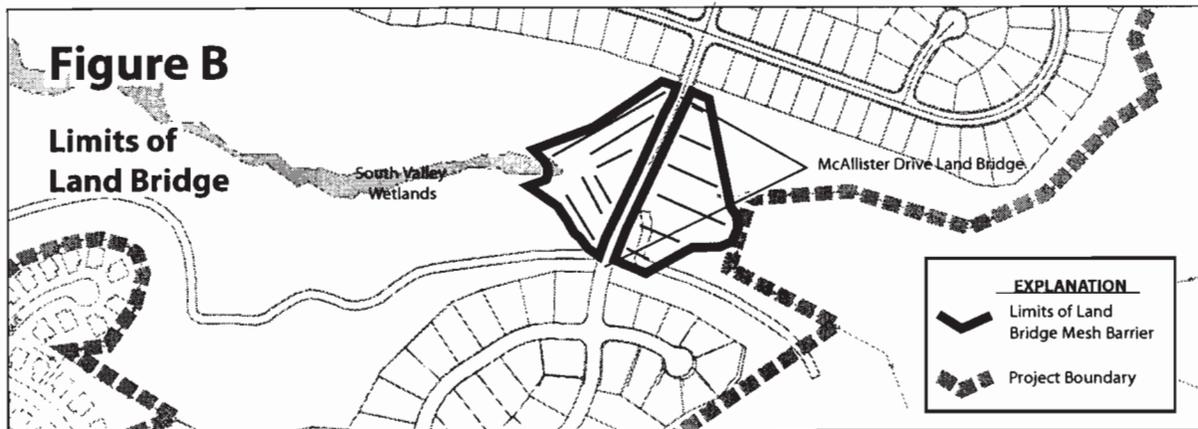
Estimated areas affected have been indicated with the red lines in the figure above. As in years past, the lines represent the seams between sections of the Mesh Barrier. This is where the barrier has been compromised. The pins holding the seams down are failing in these areas. The barrier lifts upward away from the slope at these failed points.

2

As described above and in all of the previous inspection reports, the hold-down pins are lifting in the areas shown in the figure above. This does not appear to affect the ability of the Mesh Barrier in preventing unauthorized excavation. Vegetation also aids in holding down the Mesh Barrier.

This would best be described as; linear strips of mesh barrier lifting along the seams between sections of the barrier.

Based on five years of observation, no repairs are recommended for the Mesh Barrier at the time of this report. Vegetation remains an effective aid in holding down the barrier as a whole. The affected areas are small and the photo exhibit will show the extent of the barrier lifting away from the slope.
