**Appendix A – Slope Stability and Erosion Areas  
Tourtelot Annual Inspection Report  
April 2009**

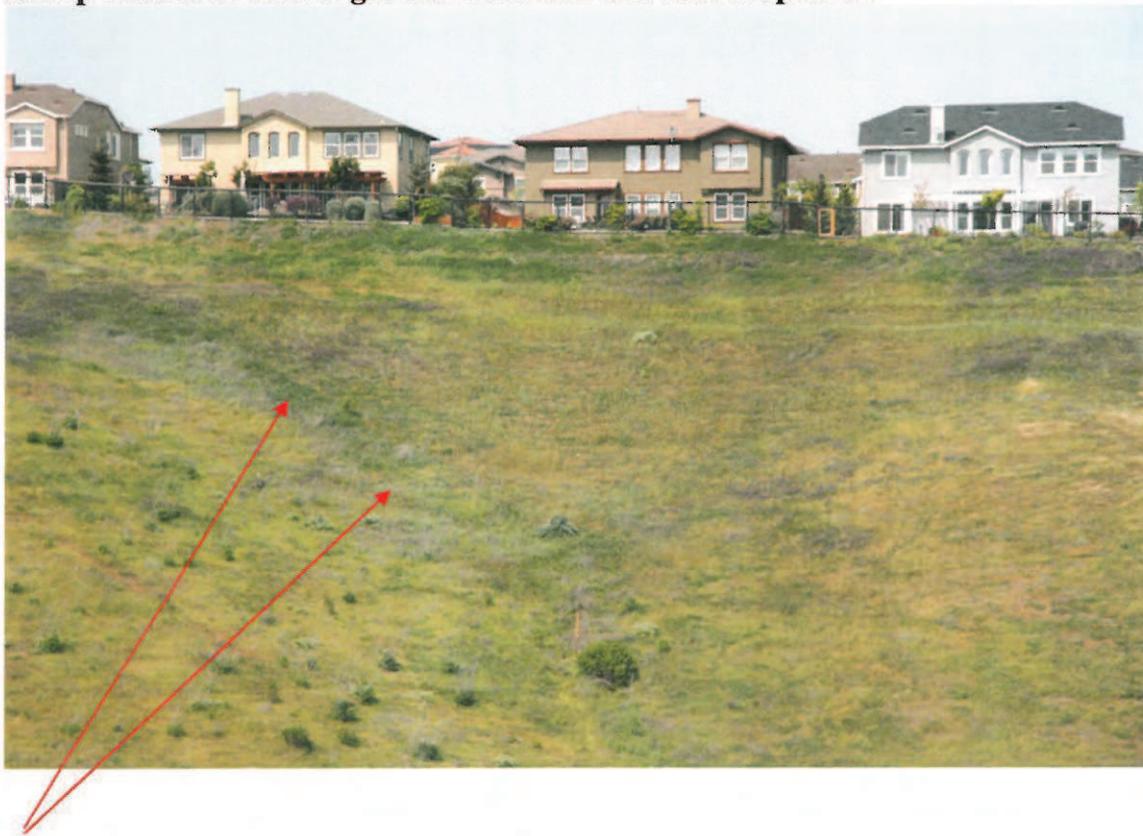
**Slump in Area H Unchanged from the 2007 and 2008 Inspection**

**Line of slump found in 2007, no change change detected.**
