**Appendix A – Slope Stability and Erosion Areas  
Tourtelot Annual Inspection Report  
April 2011**

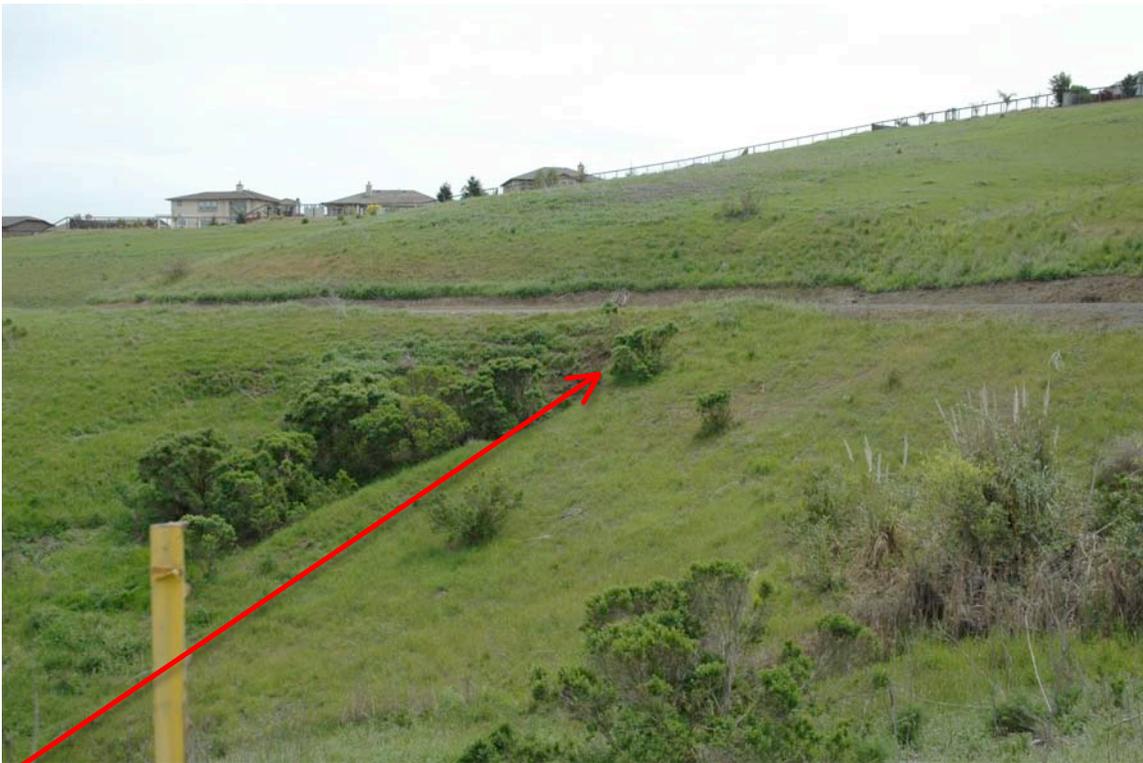
**Location of new slide identified  
Area A – Station S8**

**A new slide has been identified in this area. See photos at the end of this Appendix.**

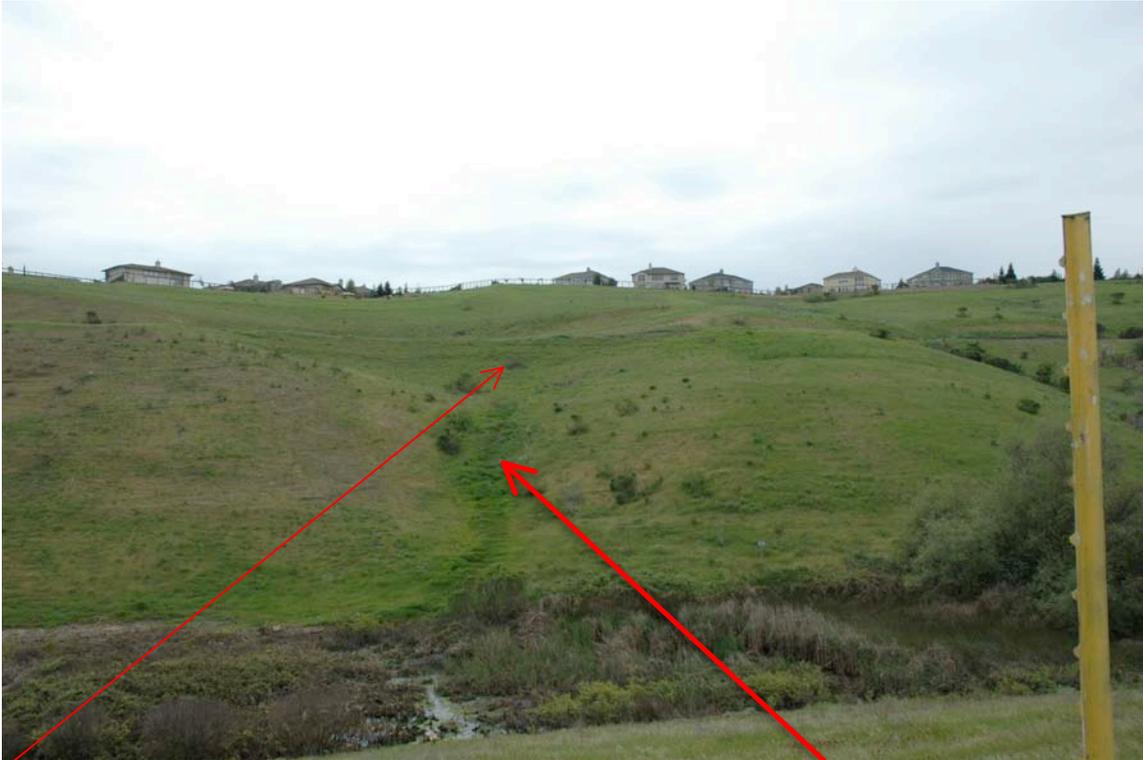
**Area B – Station S15**

**New Slump in 2011– See additional photos | Slump from 2010**

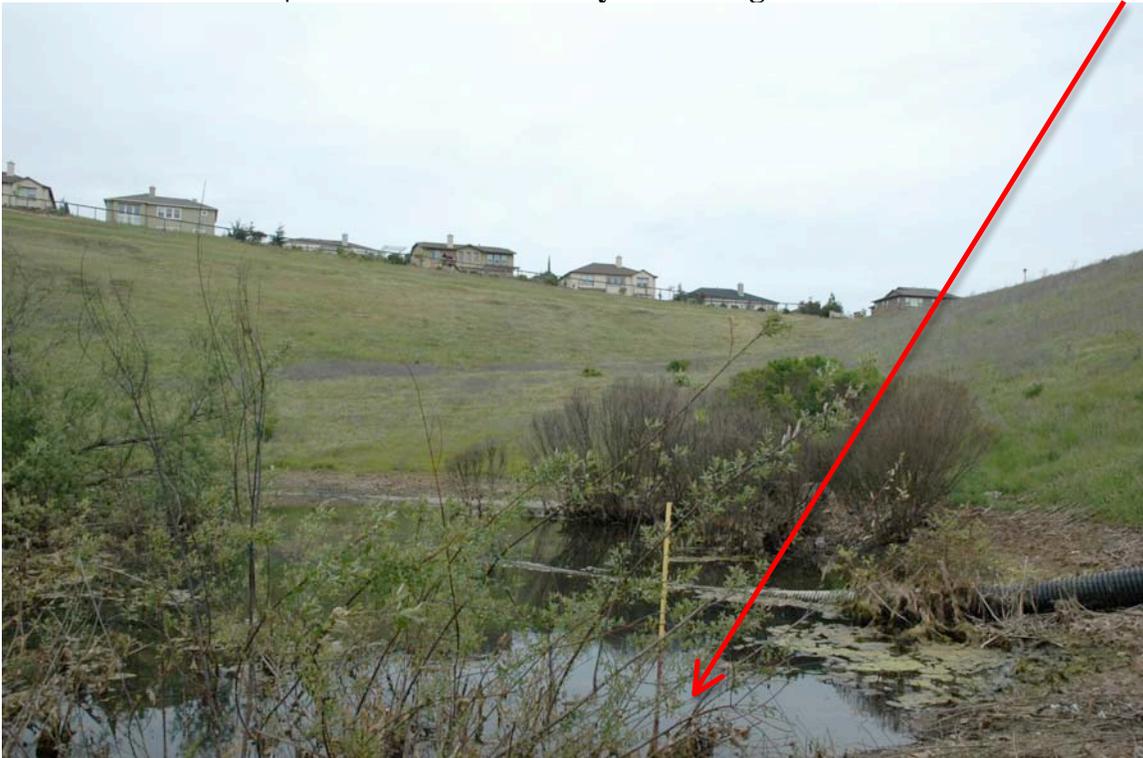
**Area I – Station S16 | Photo access limited by water height. Station is under water**

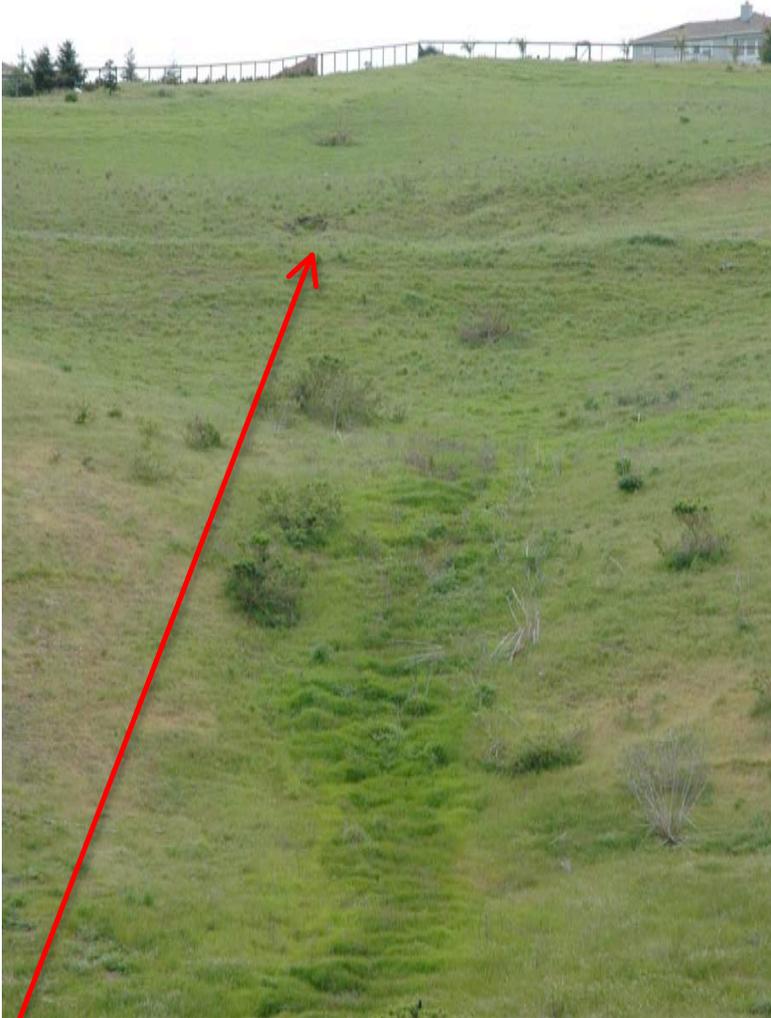
**Slump in Area B**

**New Slump as noted in Area B – Station 15 photo**

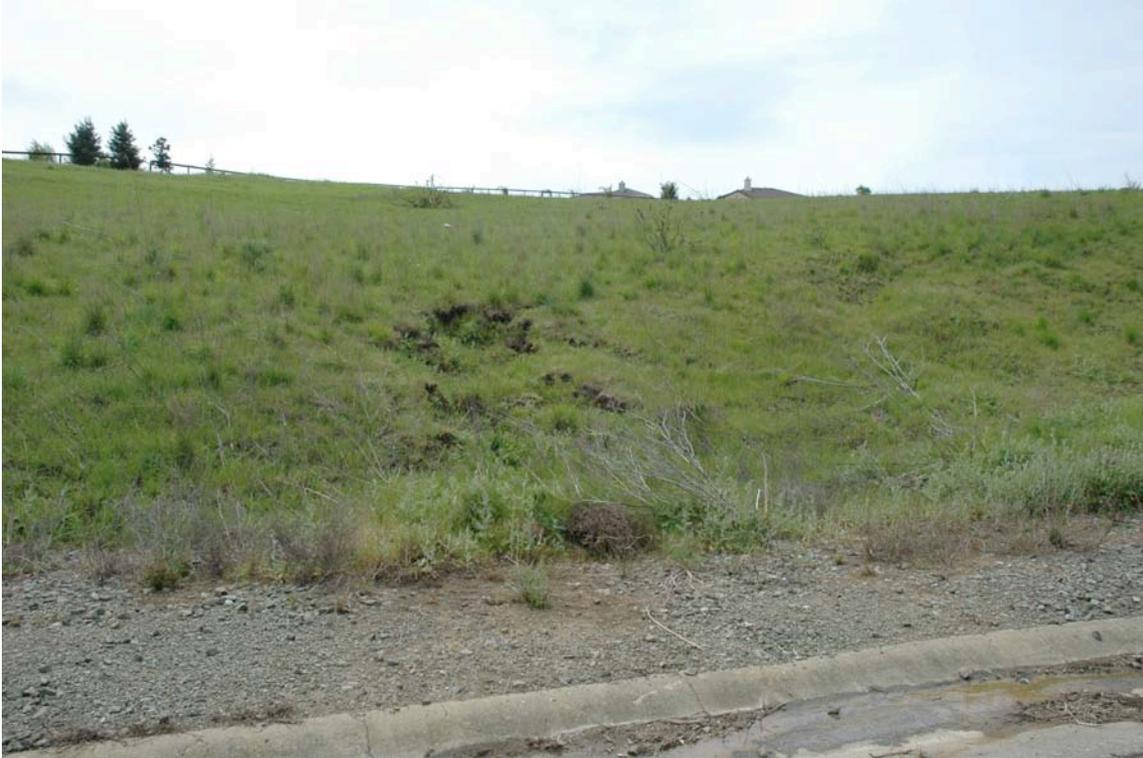
**Another view of the slump in Area B. This slump is located above Sewer Road and is a new slump which lies above the slump identified below Sewer Road in this area in 2010.**

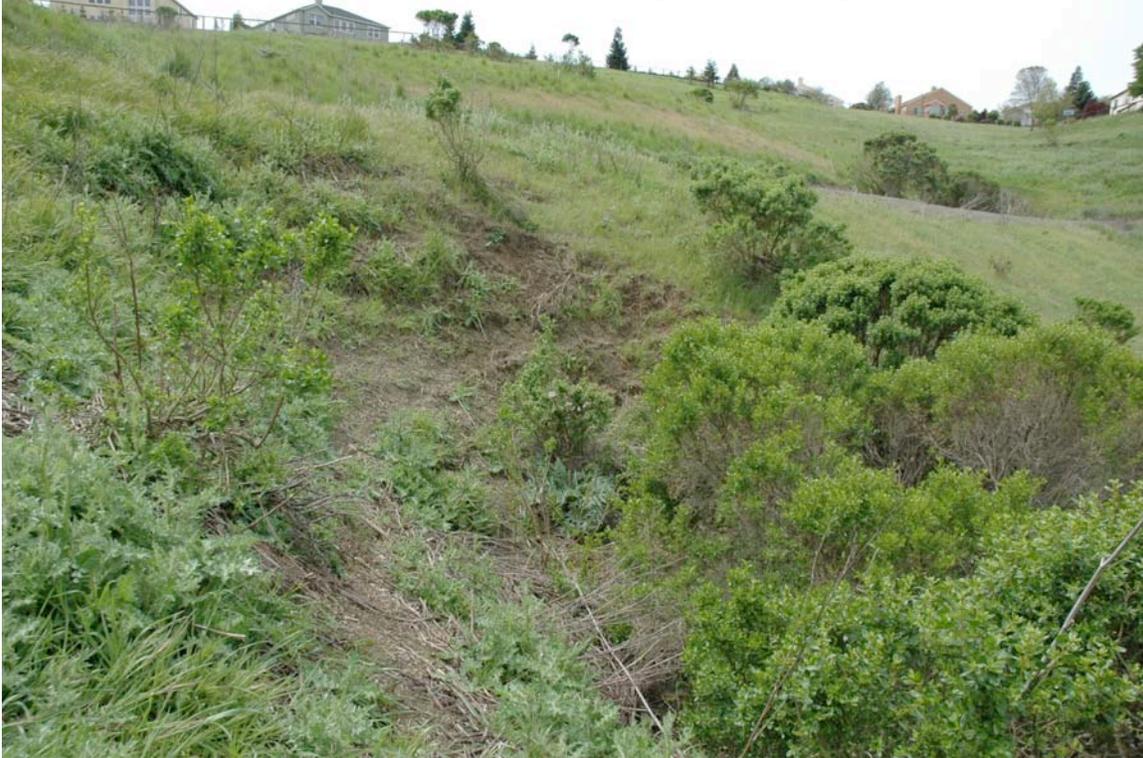
**New Slump found in Area A at Station S7 during the 2011 inspection**

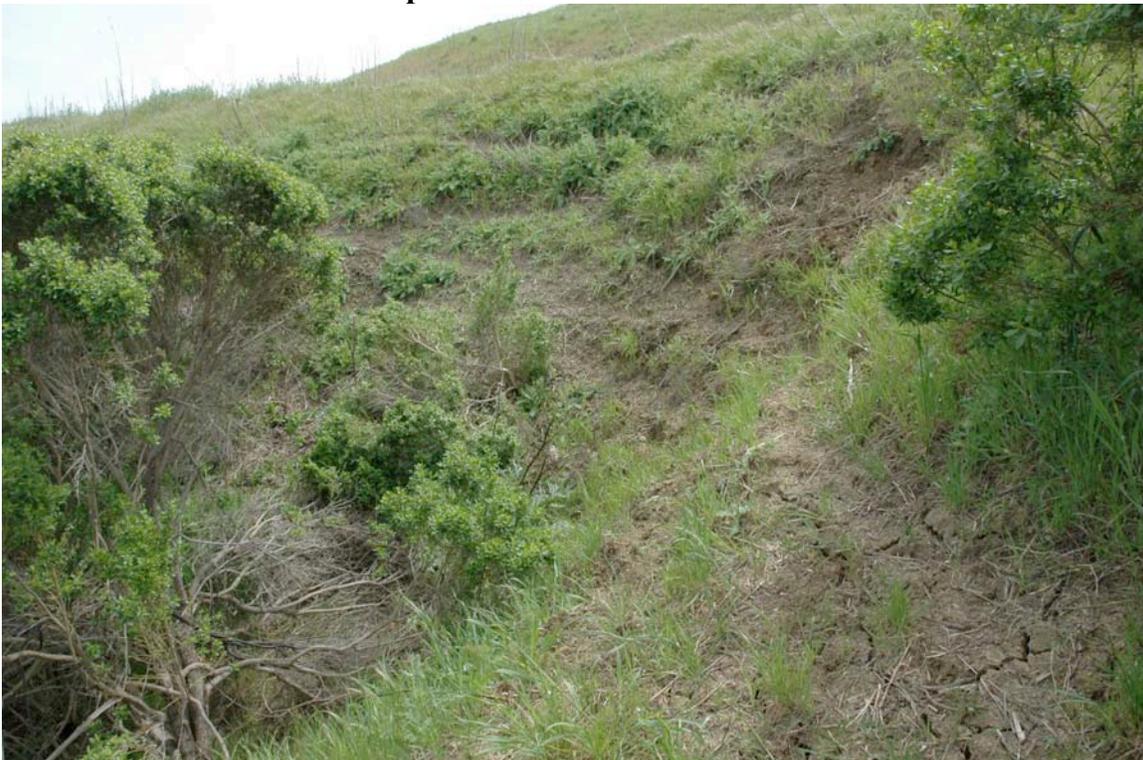
**Another view of the new slump in Area A.**
