**Appendix C – Land Bridge Mesh Barrier
Tourtelot Annual Inspection Report
April 2011**

McAllister Drive

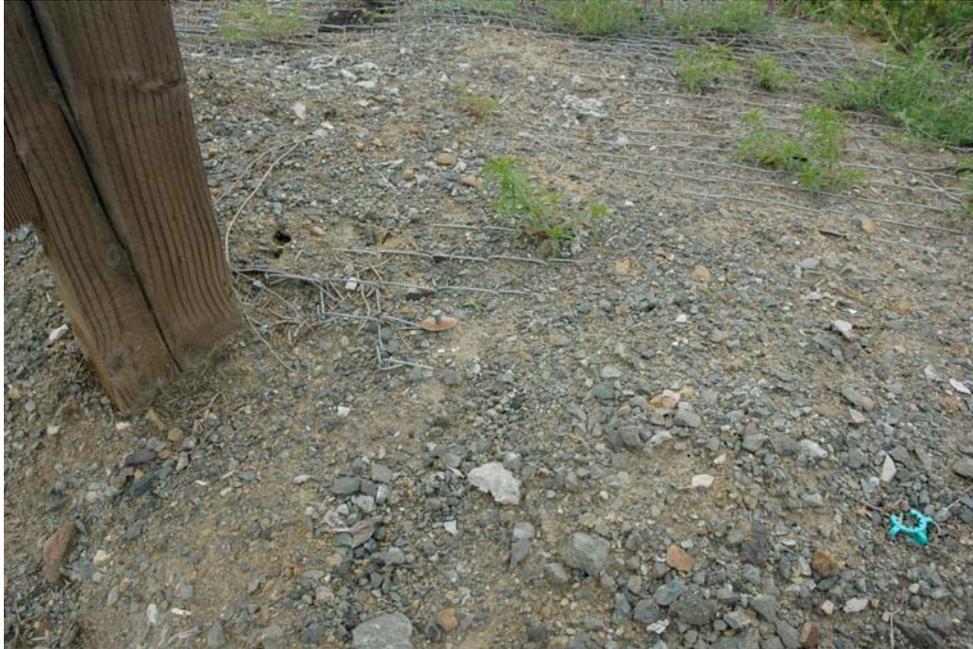
**McAllister Drive
Mesh Barrier shows good contact with the surface**

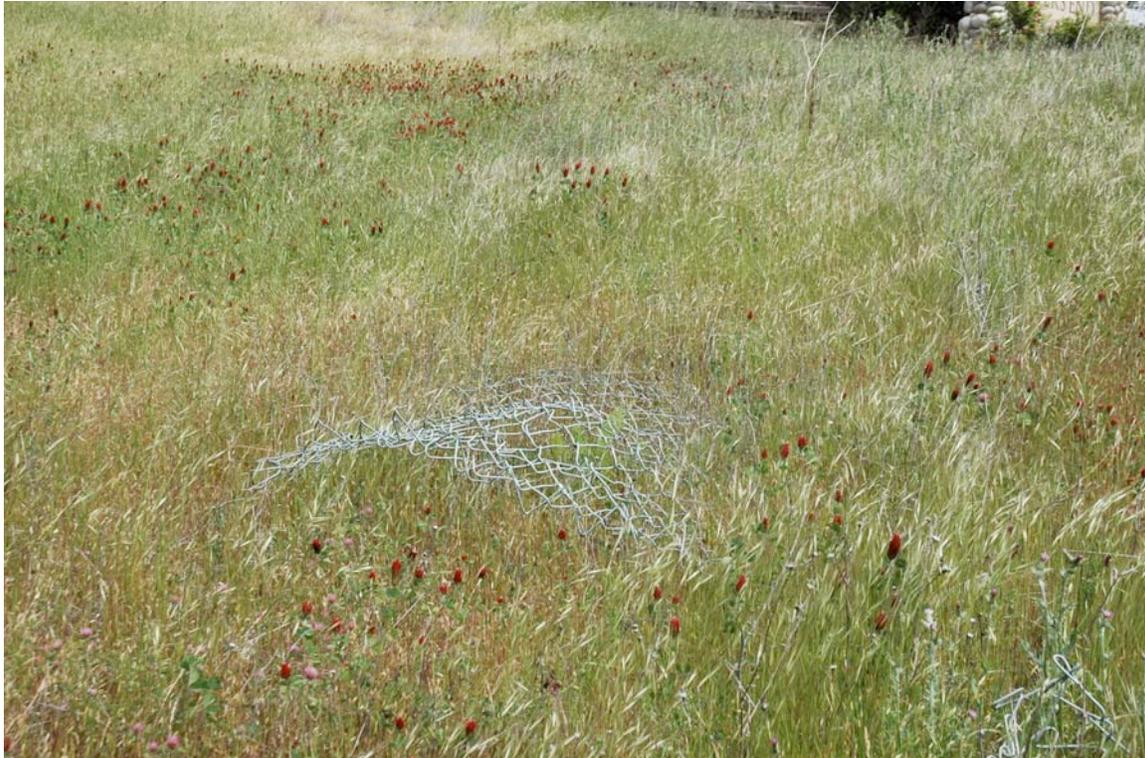
A small section lifted from the slope at the on the west side of McAllister Drive.

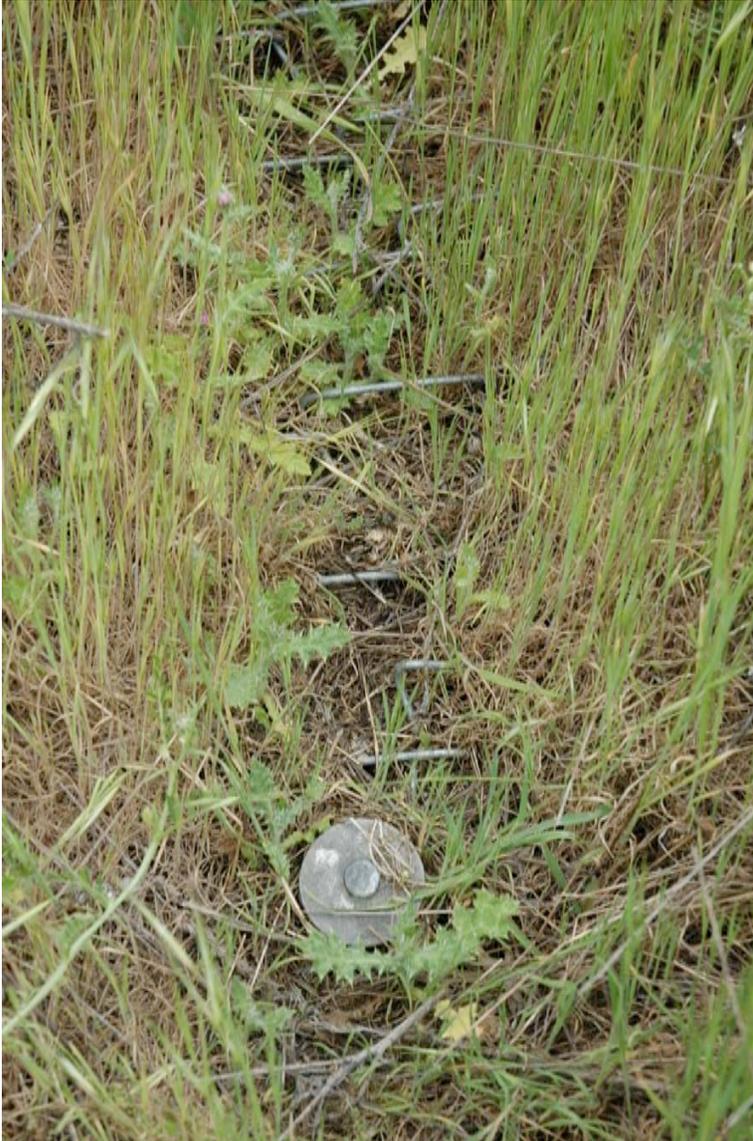
**Mesh Barrier on the eastern slope of McAllister Dr.
Barrier is intact and has good contact with the slope.**

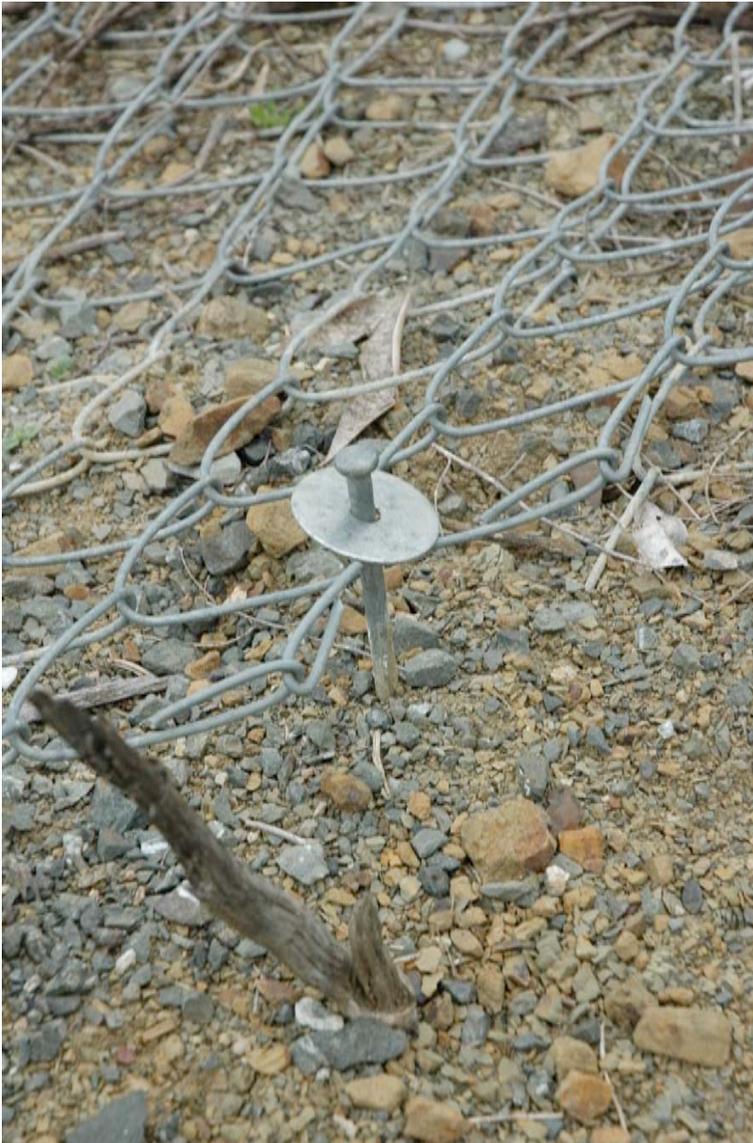
**Additional Photo of Mesh Barrier
Anchoring pin lifting from the surface along the top of slope on the west side of
McAllister Dr.**
