TOURTELOT CLEANUP PROJECT

TOURTELOT PROJECT ANNUAL INSPECTION AND REPORT FORM

Benicia, California

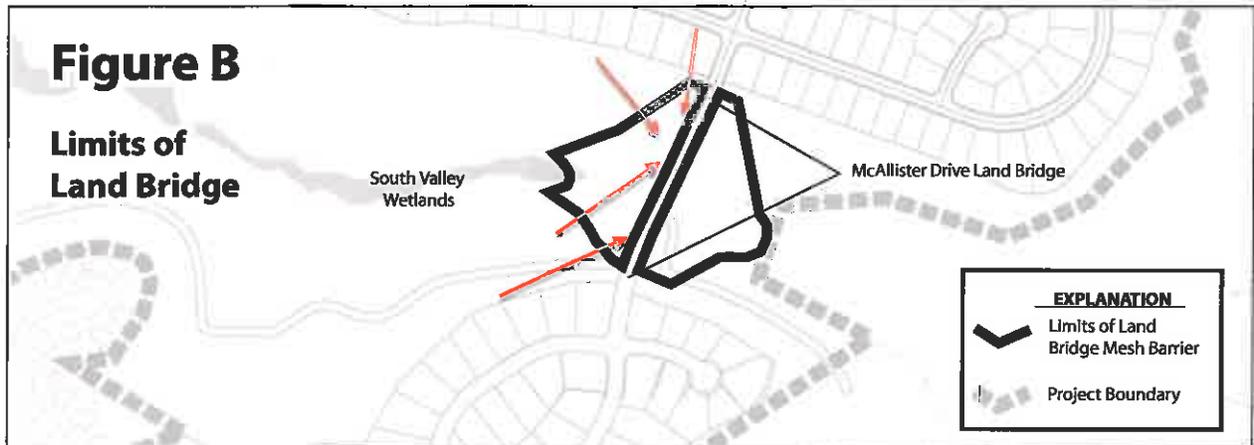
Before conducting the annual inspection of the Land Bridge Mesh Barrier, , please review Section 3.3 of the O&M Plan. The Land Bridge Mesh Barrier (See Figure B) was installed to prevent unauthorized excavation into the slopes of the Land Bridge. Excavation into the slopes of the Land Bridge could result in potential exposure to OE-Energetic or OE-Like items.

1. Where has the Land Bridge Mesh Barrier been affected? Locate on figure.
 The affected areas are in the same locations as in previous years. No new areas have been affected in the last year. The areas affected are the edges of the mesh barrier along McAllister Drive at the top of slope on the western aspect. There are also a few small areas on the western aspect where the mesh barrier has lifted from the slope. These are the same areas that have been reported in previous years.

2. On a scale of 1-10 (10 being the worst), how significant is the damage?
 2-3
3. Describe how the barrier has been affected: (i.e. cuts, weakened barrier, etc.)
 The pins that hold the mesh barrier along it's edges and at the top of slope have lifted in some localized areas. The Mesh Barrier in general can be classified as being in good condition with good adhesion to the slope.

4. Estimate size of affected area.
 The areas on the slope where the Mesh Barrier has lifted are approx. 2'x2' in size. The areas at the top of slope are lengths of 3-5' where the holding pins have been compromised.

5. Describe what has been done to repair the Land Bridge Mesh Barrier.
Note: CAP requires special precautions for repair.
 It is the recommendation of the consultant performing this inspection that the Mesh Barrier be reattached at the top of slope locations along McAllister Drive.
