Inspector Field Report

City of Benicia

SAP Evaluation of 670 East H street.

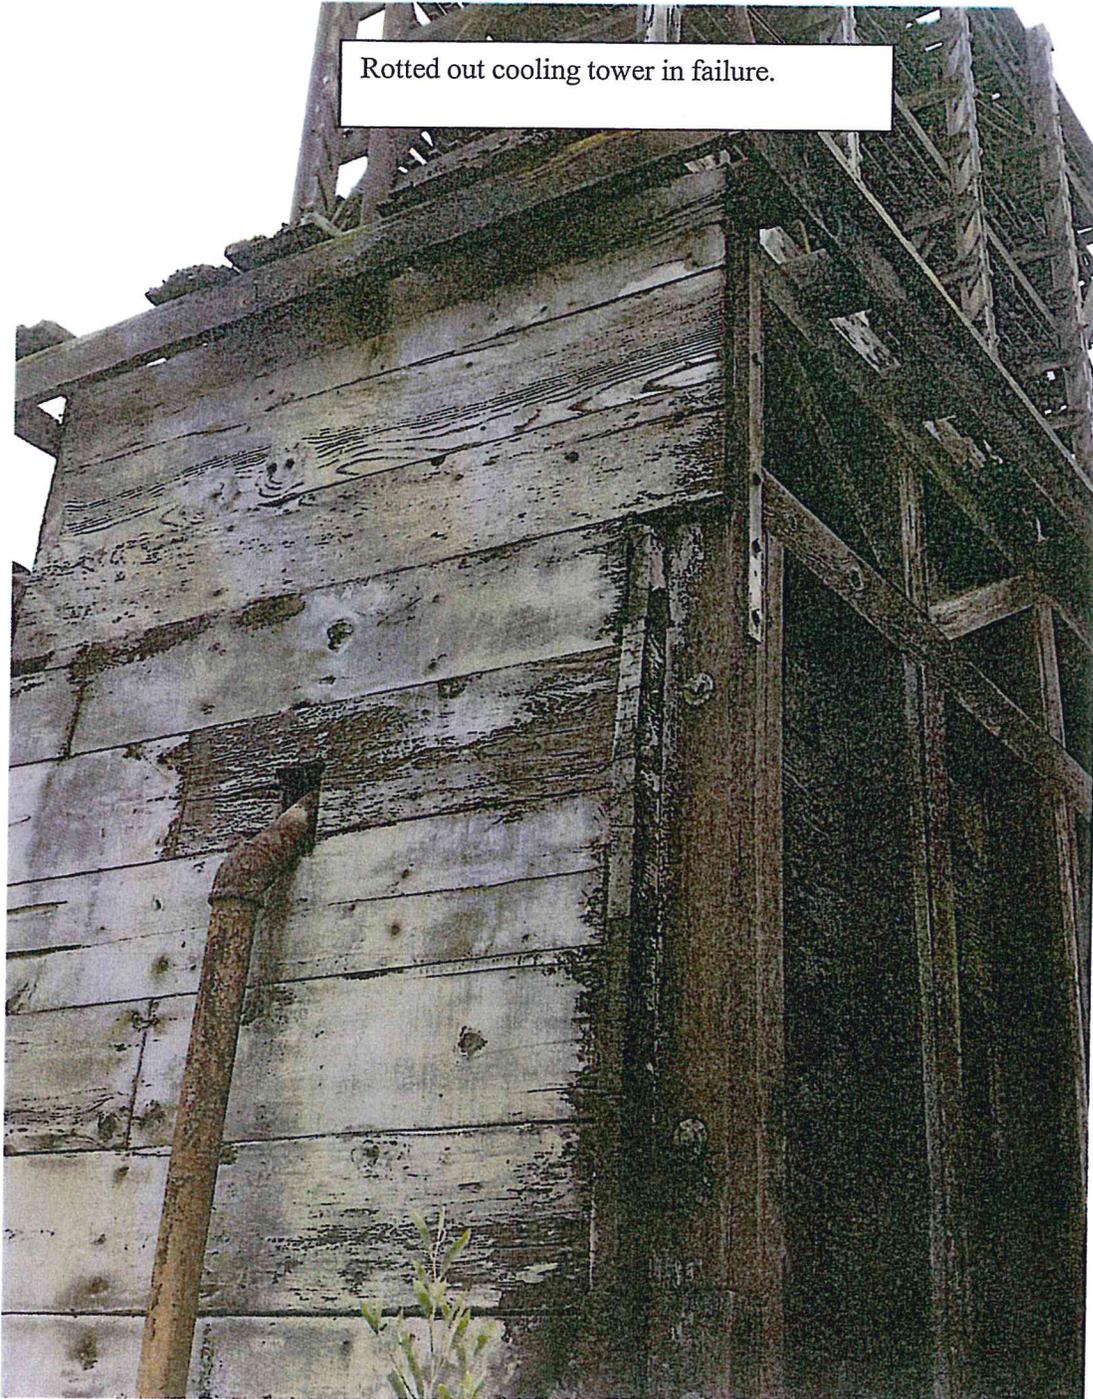
Rotted out cooling tower in failure.
