SAFETY ASSESSMENT PROGRAM EVALUATION OF 670 EAST H STREET.

4LEAF Job #: J1941

Current Site Visit: 12/8/2016

Assessor: Fred Cullum

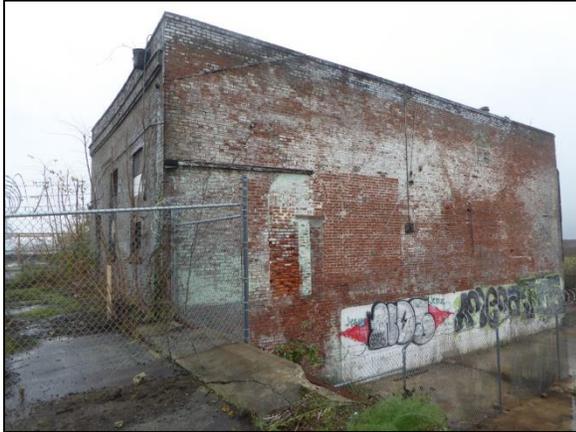
NOTE CONCAVE DEFLECTION AT TOP

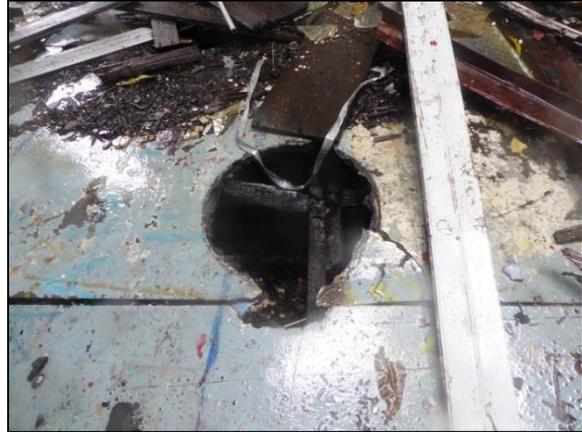
INTERIOR FLOOR FAILURE BURNT FLOOR JOISTS

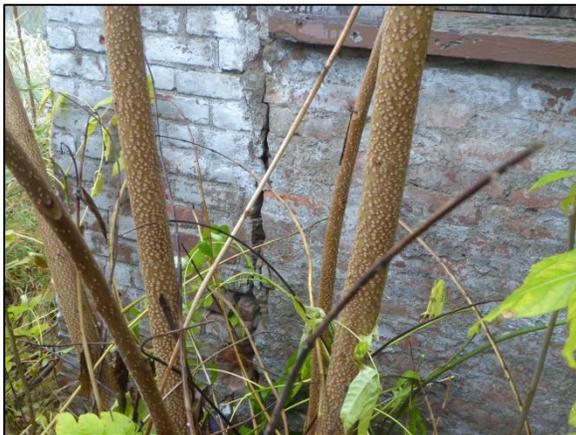
MAJOR SETTLEMENT FAILURE

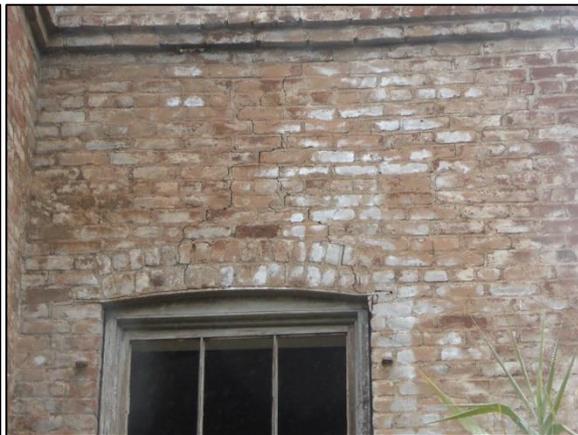
DIAGONAL CRACKS ABOVE WINDOW

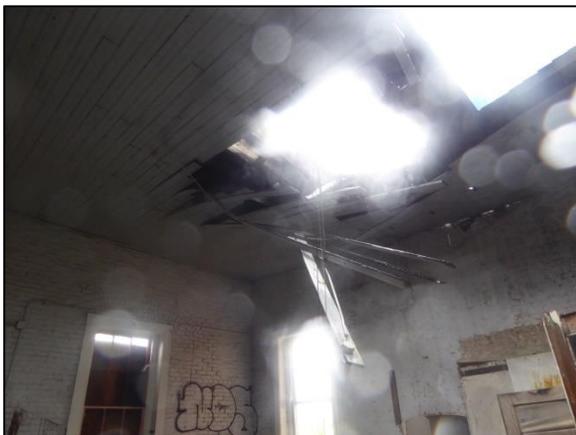
ROOF FAILURE

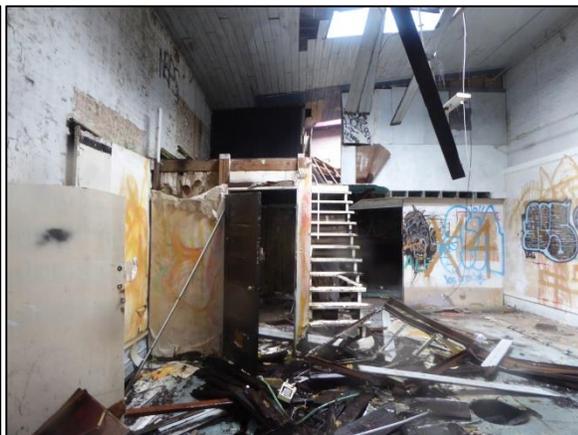
INTERIOR-NOTE FIRE LOAD

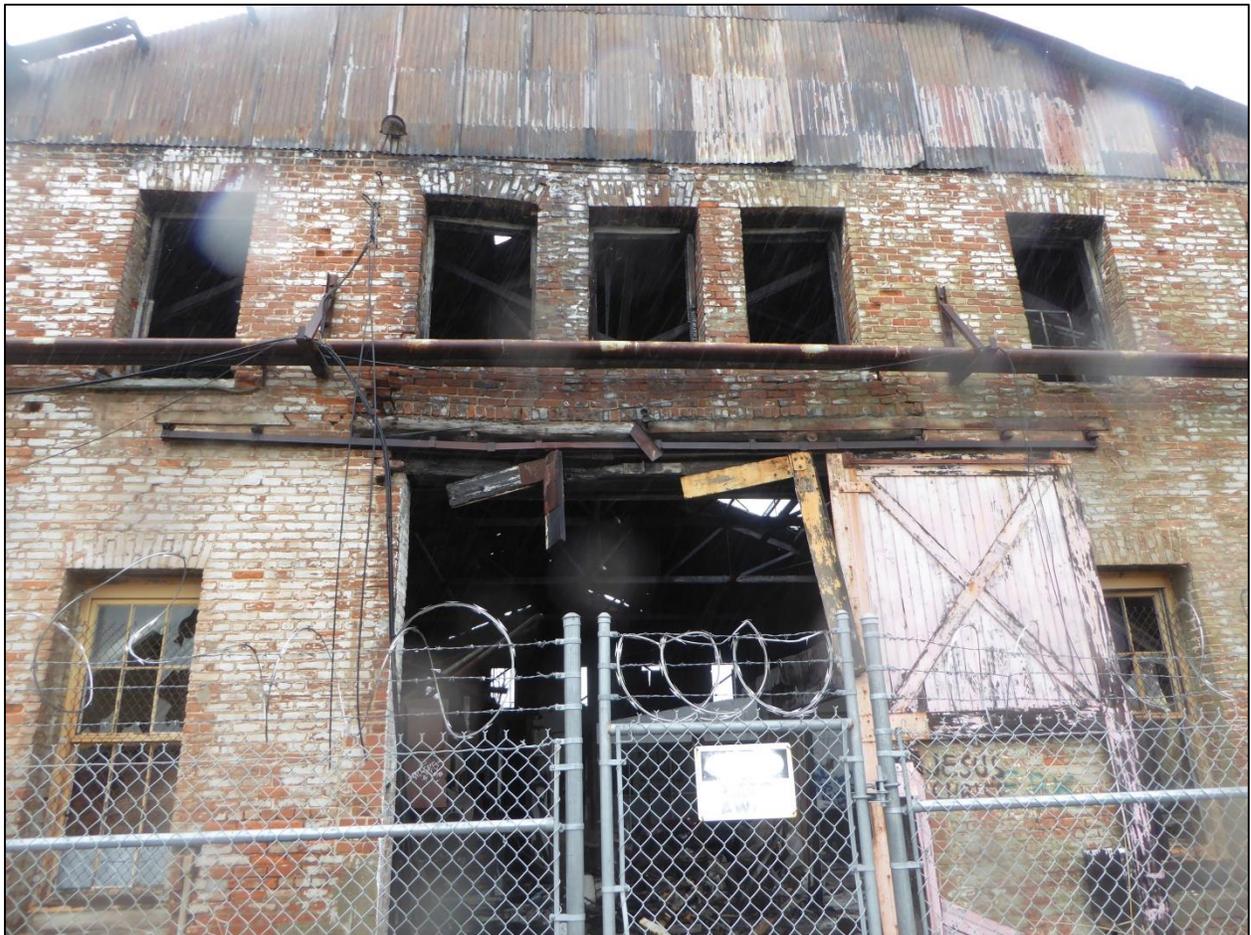
**NOTE DEFLECTION OF WALL ABOVE OPENING
THIS IS CONSIDERABLY ADVANCED OVER LAST YEAR'S REPORT.**

I have reviewed the December 2015 report and accompanying photos. The SAP Evaluator listed several bullet points, all of which I agree with, but have expanded upon below. The buildings continue to fail structurally and this is most notable in the Foundry. The wood lintel supporting the bricks above the large opening had cracked due to excessive deflection at some point in the past and had a crude repair to limit the crack. The failure now, due to recent fires, has markedly increased with more bricks falling out for the full depth of the wall and much more loss of bricks above the lintel. The added deflection over the last year appears to be approximately 4".

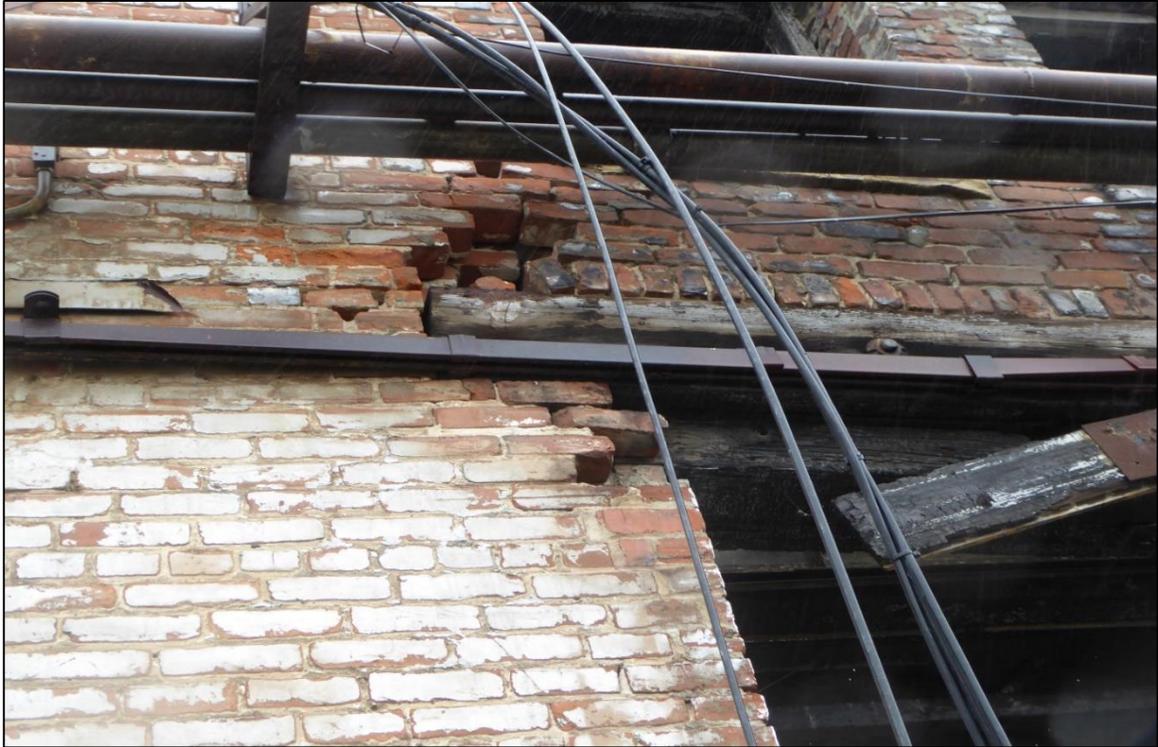
EXTREME FAILURE OF MULTI-WYTHE WALL-BRICKS BELOW CRUSHED BY DEFLECTION OF WALL ABOVE DUE TO FAILURE OF WOOD LINTEL DUE TO DRYROT AND FIRE-BRICKS ABOVE SIMILARLY DAMAGED DEFLECTION EXHIBITED IS MUCH GREATER THAN LAST YEAR. FAILURE OF BEAM WILL RESULT IN COLLAPSE OF THE WALL ABOVE, THUS PULLING THE LONG WALL OVER

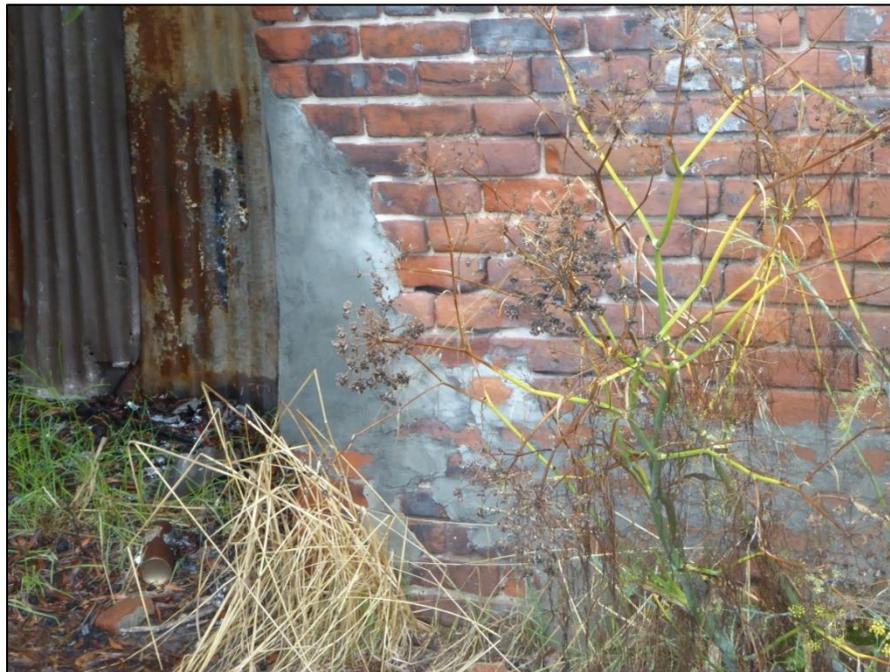
CONCRETE REPAIR OF FAILED CORNER-NOTE LACK OF MORTAR ON EXPOSED BRICK

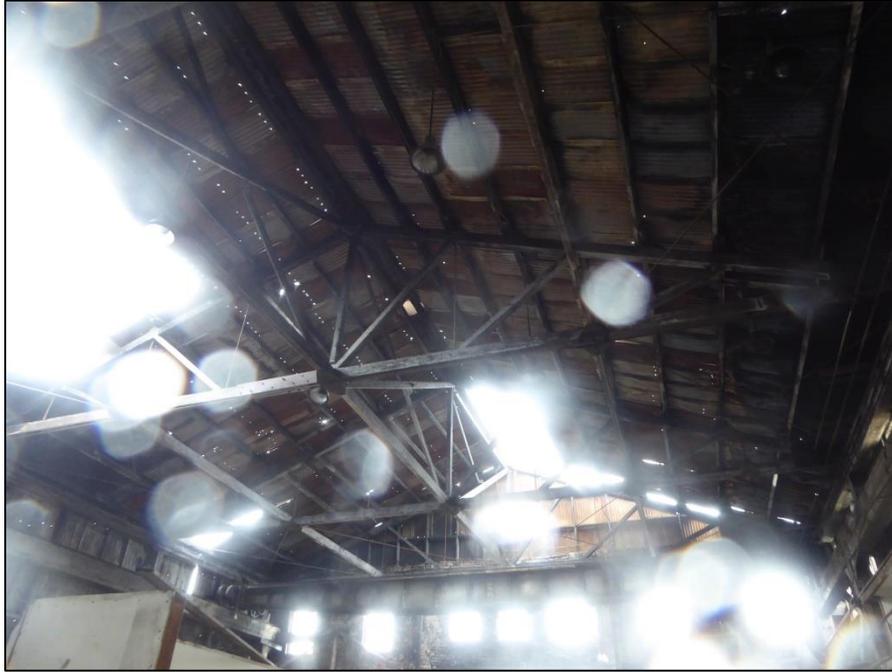
LIGHT WOOD TRUSSES-NOT CONTEMPORANEUS WITH ORIGINAL STRUCTURE

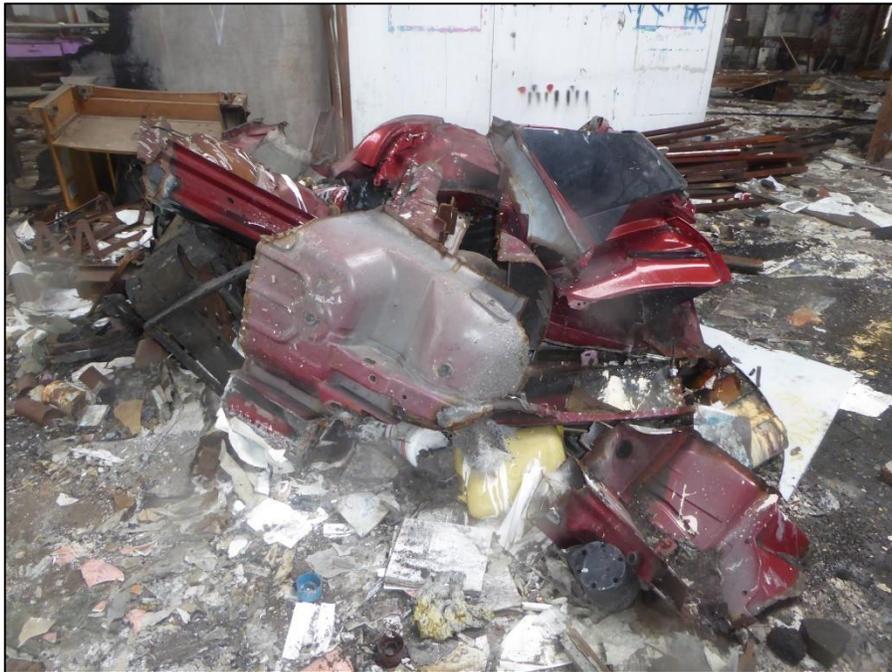
CUT UP CAR-NEW SINCE LAST REPORT

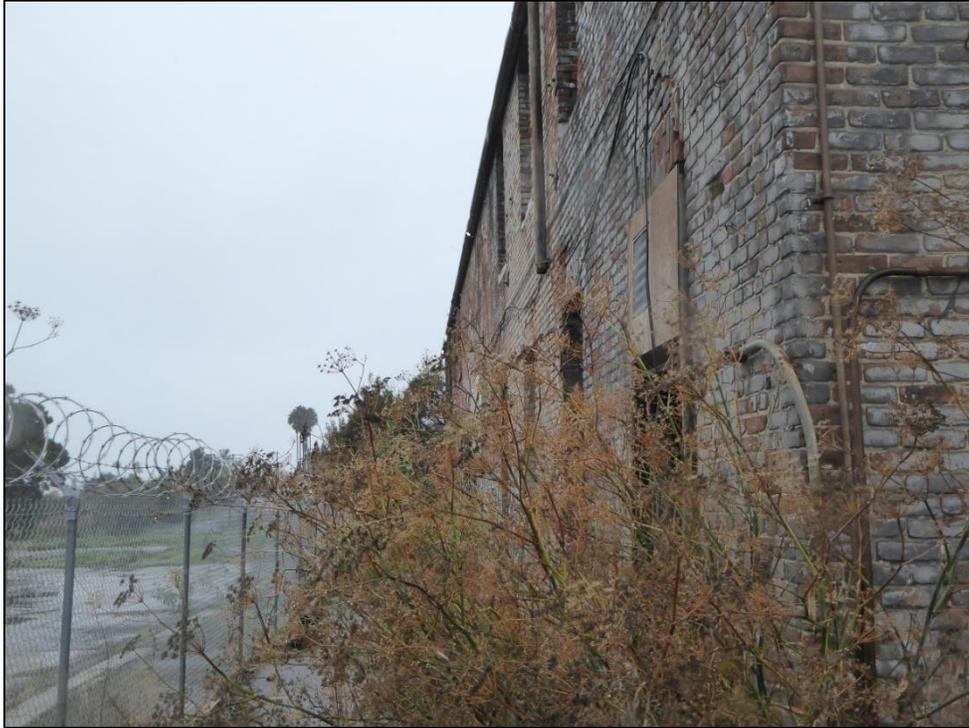
LEFT WALL BOWING OUTWARD AT TOP-LOW ARCH ON LOWER WINDOW FAILED-BRICKS DISPLACED

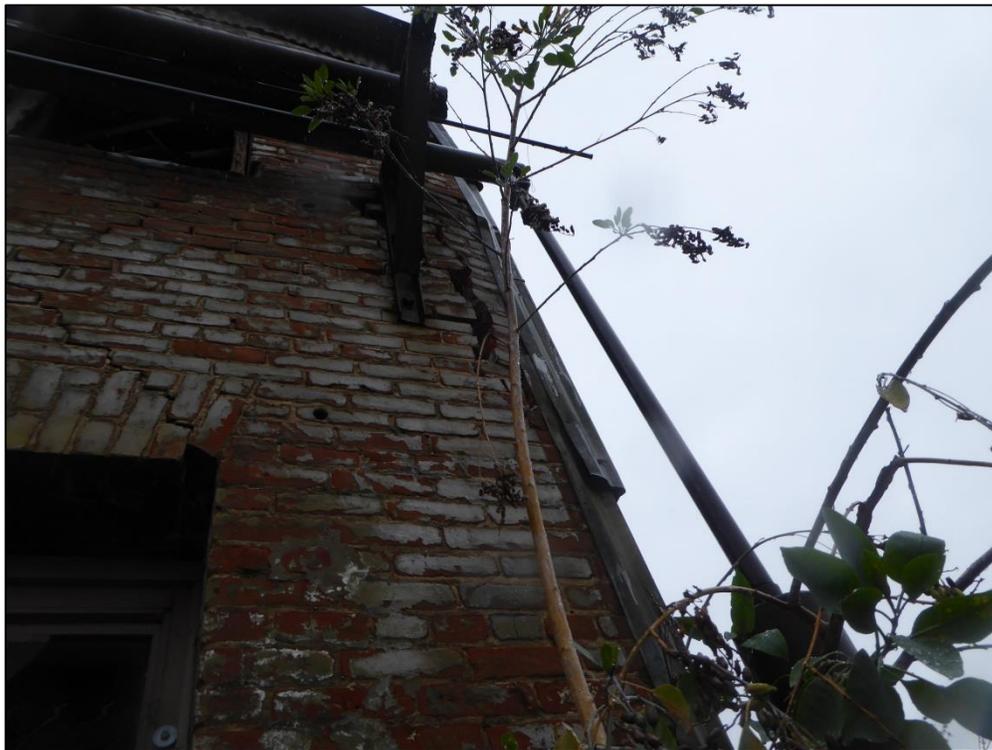
FRONT WALL: COMPLETE CORNER FAILURE-NOTE FAILURE OF FLAT ARCH-Left
