VIP Element Monitoring Monthly Monitoring Report

Site Visit Date: 1/10/2011

Report Code: VIP Monthly Report_082310_TSM

- VIP Element 2008-2 (Scrubber Process Equipment Train) – Monitoring Complete 01/2011
- VIP Element 2008-3 (Relocate Employee Parking lot)
- VIP Element 2008-4 (New Hydrogen Plant)

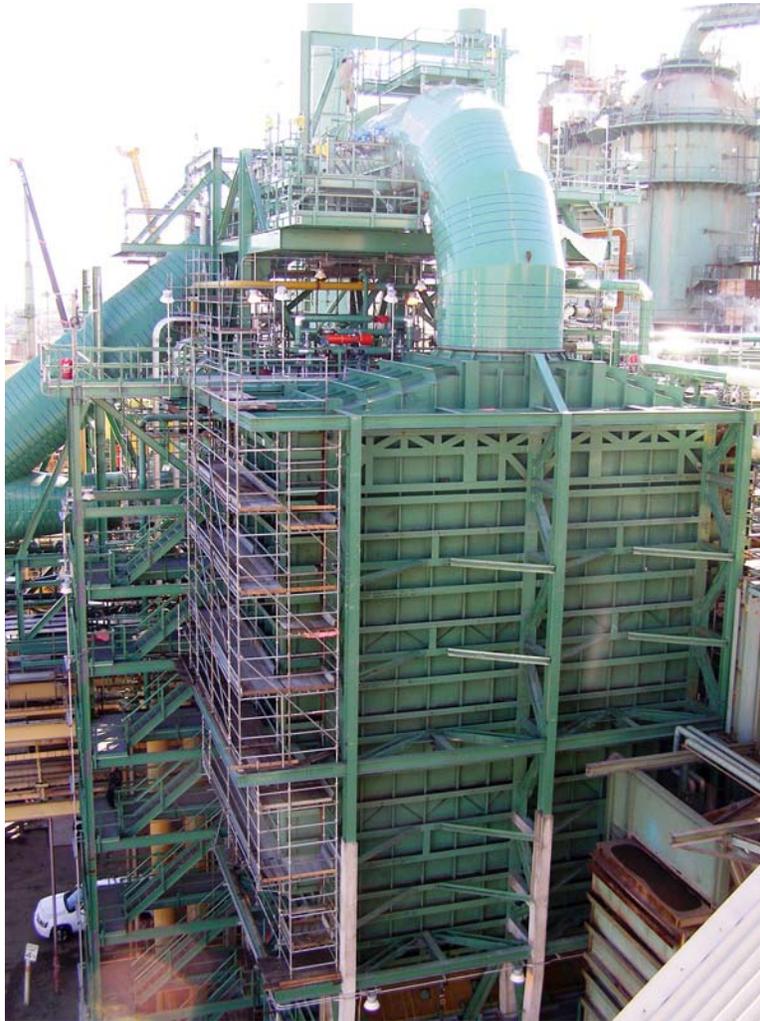
Figure 6a: VIP Element 2008-2, CO furnace position 1A, from above, facing south.

2008-2 Element was approximately 100% complete on December 31, 2010. Ducting for connection of furnaces F-105 and F-106 is shown (See Figure 6a). Additional connecting ducting can be seen from the furnaces in Figure 6b.

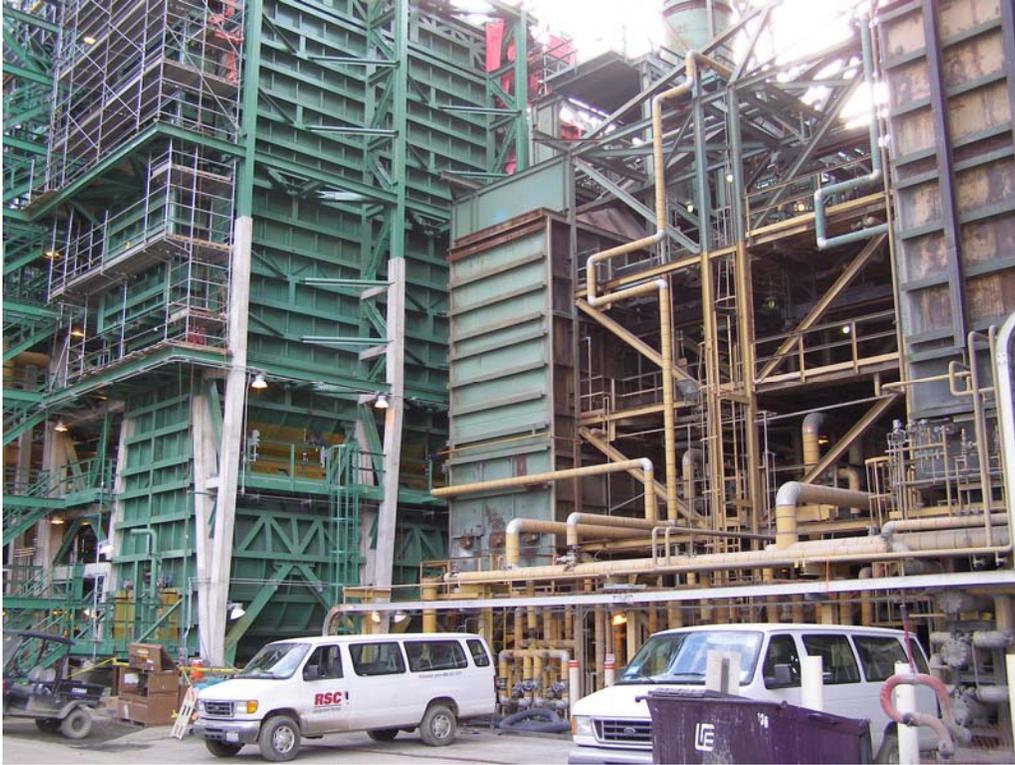
Figure 6c: VIP Element 2008-2, CO furnace position 7A, from below, facing southwest.

Alternative photo vantage points for Figure 6 was used to document construction of Element 2008-2 F-105 and F-106 furnaces as the furnace foundations are no longer visible from original photo vantage points. Figure 6c depicts the finished F-106 foundations from below. Access to vantage point for Figure 7A was not possible so this report does not show furnace components from below. All remaining figures capture original established photo vantage points to the extent possible. Note that Figure 6c thru 10 were shot on January 10, 2011 during the site visit and the remainder of the figures were shot on January 31, 2011. This was necessary because work being conducted on January 10th precluded access to viewing location 2.

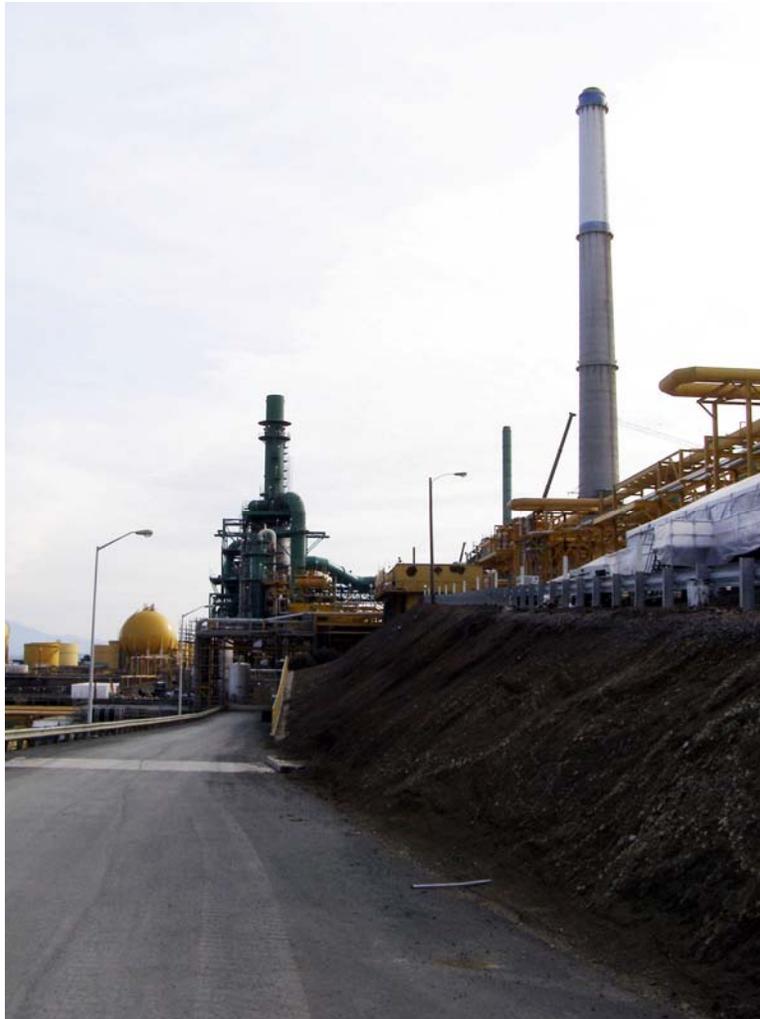
Figure 10: VIP Element 2008-2, FGS position 3 facing south.

SO₂ regeneration facilities and clarifier sump are now finished to the north of the FCCU/CKR Scrubber vessel (See Figures 10 and 11). FCCU/CKR Scrubber vessel is now finished (See Figures 8-13); superstructure is constructed and connecting ductwork is underway (See Figures 14-15). Belco pre-scrubber is finished (See Figures 13b).
