TOURTELOT CLEANUP PROJECT

TOURTELOT PROJECT ANNUAL INSPECTION AND REPORT FORM

Benicia, California

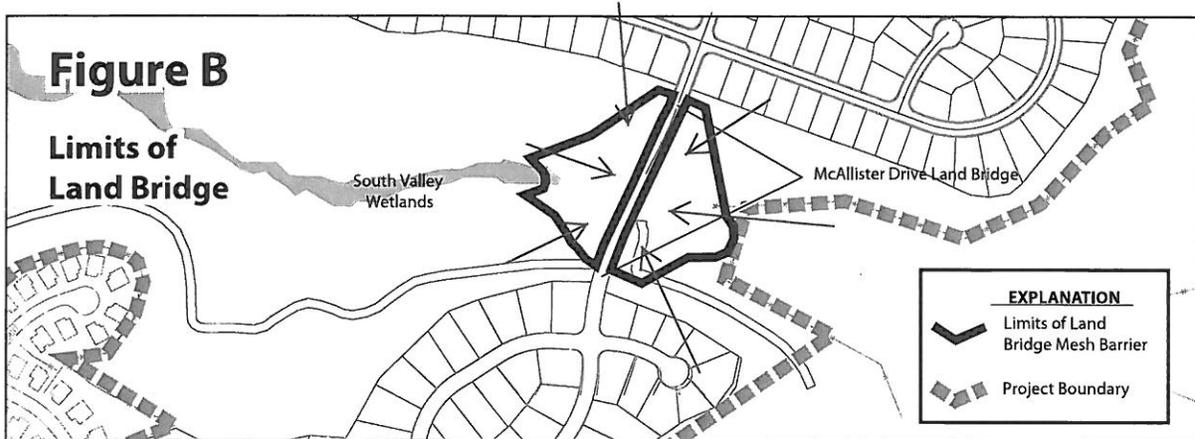
The locations where the Mesh Barrier is affected has been indicated by arrows on the diagram.

2-3

As previously described, the barrier is lifting from the force of the weeds and ground cover growing beneath it.

The affected areas vary in size and shape. Average areas are 5 foot square.

The City put the project out to bid. Based on the project scope, cost and risk, no contractors bid on the proposal. The City will incorporate into future locally funded projects.
