**Appendix C – Land Bridge Mesh Barrier
Tourtlot Annual Inspection Report
June 2014**

2014 Summary

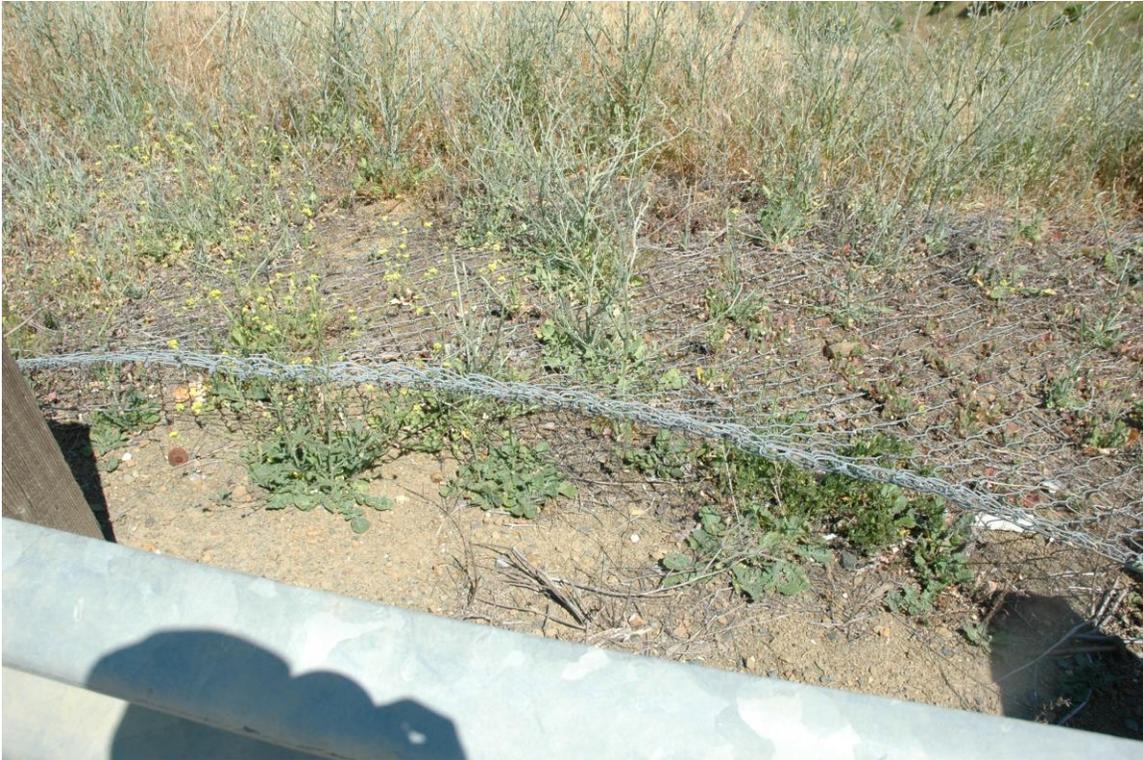
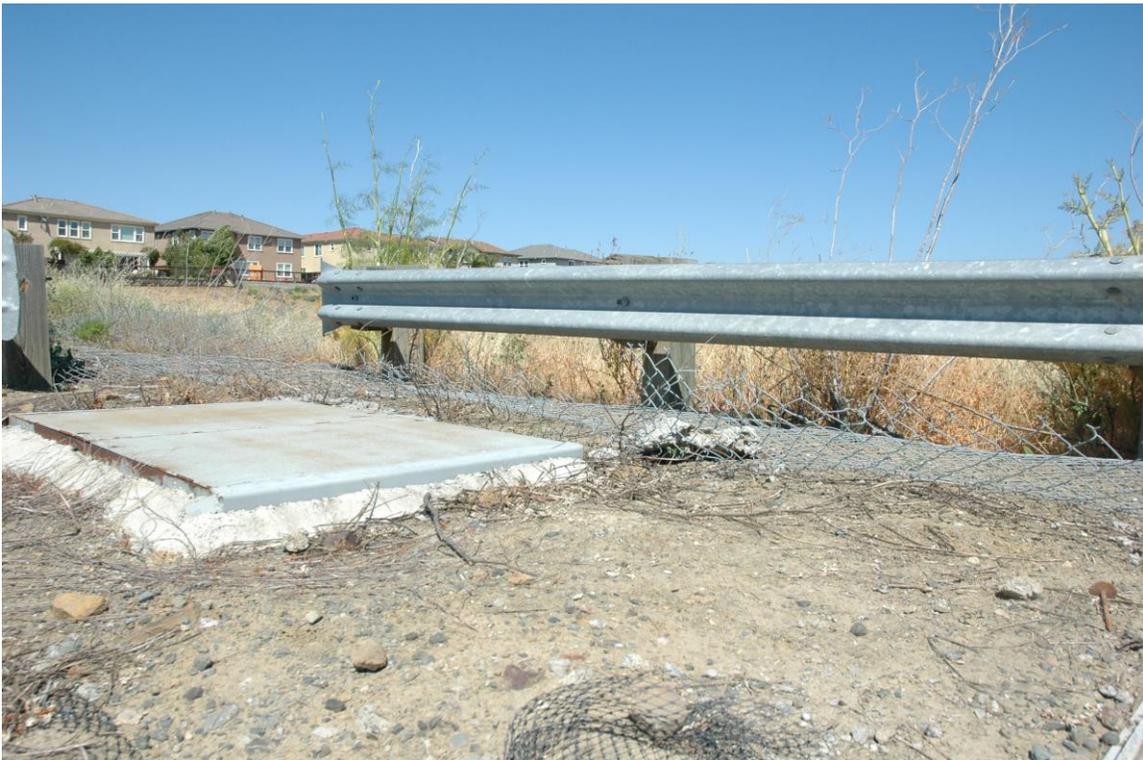
McAllister Drive | Photos are all from the Top-of-slope along the sidewalk. There is no noticeable change in the size or area affected as compared to previous years.

As mentioned above, the current conditions are similar to conditions found over the last seven years. The photos included are representative of the lifting that has occurred along McAllister Drive. It is our recommendation that maintenance be performed in accordance with the O&M plan and the CAP to re-pin the mesh barrier to the surface to prevent further “lifting” from the slope. The condition of the barrier on the western and eastern slopes is satisfactory and we do not recommend any maintenance in these areas. The ground cover is established and maintains the hold of the mesh barrier adequately on the slopes.
