Inspector Field Report

City of Benicia

SAP Evaluation of 670 East H street.

IFR#: 001 DATE: 12/17/15

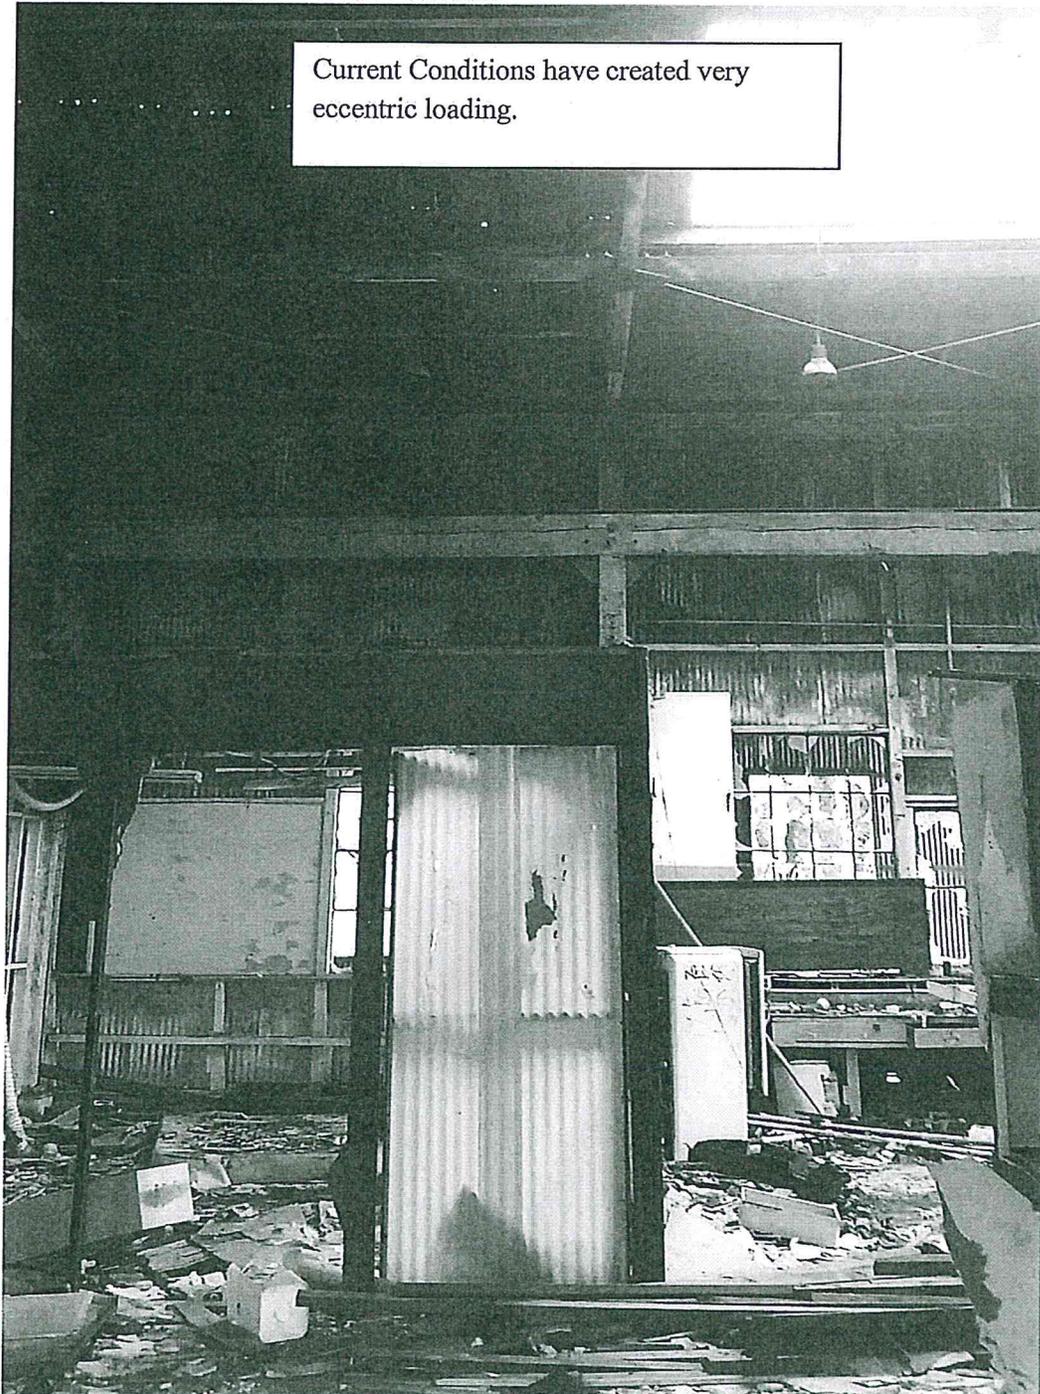
Current Conditions have created very eccentric loading.

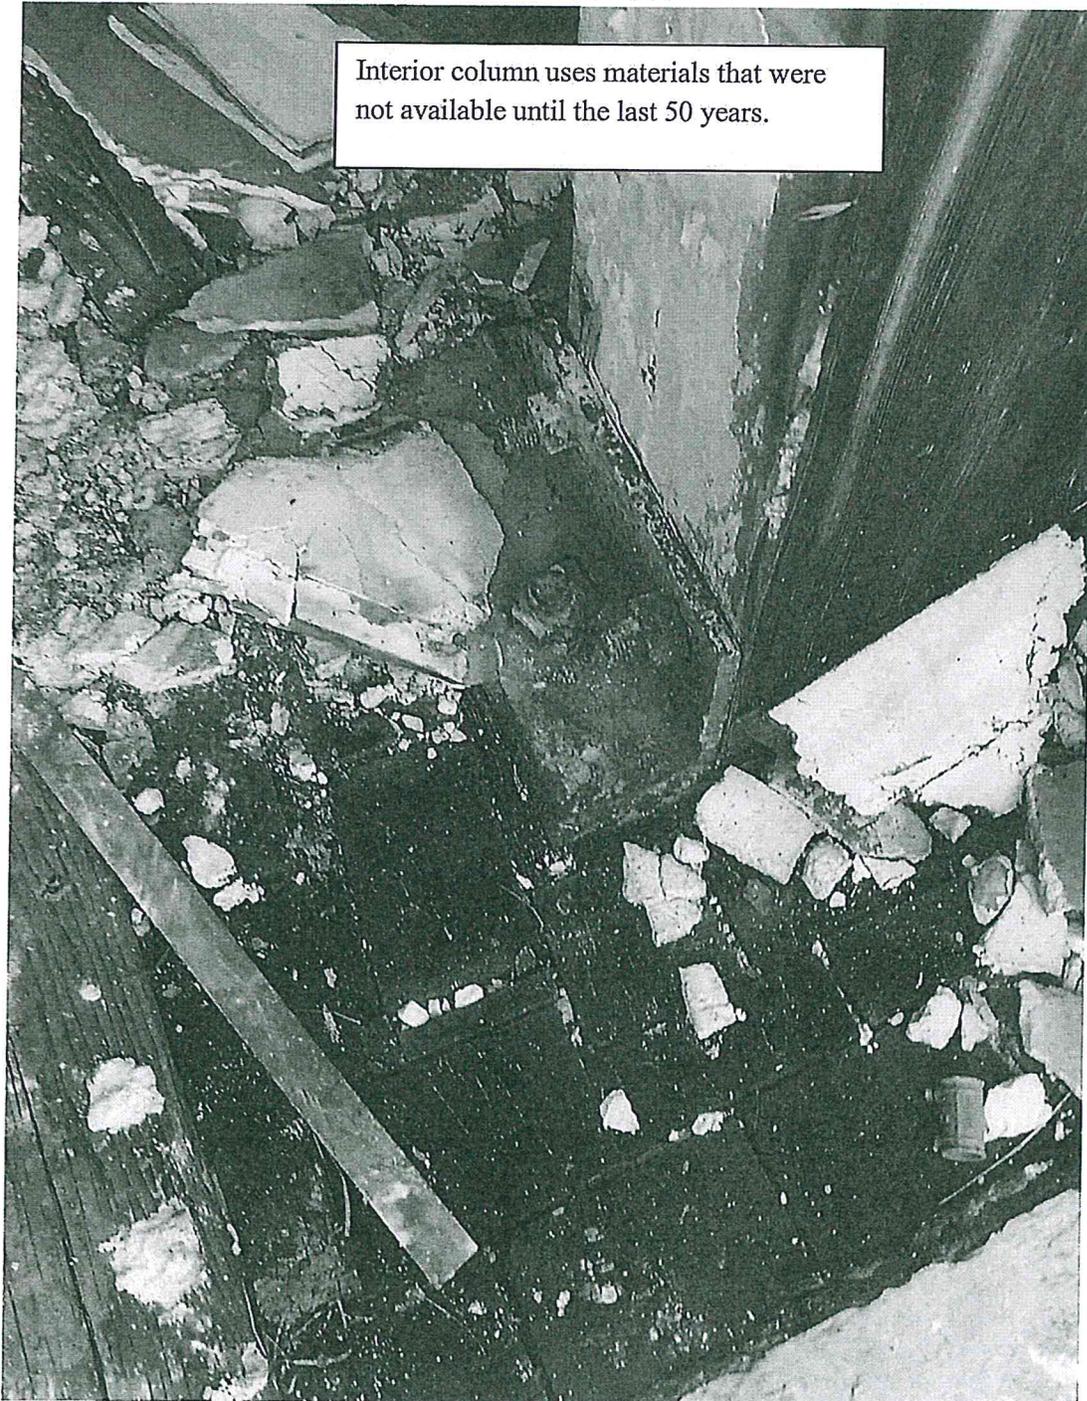
Interior column uses materials that were
not available until the last 50 years.

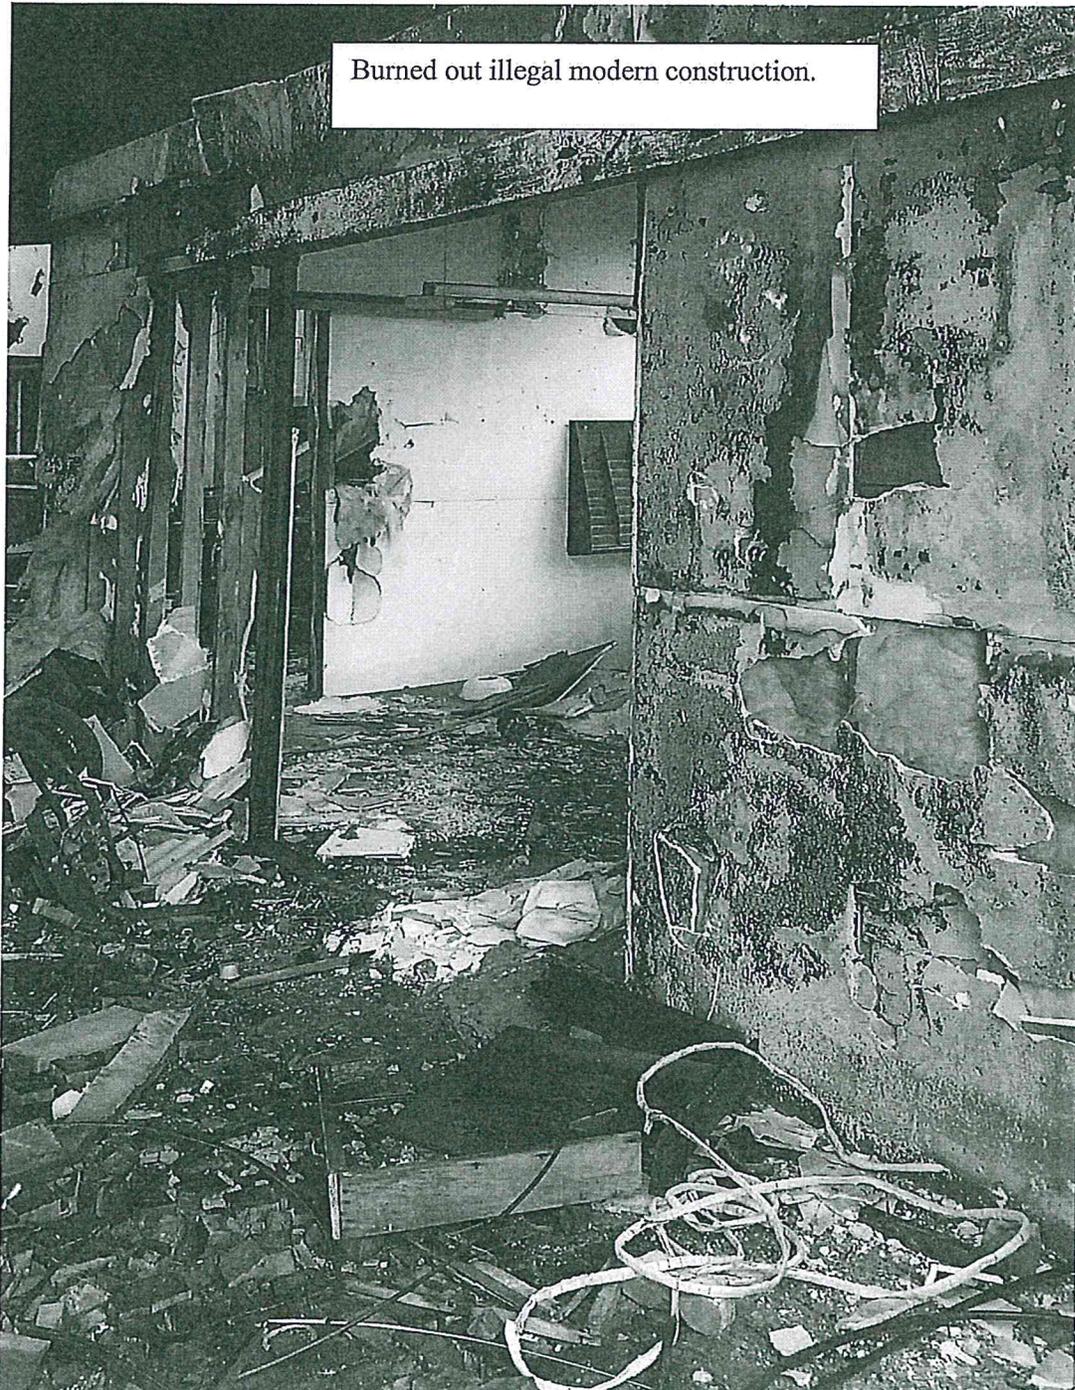
Burned out illegal modern construction.
