**SAFETY ASSESSMENT PROGRAM EVALUATION OF 670 EAST H STREET.**

**4LEAF Job #: J1941**

**Current Site Visit: 12/8/2016**

**Assessor: Fred Cullum**

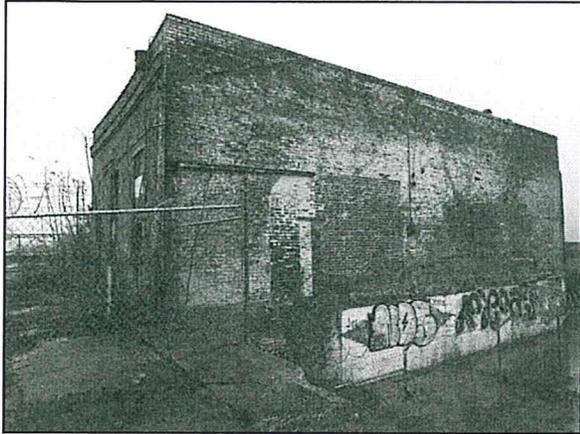
**NOTE CONCAVE DEFLECTION AT TOP**

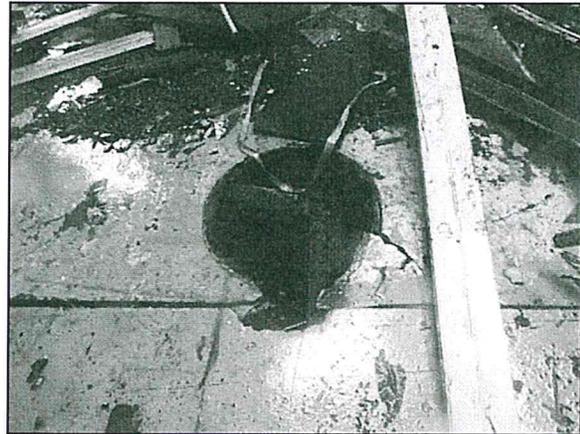
**INTERIOR FLOOR FAILURE BURNT FLOOR JOISTS**

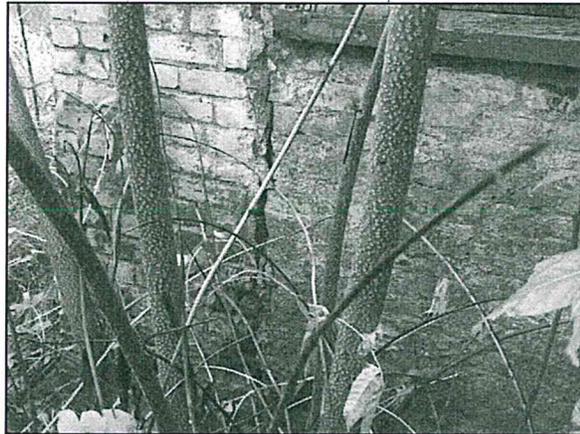
**MAJOR SETTLEMENT FAILURE**

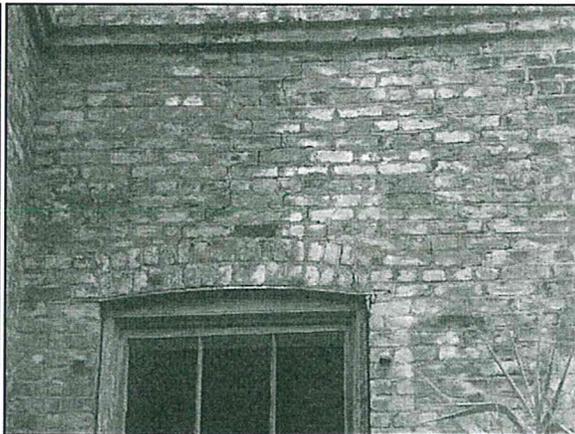
**DIAGONAL CRACKS ABOVE WINDOW**

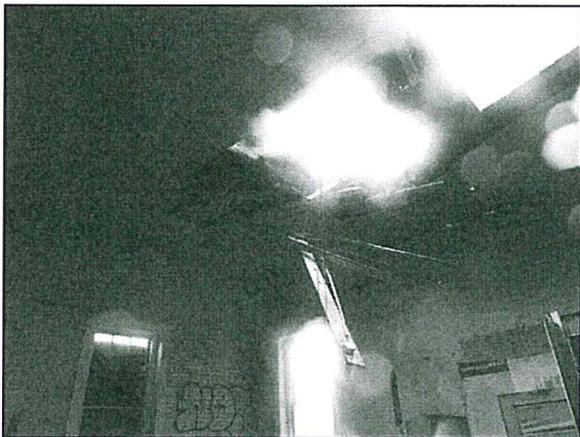
**ROOF FAILURE**

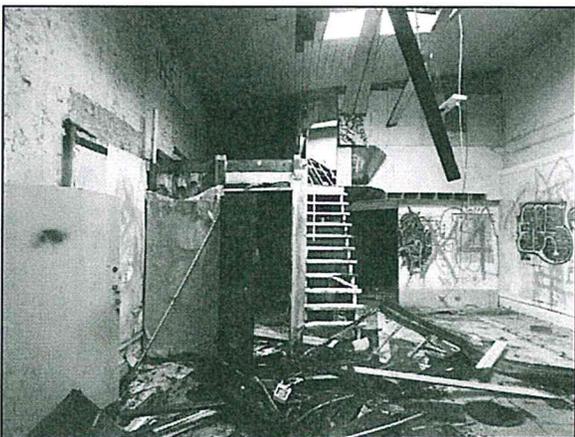
**INTERIOR-NOTE FIRE LOAD**

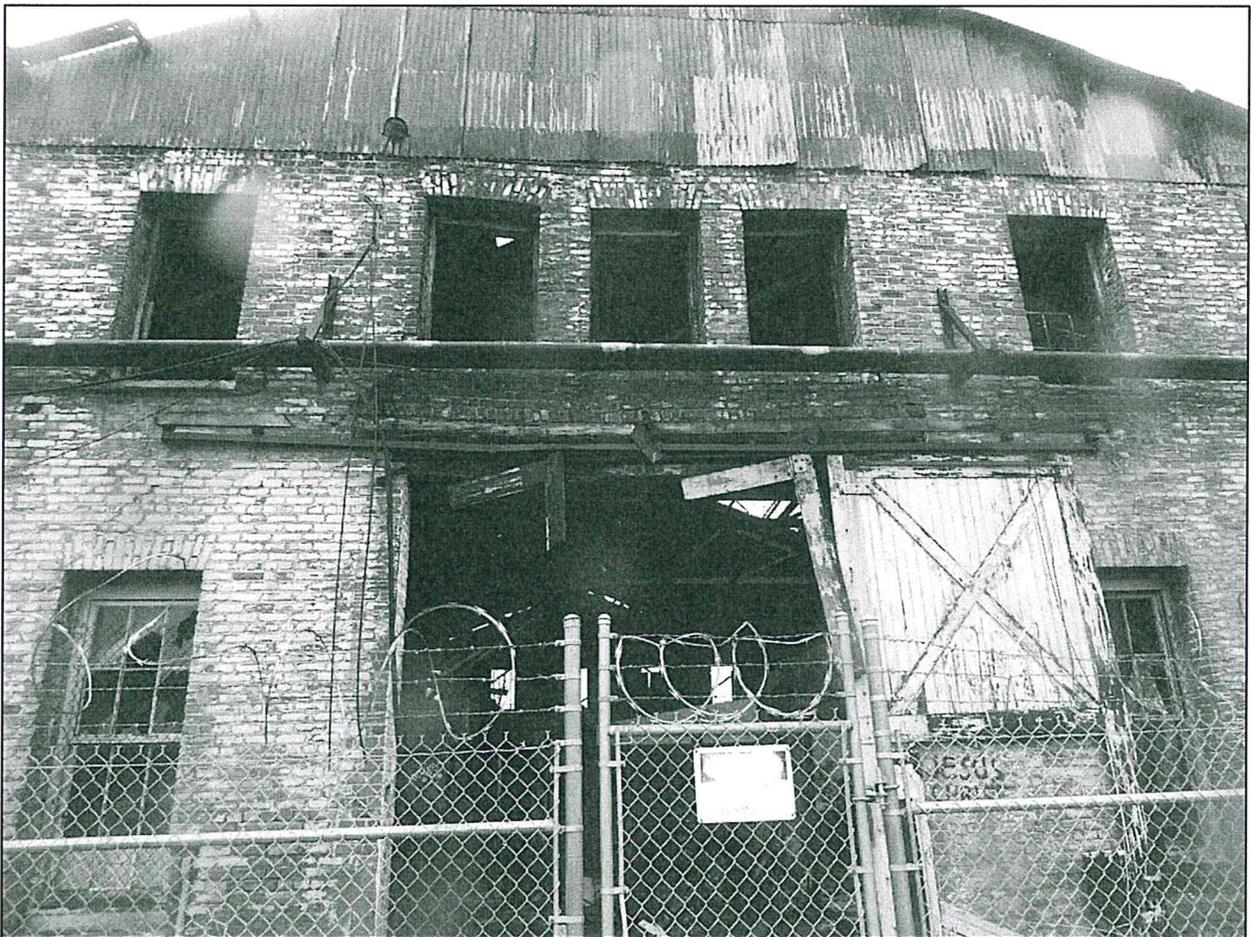
**NOTE DEFLECTION OF WALL ABOVE OPENING  
THIS IS CONSIDERABLY ADVANCED OVER LAST YEAR'S REPORT.**

I have reviewed the December 2015 report and accompanying photos. The SAP Evaluator listed several bullet points, all of which I agree with, but have expanded upon below. The buildings continue to fail structurally and this is most notable in the Foundry. The wood lintel supporting the bricks above the large opening had cracked due to excessive deflection at some point in the past and had a crude repair to limit the crack. The failure now, due to recent fires, has markedly increased with more bricks falling out for the full depth of the wall and much more loss of bricks above the lintel. The added deflection over the last year appears to be approximately 4".

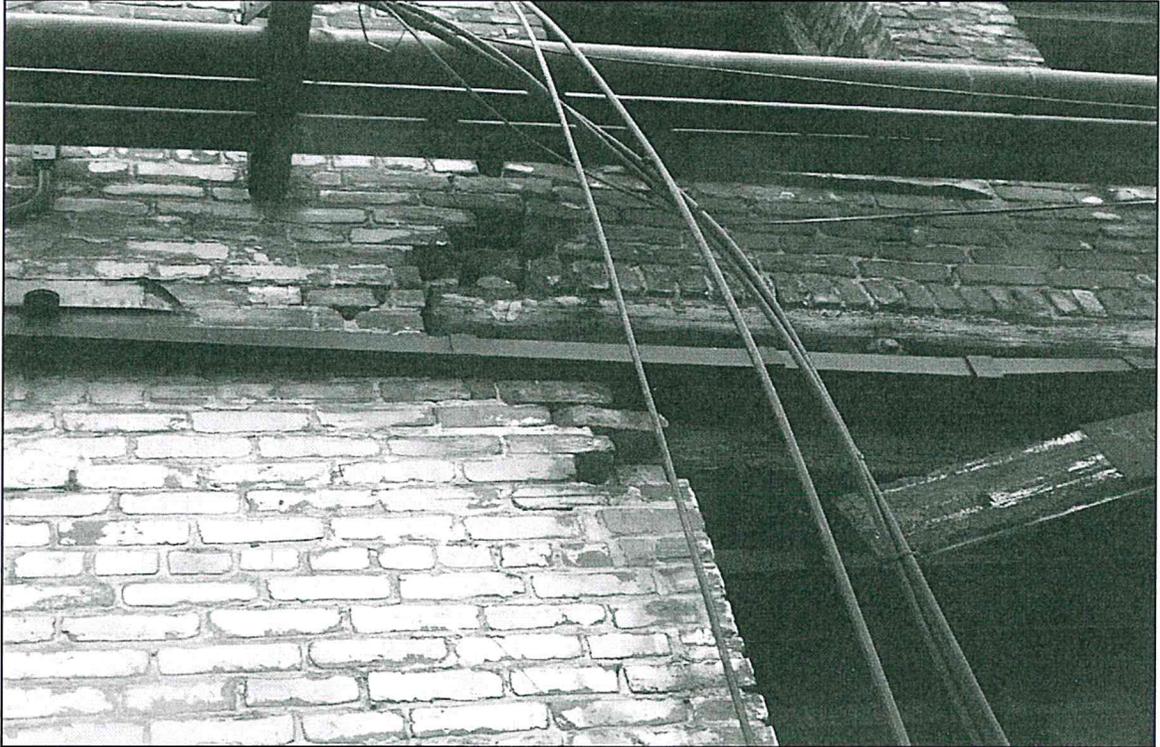
**EXTREME FAILURE OF MULTI-WYTHE WALL-BRICKS BELOW CRUSHED BY DEFLECTION OF WALL ABOVE DUE TO FAILURE OF WOOD LINTEL DUE TO DRYROT AND FIRE-BRICKS ABOVE SIMILARLY DAMAGED DEFLECTION EXHIBITED IS MUCH GREATER THAN LAST YEAR. FAILURE OF BEAM WILL RESULT IN COLLAPSE OF THE WALL ABOVE, THUS PULLING THE LONG WALL OVER**

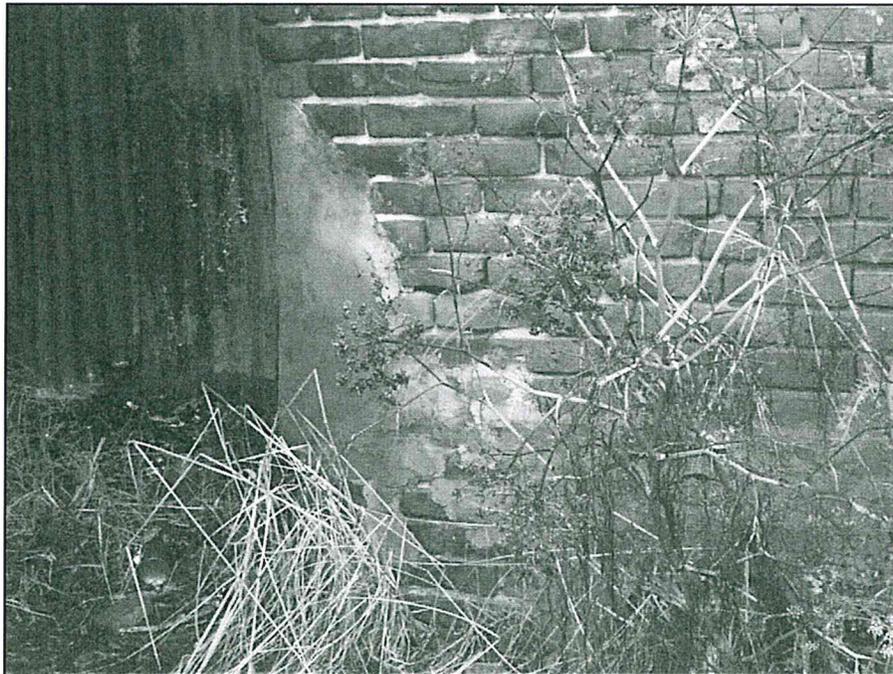
**CONCRETE REPAIR OF FAILED CORNER-NOTE LACK OF MORTAR ON EXPOSED BRICK**

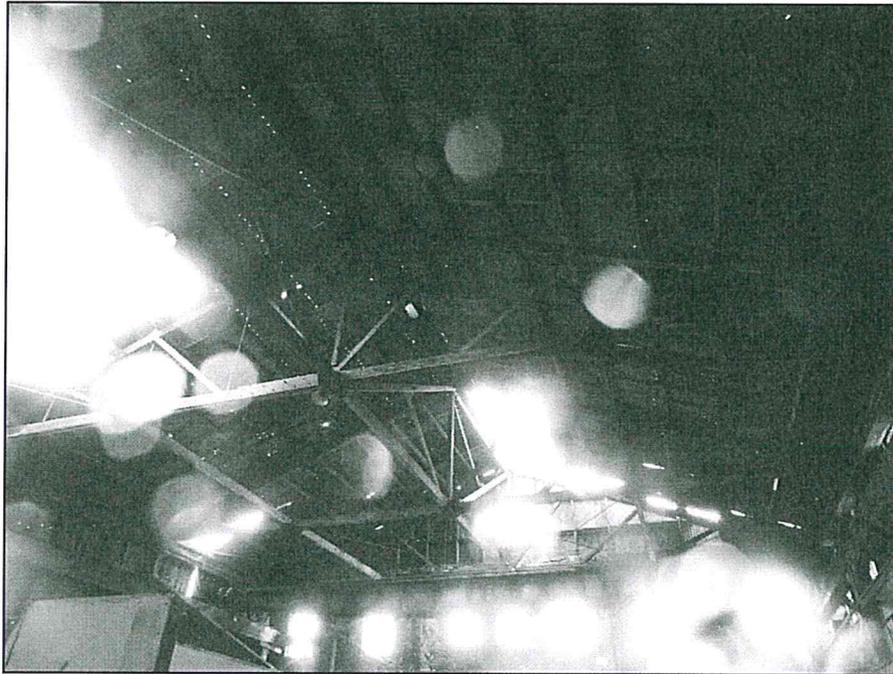
**LIGHT WOOD TRUSSES-NOT CONTEMPORANEUS WITH ORIGINAL STRUCTURE**

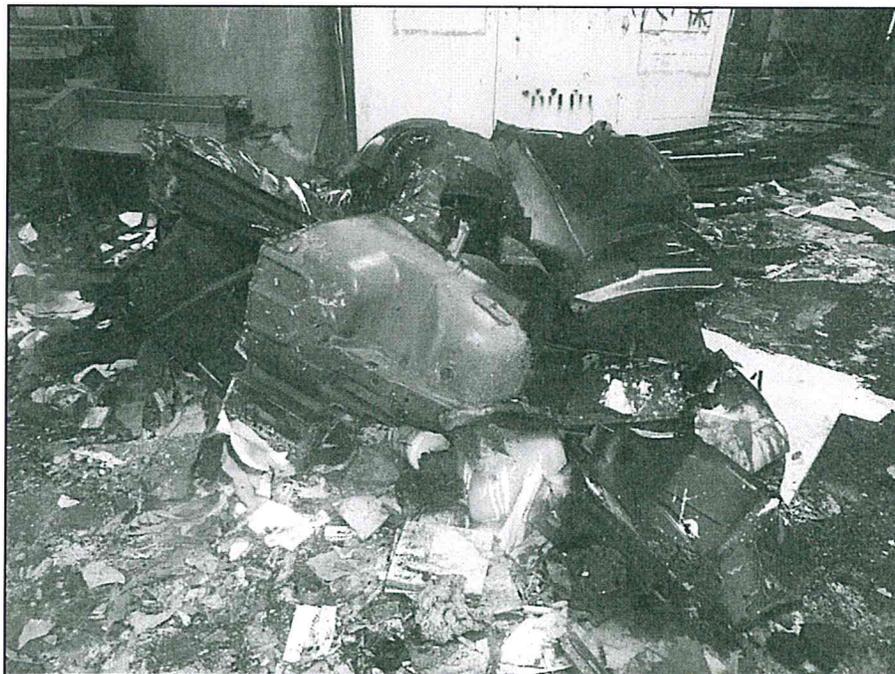
**CUT UP CAR-NEW SINCE LAST REPORT**

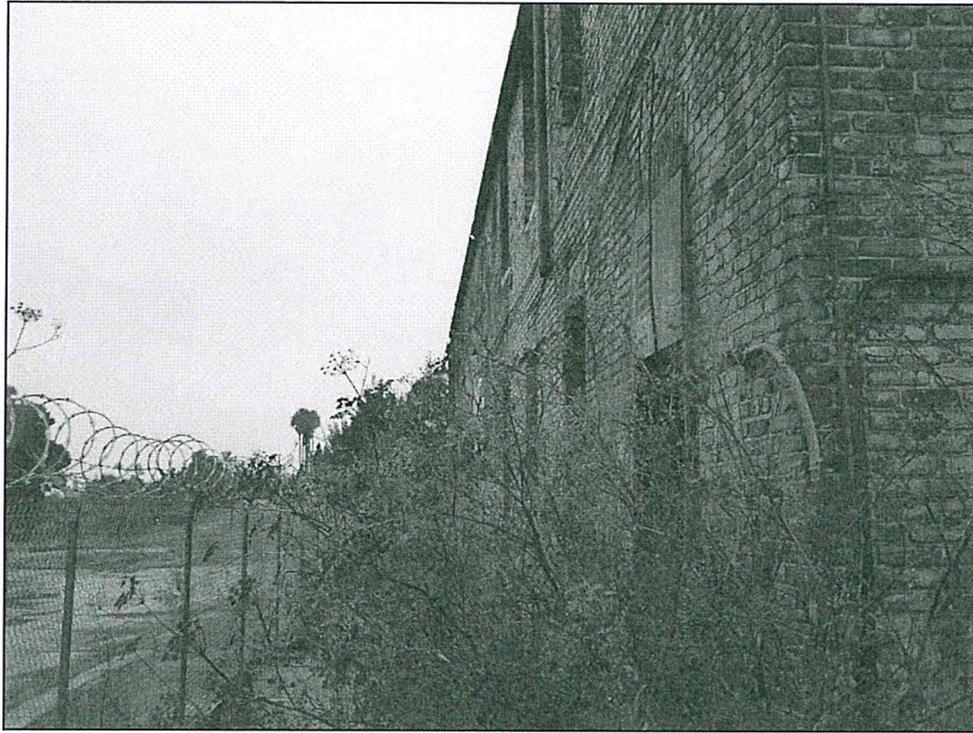
**LEFT WALL BOWING OUTWARD AT TOP-LOW ARCH ON LOWER WINDOW FAILED-BRICKS DISPLACED**

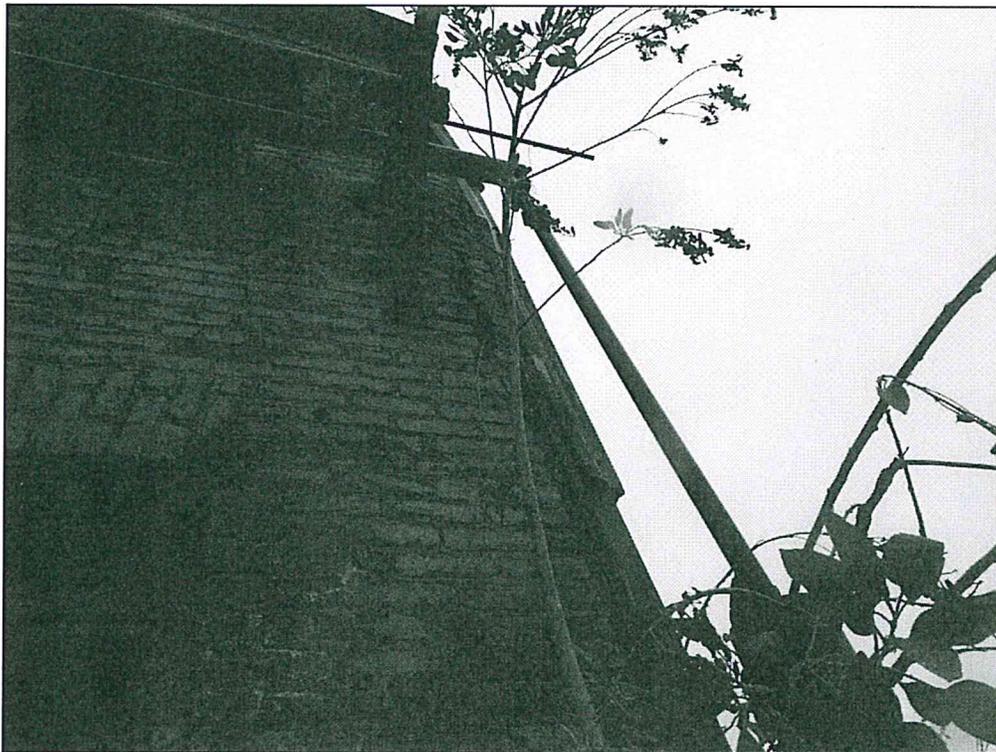
**FRONT WALL: COMPLETE CORNER FAILURE-NOTE FAILURE OF FLAT ARCH-Left**
