TOURTELOT CLEANUP PROJECT

TOURTELOT PROJECT ANNUAL INSPECTION AND REPORT FORM

Benicia, California

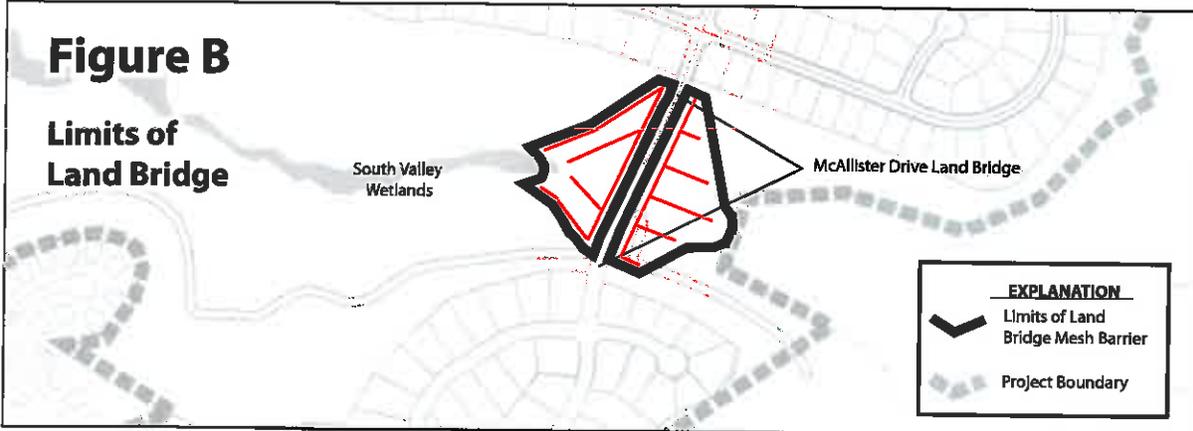
LAND BRIDGE MESH BARRIER

Using the red lines as indicators in the figure above, the red lines represent the outer edge and overlap seams of the mesh barrier. These edges and seams are held down with large pins and washers, these pins are lifting which allow the edge of the barrier to rise. This poses no threat to the overall stability of the mesh barrier.

2

As described above, the lifting of the pins has allowed the edges of the barrier to rise. This has been reported in both the 2006 and 2007 annual reports. There has been no significant decrease in the ability of the barrier to provide slope stability.

This can be best described as seams along the edges and in the overlap areas.

No repair is recommended for the mesh barrier, only monitoring. The vegetation remains effective as a long-term hold down for the barrier.

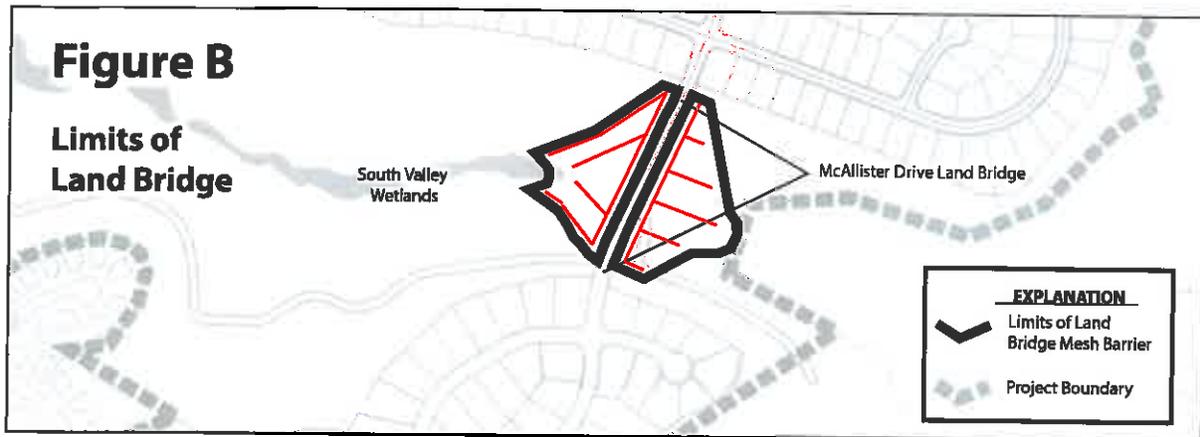
LAND BRIDGE MESH BARRIER

Using the red lines as indicators in the figure above, the red lines represent the outer edge and overlap seams of the mesh barrier. These edges and seams are held down with large pins and washers, these pins are lifting which allow the edge of the barrier to rise. This poses no threat to the overall stability of the mesh barrier.

2

As described above, the lifting of the pins has allowed the edges of the barrier to rise. This has been reported in both the 2006 and 2007 annual reports. There has been no significant decrease in the ability of the barrier to provide slope stability.

This can be best described as seams along the edges and in the overlap areas.

No repair is recommended for the mesh barrier, only monitoring. The vegetation remains effective as a long-term hold down for the barrier.
