# TOURTELOT CLEANUP PROJECT

## FIVE-YEAR INSPECTION AND WRAP-UP REPORT

Benicia, California

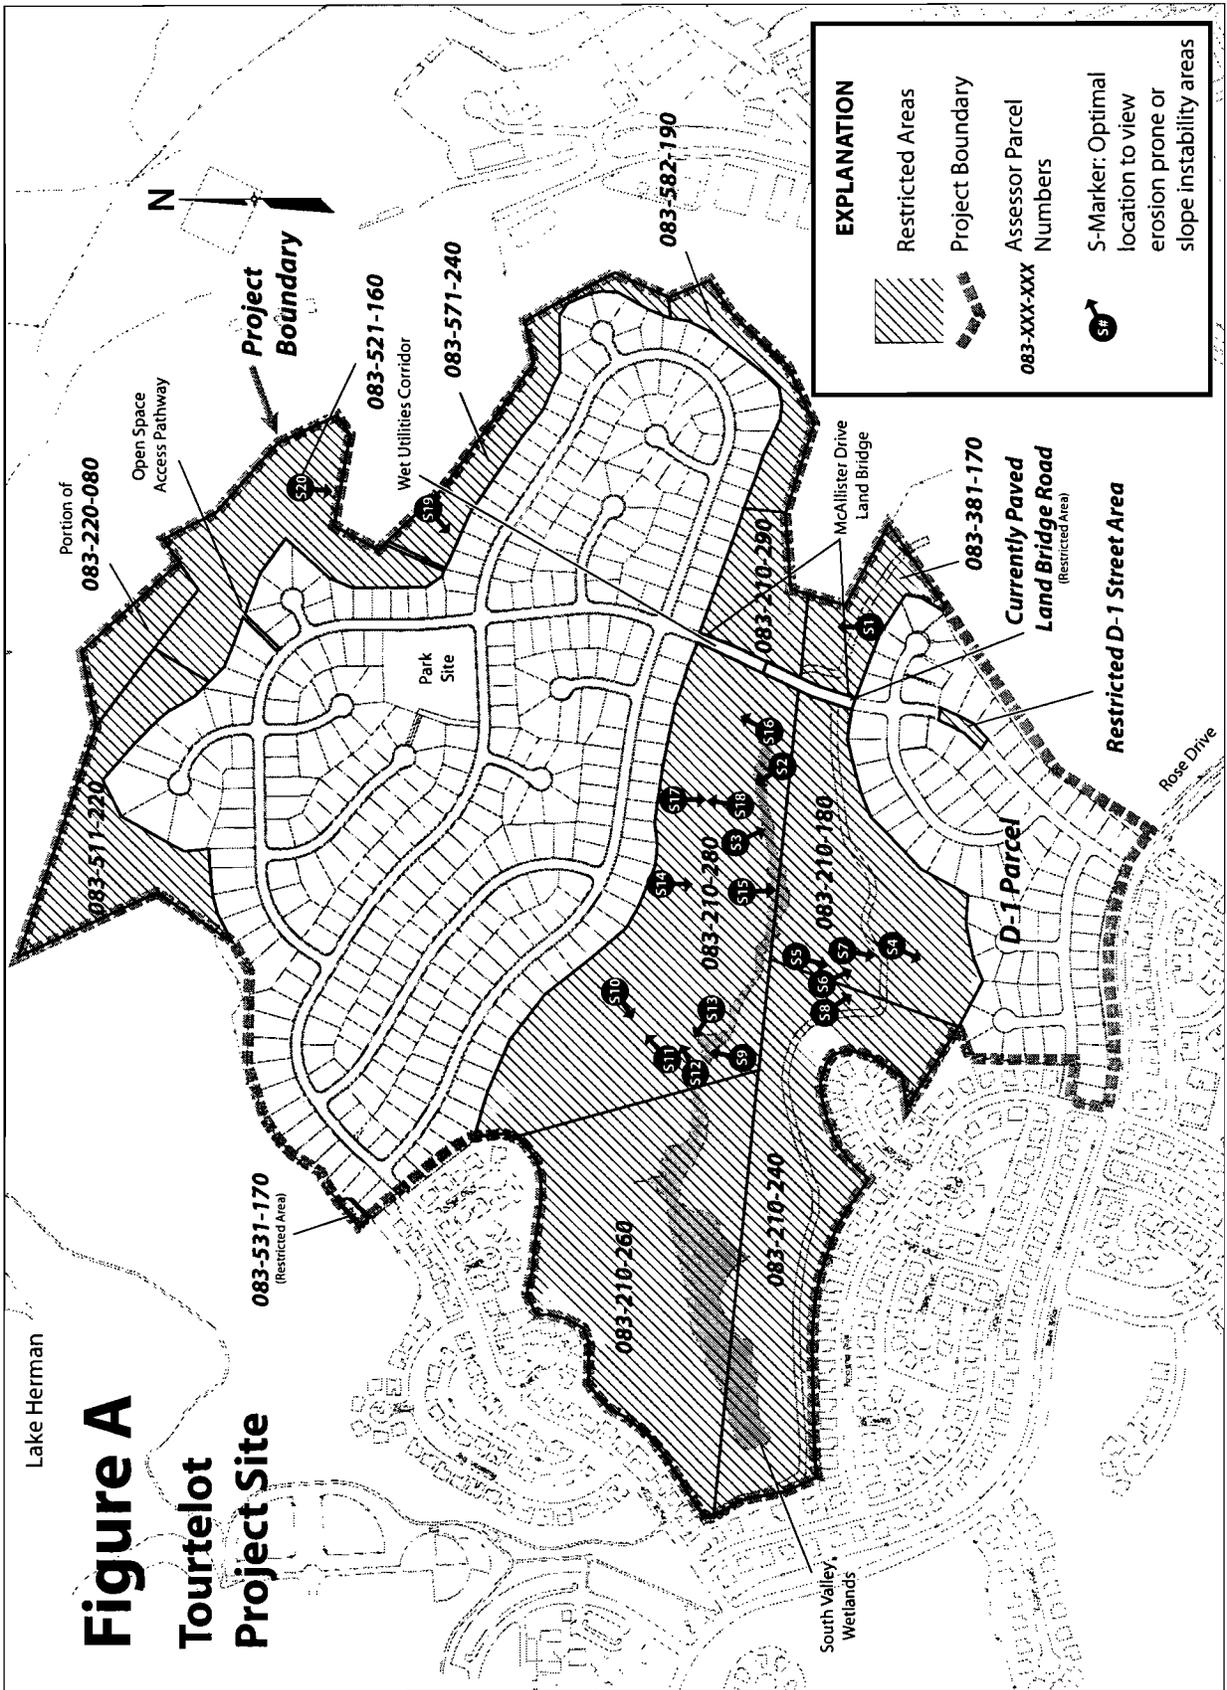
Over the past five years, site inspections have determined the Historical Landslide Areas to be stable. A small slump first noticed in 2007 above S18 (see Figure A) has not not changed in the last two years. It is important to note that the marker at S5 has been undercut by the upstream outfall and no longer exists. This has been closely monitored and no further action is necessary at this time.

No Station marker S5 is no longer in it's original location. The marker has been relocated onto the rock embankment.

We are not recommending that the City try to repair the S5 Station Marker. The Rock embankment where the stake has been set in stone, provides an effective vantage point for the necessary photos. The rock has also been tagged with the number 5.

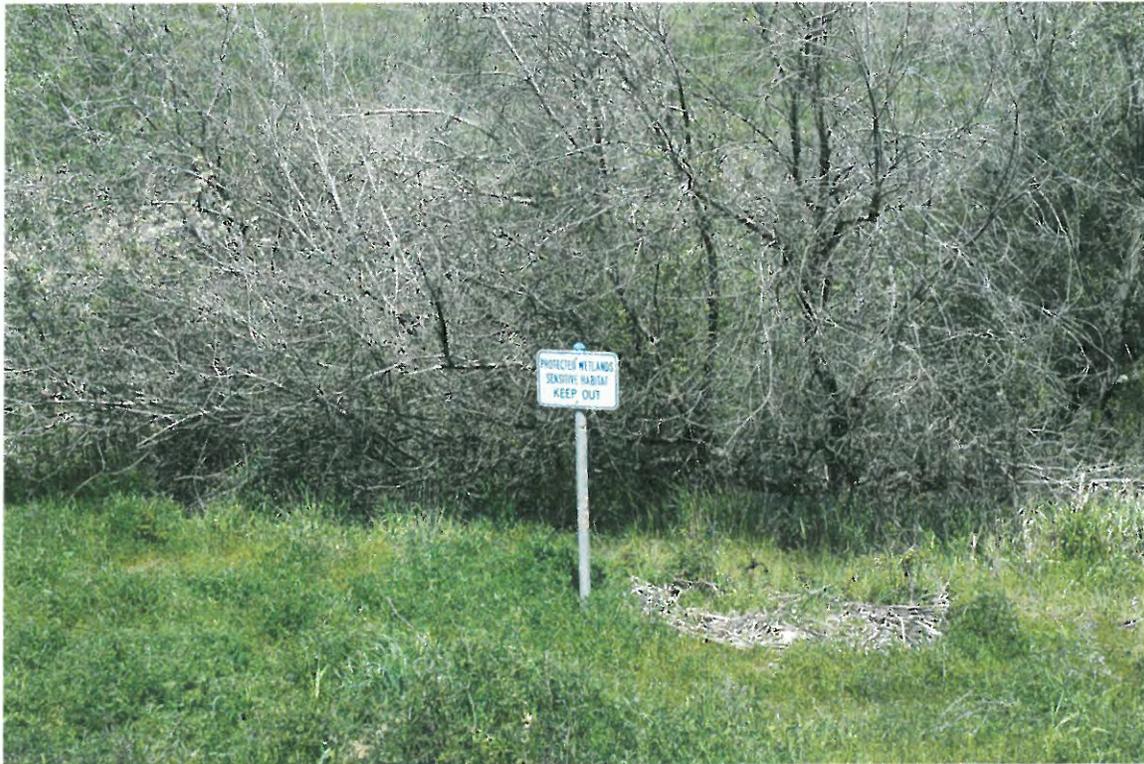
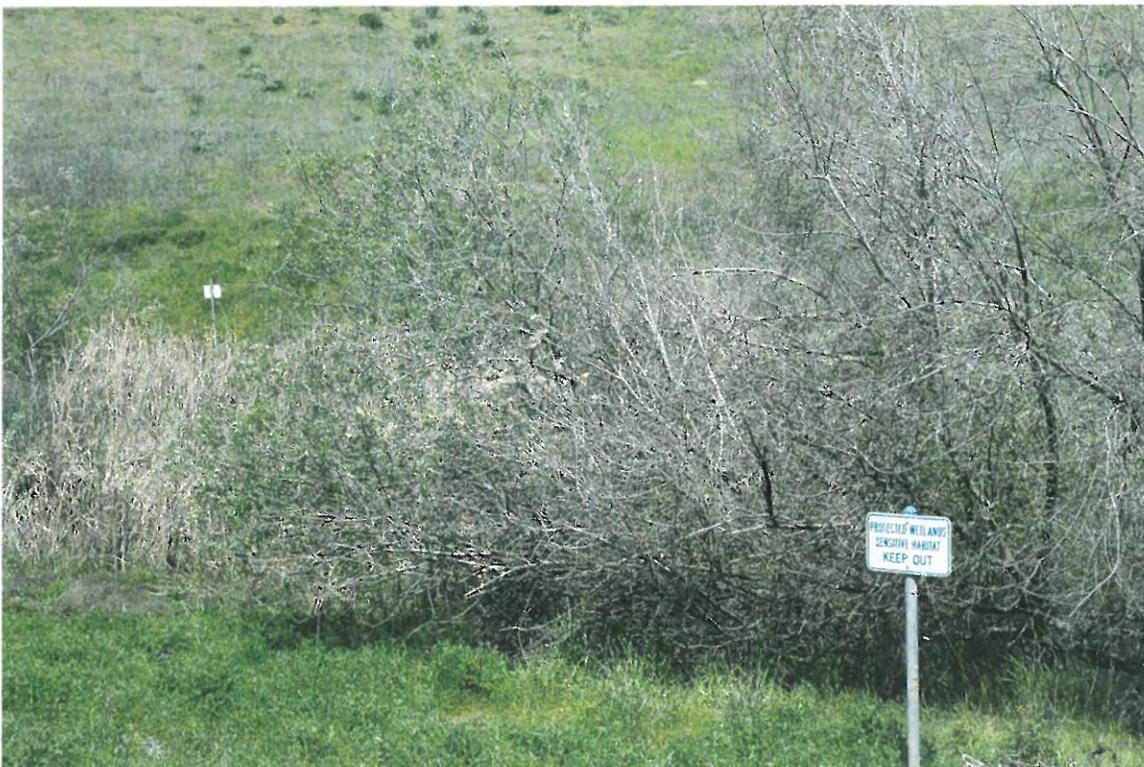
**Wetlands Protective Signage**

The Wetlands Area is well marked by the Protective Wetlands Signs. All of the signs are intact and have no damage or deterioration. Photos of the Wetlands Signs are in Appendix A of this Five Year Wrap Report.

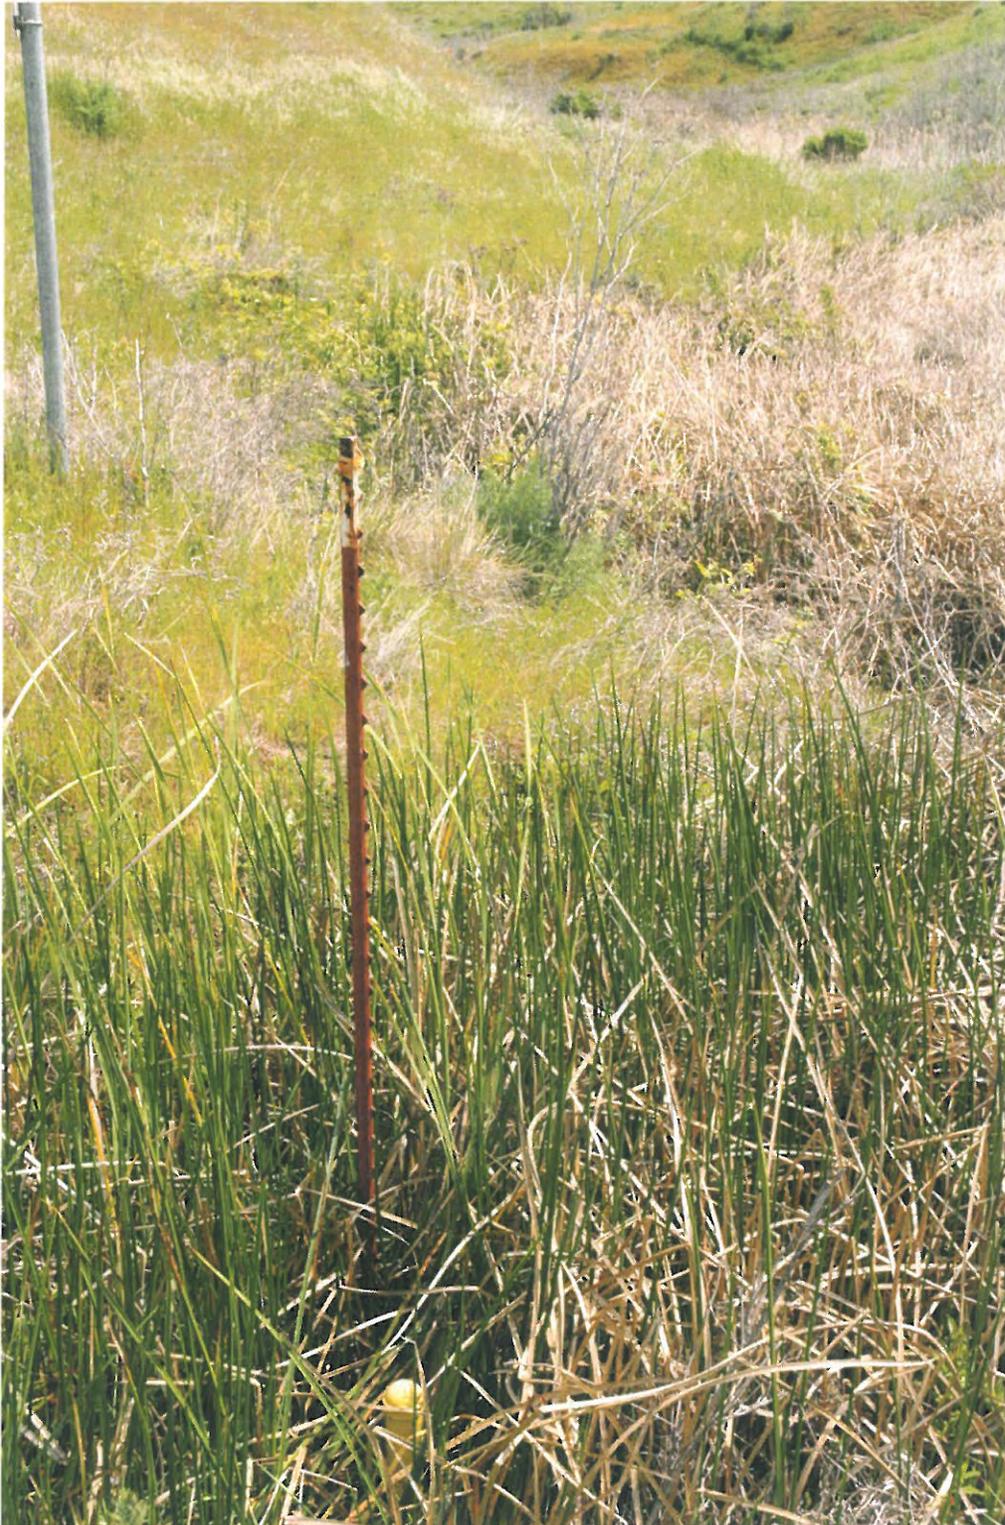
**Station S12 – Station marker is now within a wetlands area.**

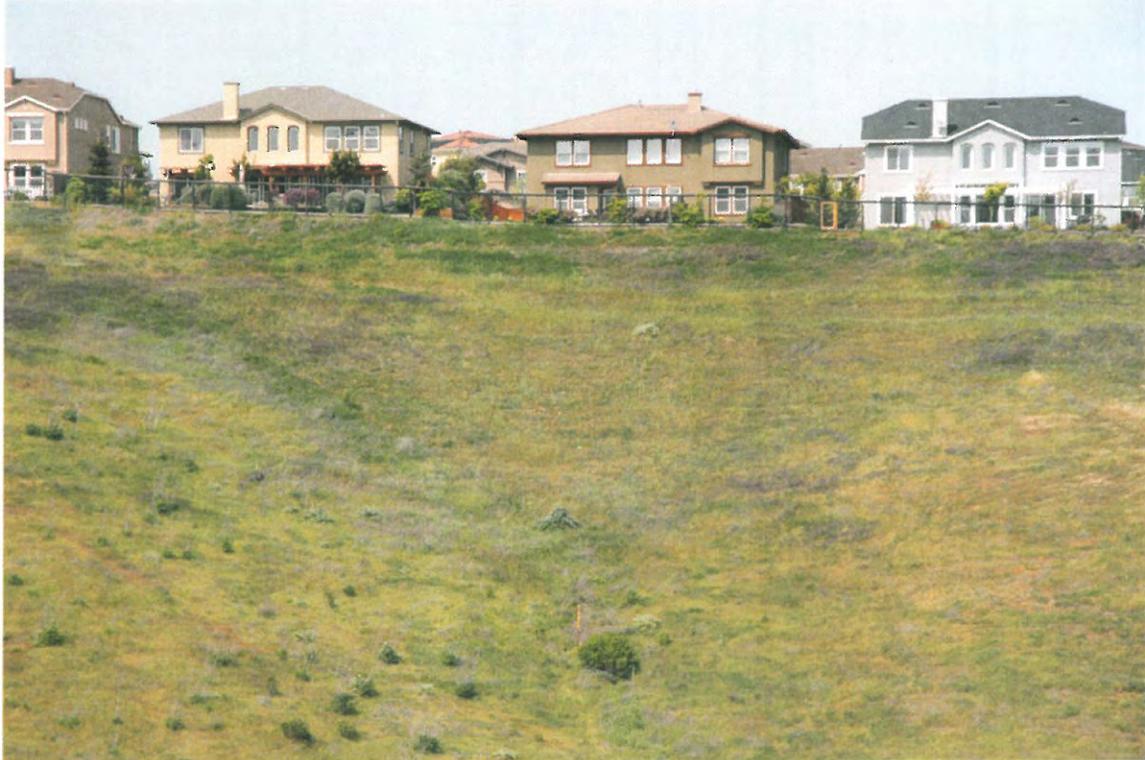
**Slump in Area H- Unchanged from the 2007 and 2008 Inspection**
