EXPANDED SITE INSPECTION ADDENDUM REPORT

Environmental Investigation at the Formerly Used Defense Site (FUDS)
at the former Benicia Army Arsenal, Benicia, California
FUDS Number: J09CA075600

EXPANDED SITE INSPECTION ADDENDUM REPORT
BENICIA ARMY ARSENAL, BENICIA, CALIFORNIA

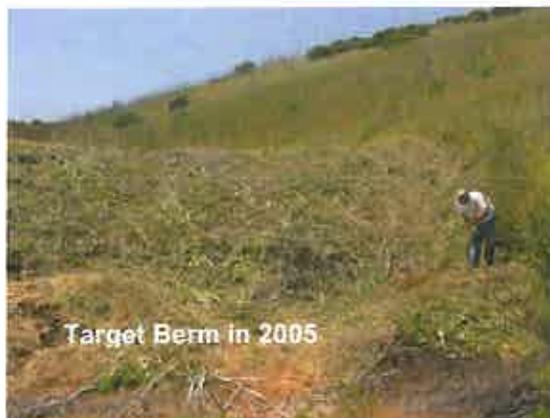
This firing range target berm is located in the western portion of Area S, a remote area of the former Arsenal and now part of a restricted buffer zone for the Valero Refinery. The Army used the target berm to test fire .45 and .50 caliber weapons in the 1940s.

During the 2005 Expanded SI, the berm was cleared of brush, the target berm measured approximately 150 cubic yards. Composite samples were taken every 50 cubic yards, therefore, three composite soil samples (FR01SC001 through FR01SC003). These samples were collected to determine the presence or absence of antimony, arsenic, copper, lead, and zinc, metals commonly associated with ammunition (Interstate Technology and Regulatory Council, 2003), in the target berm soil. Slugs and slug fragments were removed from the soil using a No. 10 sieve. All the sample results for the individual metals were below BSLs.

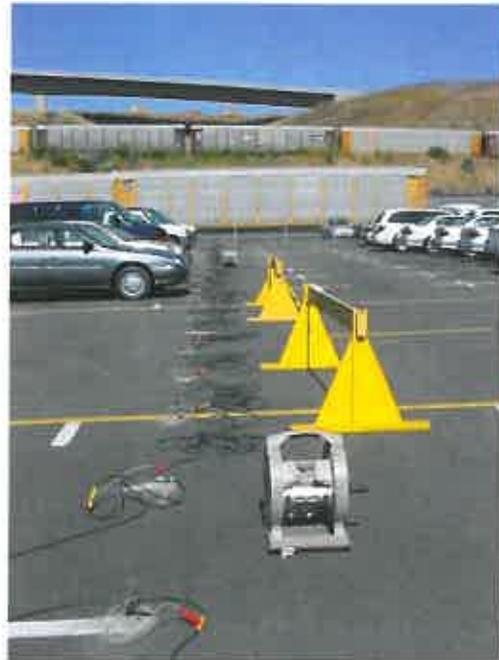
VMG survey setup at the Post Dumpsite

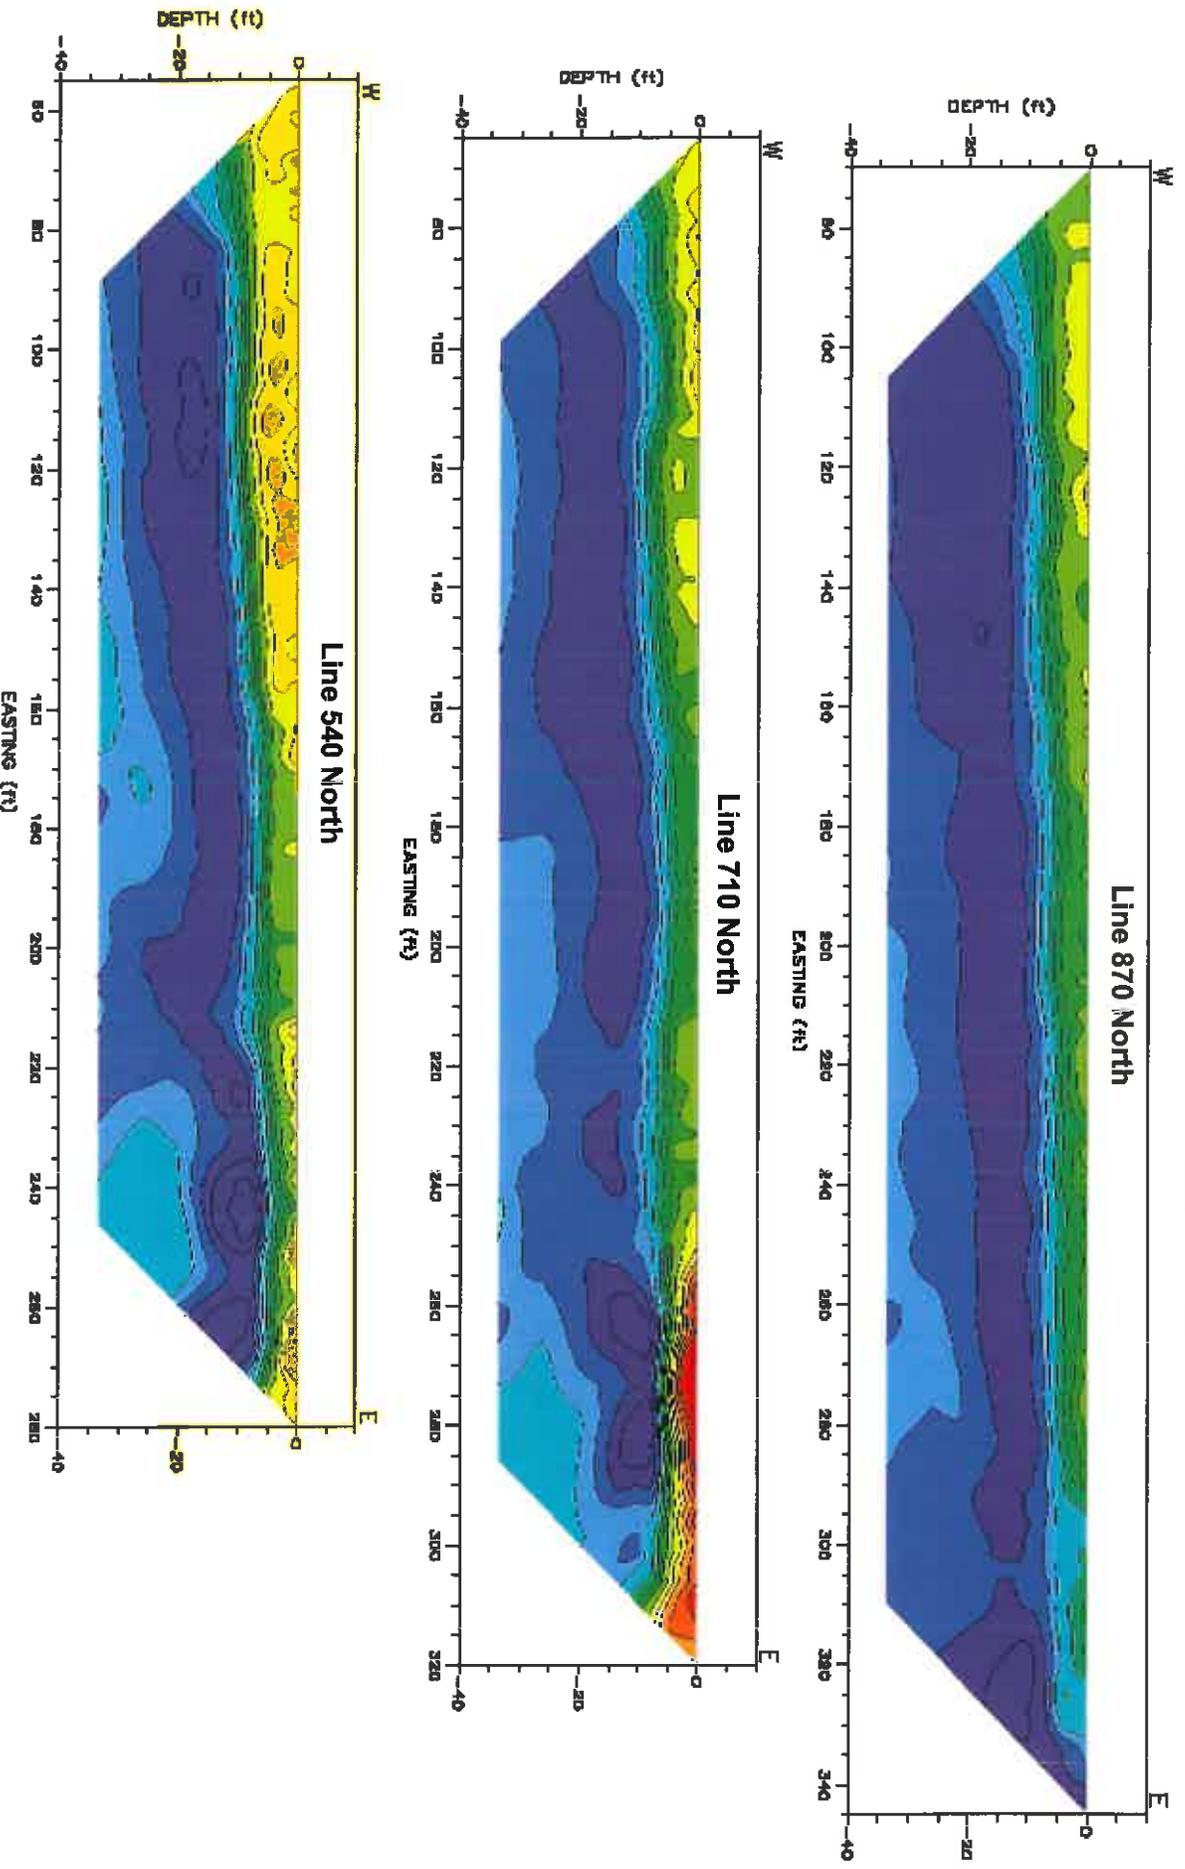
Figure 3-2
Geophysical Electrical Resistivity
Profiles - Post Dumpsite

In 1928, the area of the alleged Post Dumpsite was undisturbed land. This photo and the anomalous areas identified during the geophysical survey were overlaid on top of the 1928 photo, as shown on Figure 3-1. The anomalous areas are positioned west of the 1928 shoreline and east of an irregular white line. This white line could represent high tide. The dark material on the photo is vegetation. It is presumed that the anomalous areas are likely construction debris that was pushed into this area as a means to support the existing paved surface and/or a foundation for the existing levee. The location of the levee coincides with the eastern extent of the survey area and is also located at the boundary between the marsh and the paved area.

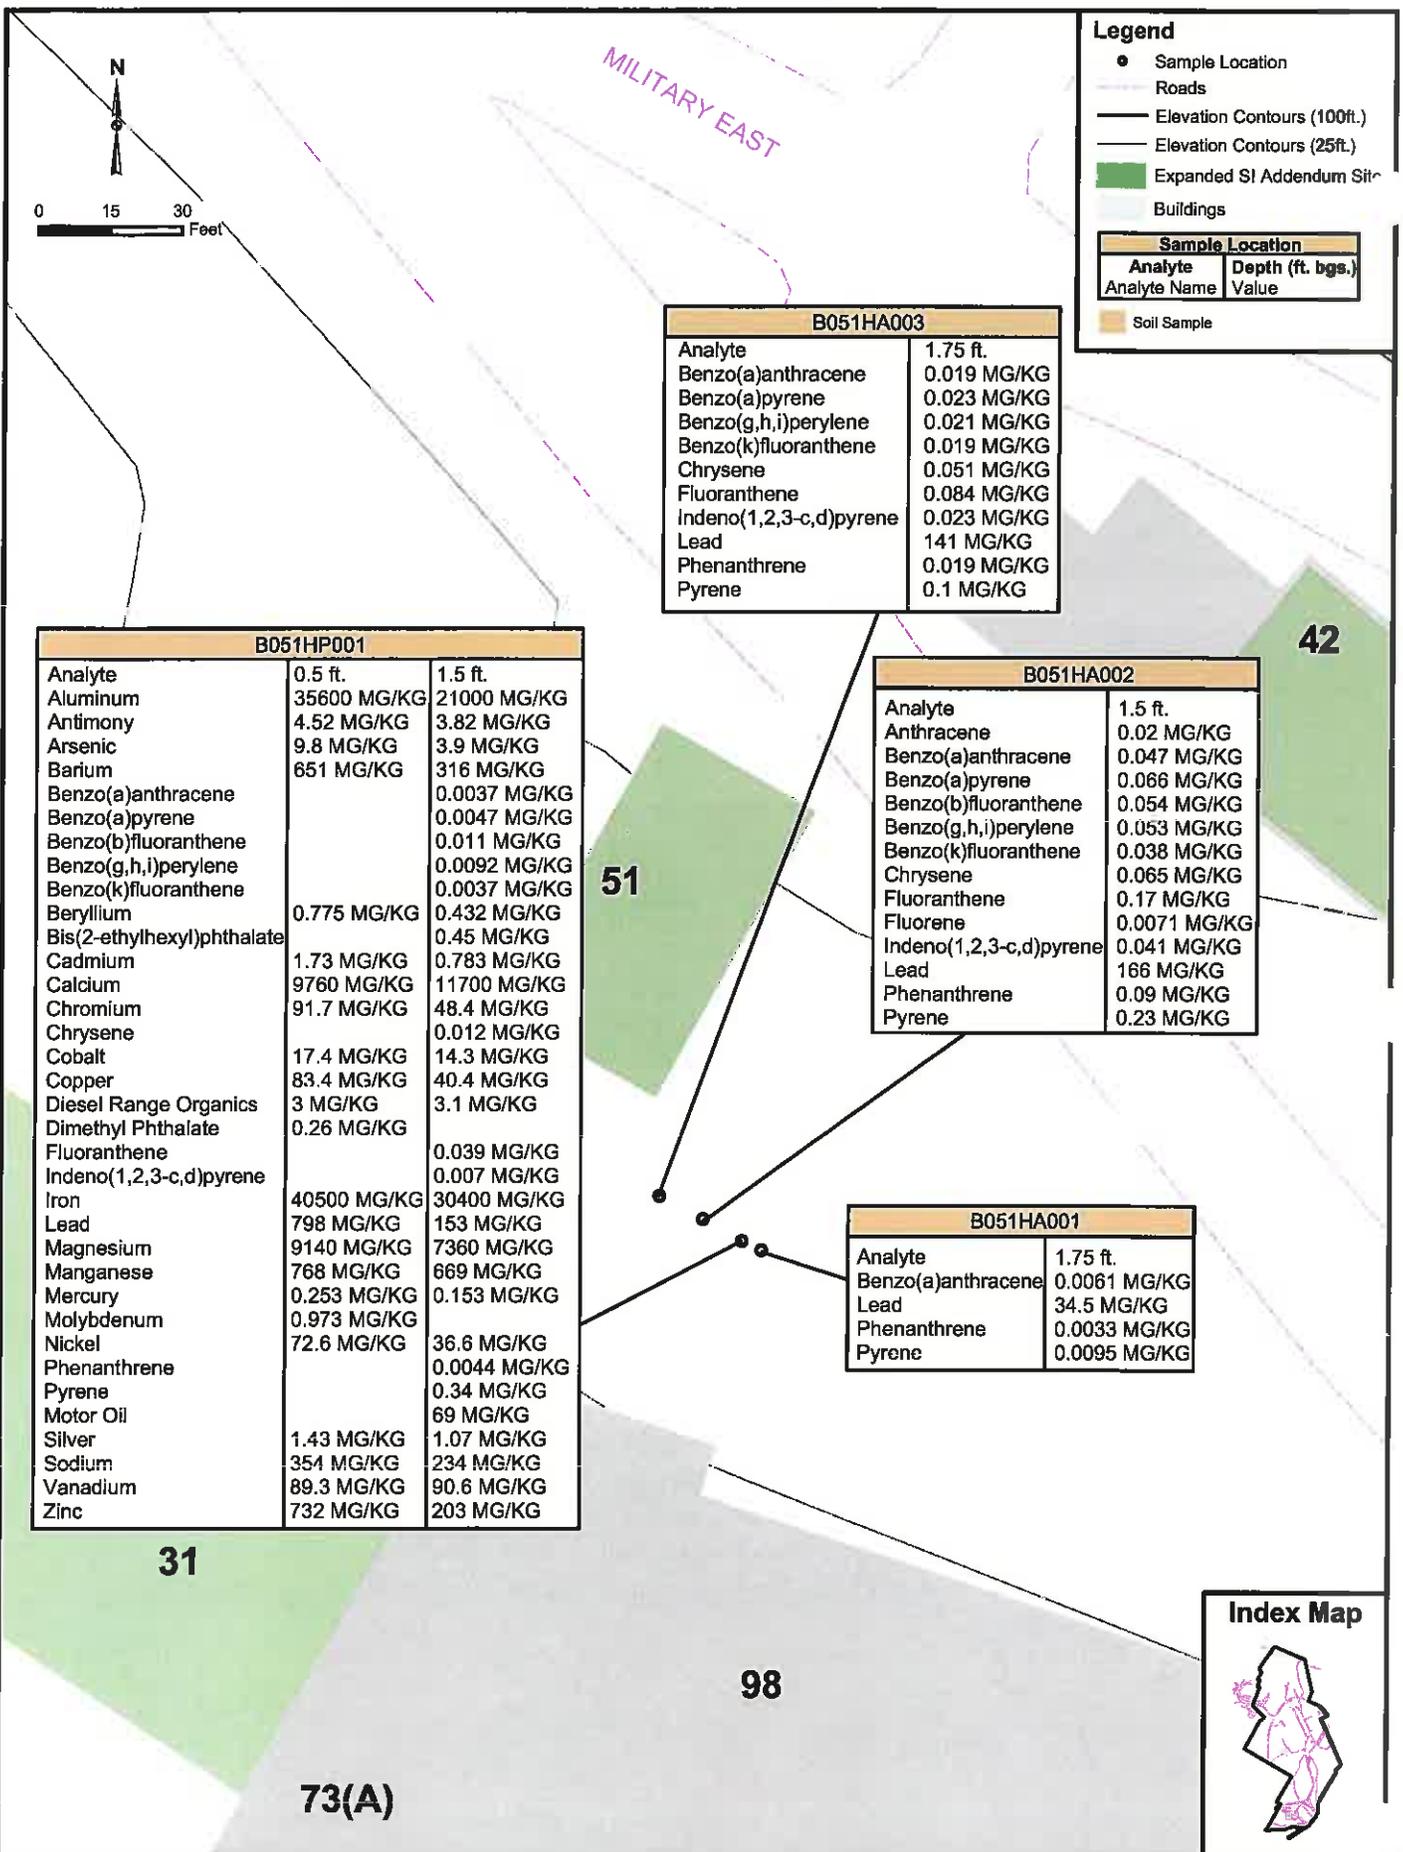
TITLE: **Sampling Locations and Detected Results at Building 51**
 SITE: **Benicia Arsenal, Benicia, California**

Detected results of all samples collected at Building 51 are shown on Figure 6-1. A comparison of the lead data from this investigation and the Expanded SI also is provided in Table 6-1. Concentrations of lead are consistent with the reported results in the Expanded SI Report, around 150 mg/kg (BC, 2005a). Since the lead reported in shallow soil from the June 2004 sampling location is below the Water Board ESL, the June 2004 duplicate sample of 798 mg/kg can be considered an anomaly.

No further investigation is recommended at the former drum storage area at Building 51. A risk evaluation will be performed.

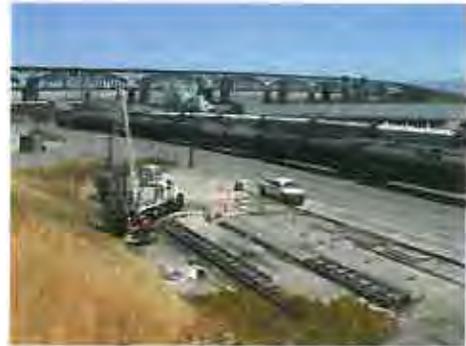
Only the foundation remains. The hillside was carved out for the building. This photo was taken in 2001 and not during this investigation.

No further investigation is recommended at former Building 101. A risk evaluation will be performed.

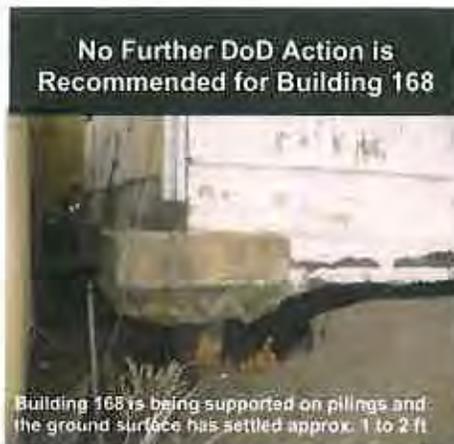
Building 168 was built in 1945 as a vehicle shop during the World War II expansion at the former Arsenal. Historical records did not indicate whether maintenance work was performed. The building is located on the former marshland and is supported by pilings that have been driven to the top of the underlying sandstone. The land surface around these buildings has sunk 1 to 2 feet as shown in the photo at right.

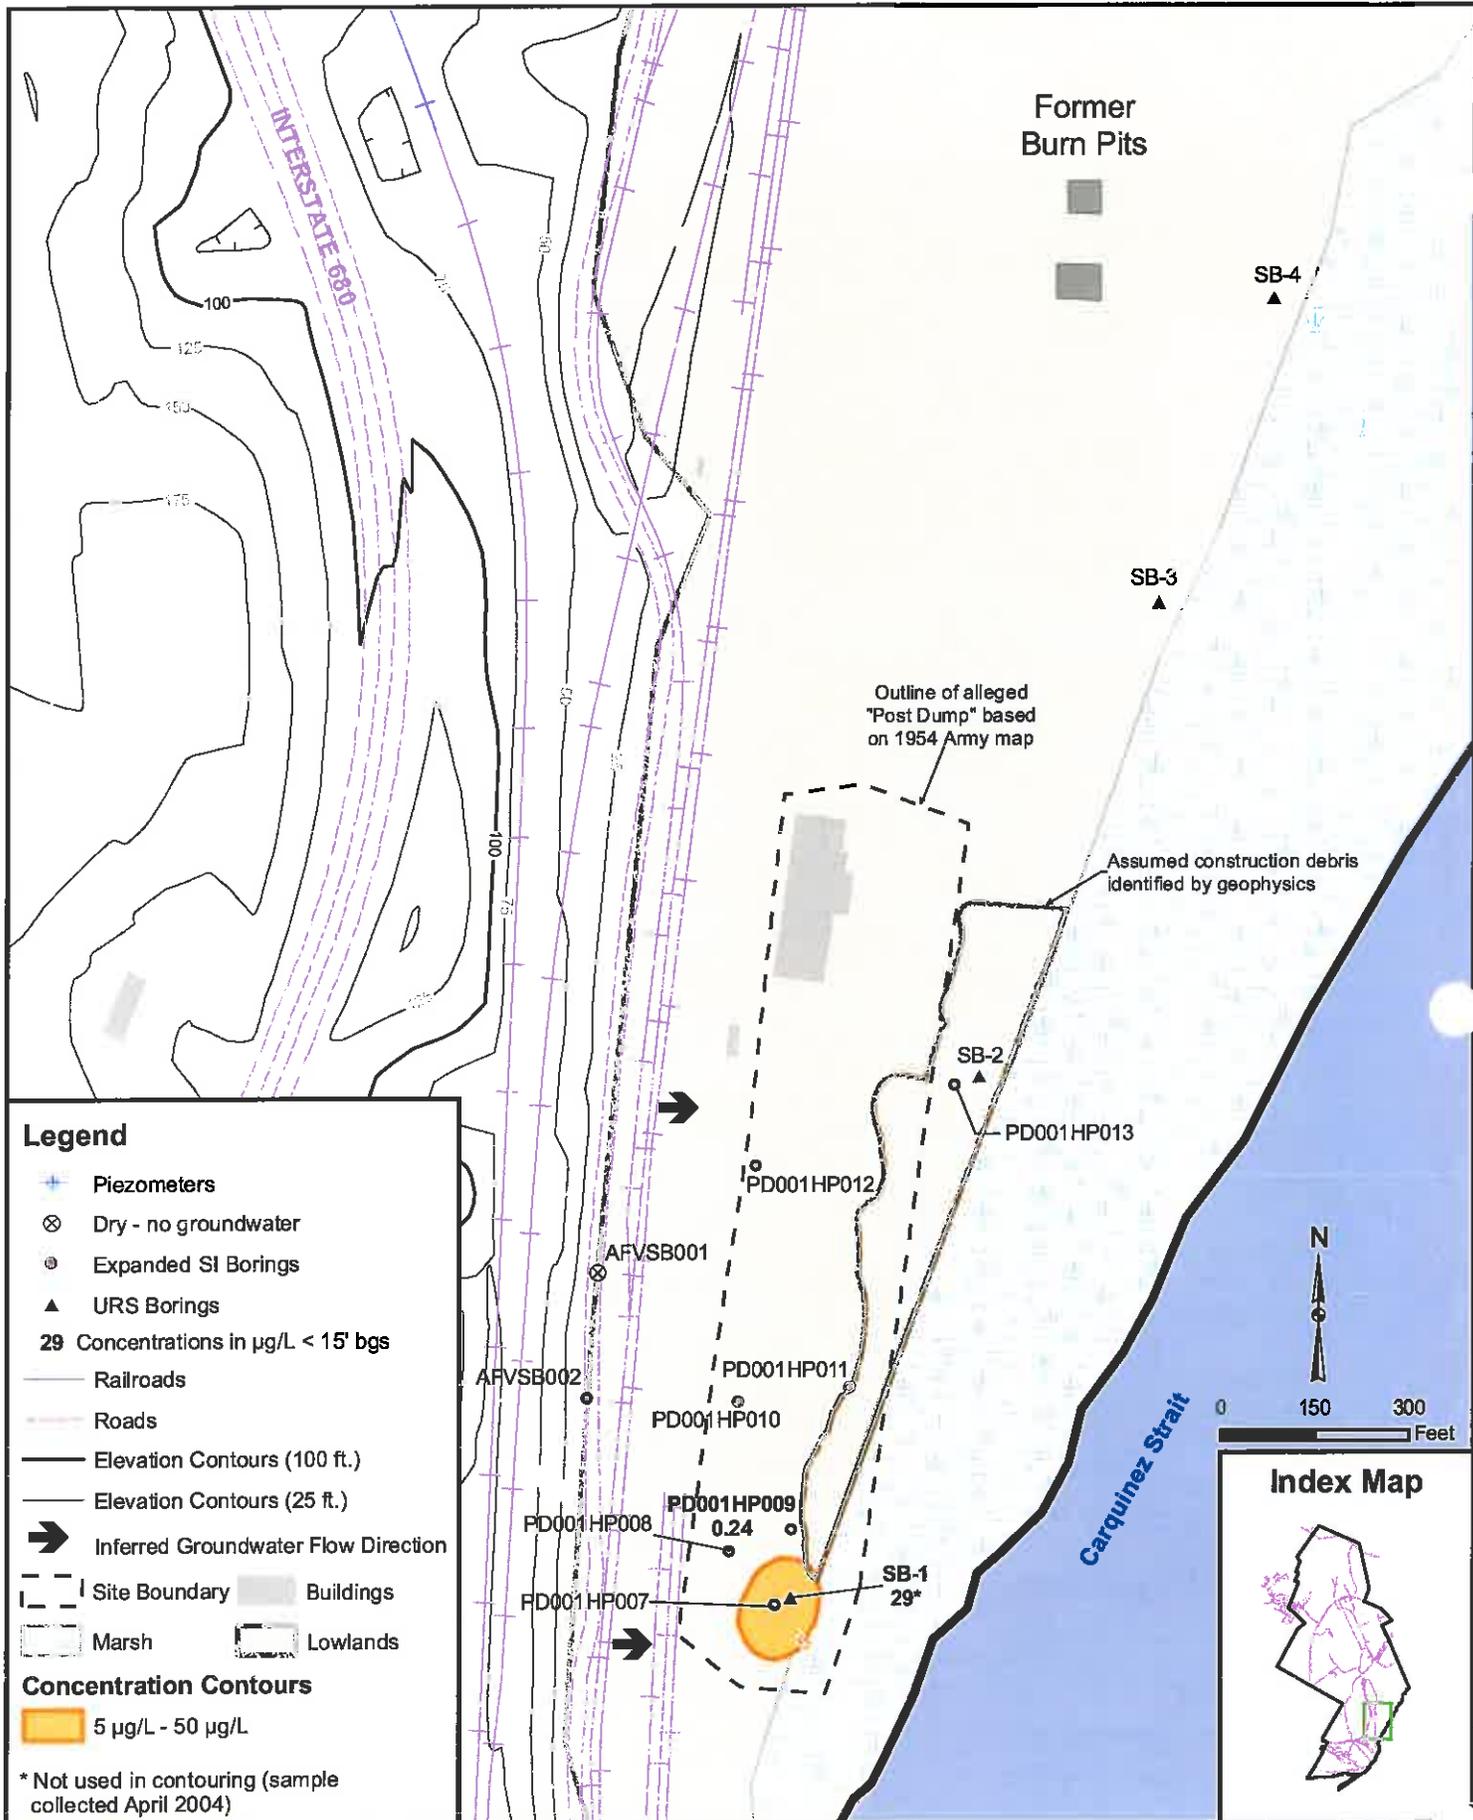
Figure 6-7

TITLE: TCE Detected in Shallow Groundwater
 at the Alleged "Post Dump"
 SITE: Benicia Arsenal, Benicia, California

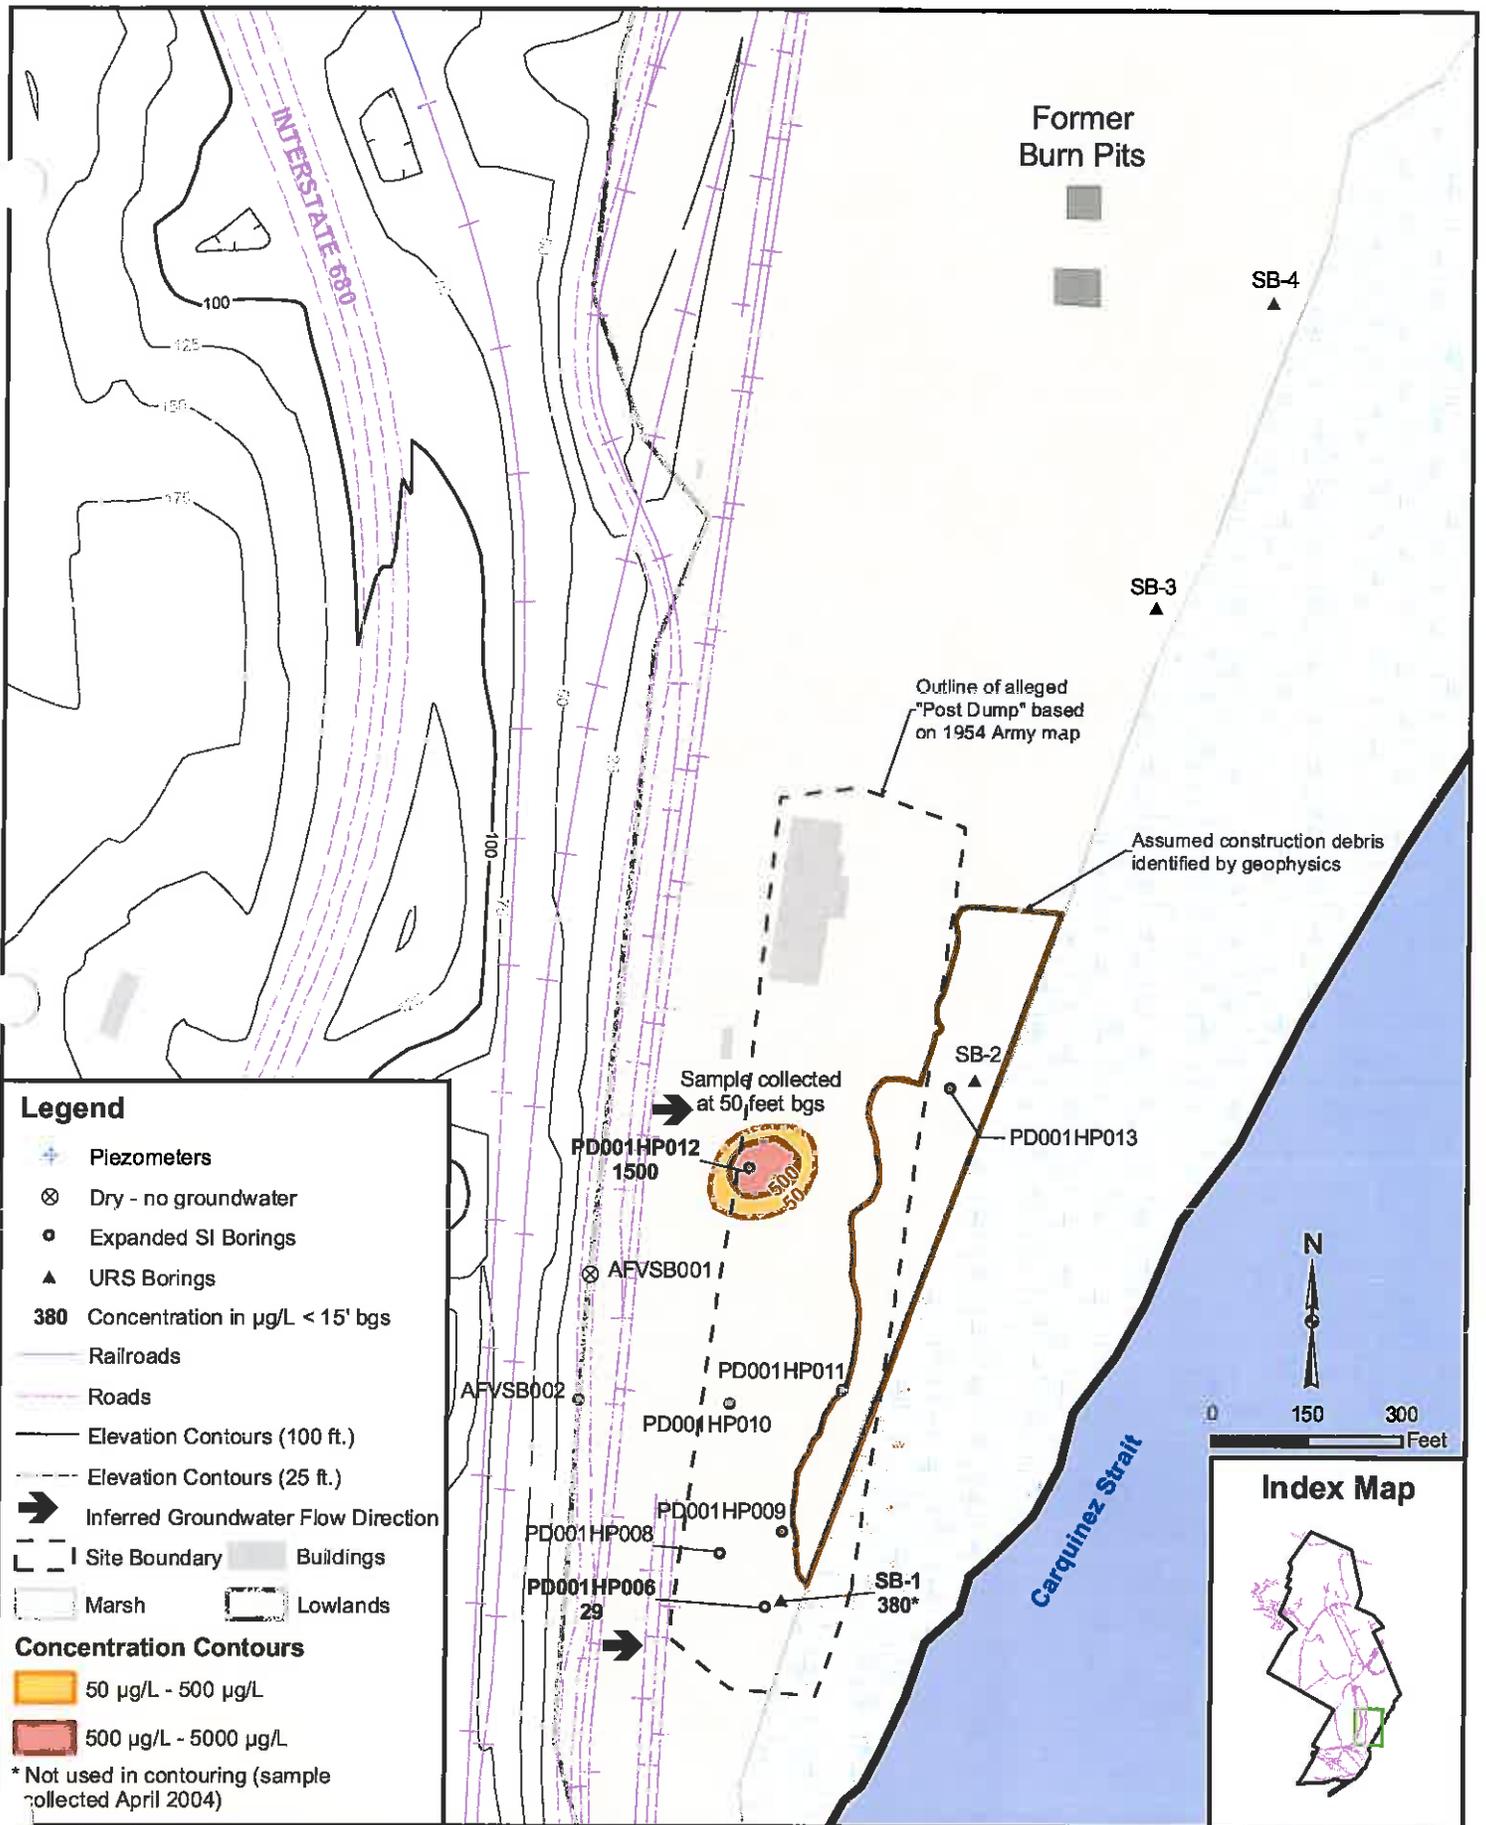
Figure 6-9

TITLE: Gasoline Detected in Shallow and Deep Groundwater at the Alleged "Post Dump"
 SITE: Benicia Arsenal, Benicia, California

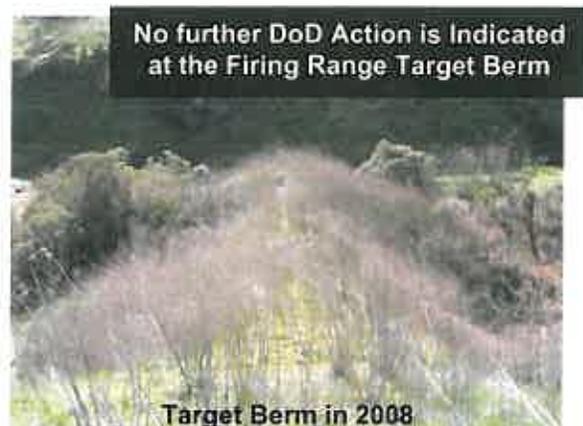
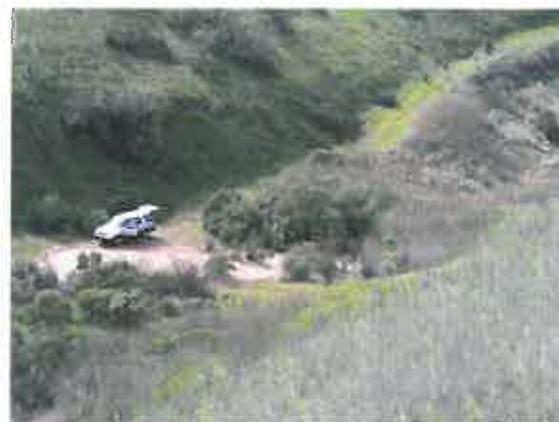
For the 2008 sampling effort at the firing range target berm target, a revised figure was created from the 2005 Expanded SI (BC, 2005a) that shows the direction of firing to the south-southwest (up the canyon to the west) (Figure 6-13). The outline of the target berm was revised based on aerial photos and then refined using GPS locations collected around the edge of the berm during the sampling effort on February 6, 2008. The locations of 2004 composite soil samples (FR01CS001 – FR01CS003) were also confirmed and were collected on the target face of the berm. Coverage of the 2004 composite soil samples on the target face was assessed at the site. There is a void where samples could not be collected on the berm due to a large bushes located on the south side of the berm. These bushes are pictured in top photo on the left side of the berm and in the bottom photo to the right of the vehicle. Because of these bushes and other bushes of significant size, their outlines using a recent aerial photo were added to Figure 6-13. Two more composite soil samples (FR01CS004 and FR01CS005) were collected on

February 6, 2008 to cover the top side of the target face of the berm and within the bushes on the south side of the target face. The soil samples were analyzed for antimony, arsenic, copper, lead, and zinc, metals commonly associated with ammunition.

During the sampling effort, water was flowing into a 12-inch diameter corrugated steel culvert at the west base of the berm, beneath the berm, beneath a parking area (see bottom photo), and then exiting the berm at the east face and out of a 24-inch diameter corrugated steel culvert. The distance between the inlet and the outlet was approximately 180 feet (Figure 6-13). The berm and the parking is comprised of fill material.

Because of the age of the berm, at least 40 years old and the steel culvert likely the same age, there is a potential that surface water flowing through the culvert is in contact with the berm material. In order to determine if there was any impact, a water sample was collected on the inlet side, before the berm (FR01GR001) and another sample (FR01GR002) on the outlet side of the culvert. Locations of these samples are shown on Figure 6-13. The downstream sample (FR01GR002) was collected from a hand auger boring with a temporary casing installed to a depth of 8.2 feet bgs.

Detected metals concentrations from the Expanded SI and this investigation are shown on Figure 6-13 and in Table 6-9 for soil. All the sample results for the individual metals were below BSLs (Table 6-9).

For water, detected metals concentrations are shown on Figure 6-13 and listed in Table 6-10. All the sample results for the individual metals were below MCLs (Table 6-10).

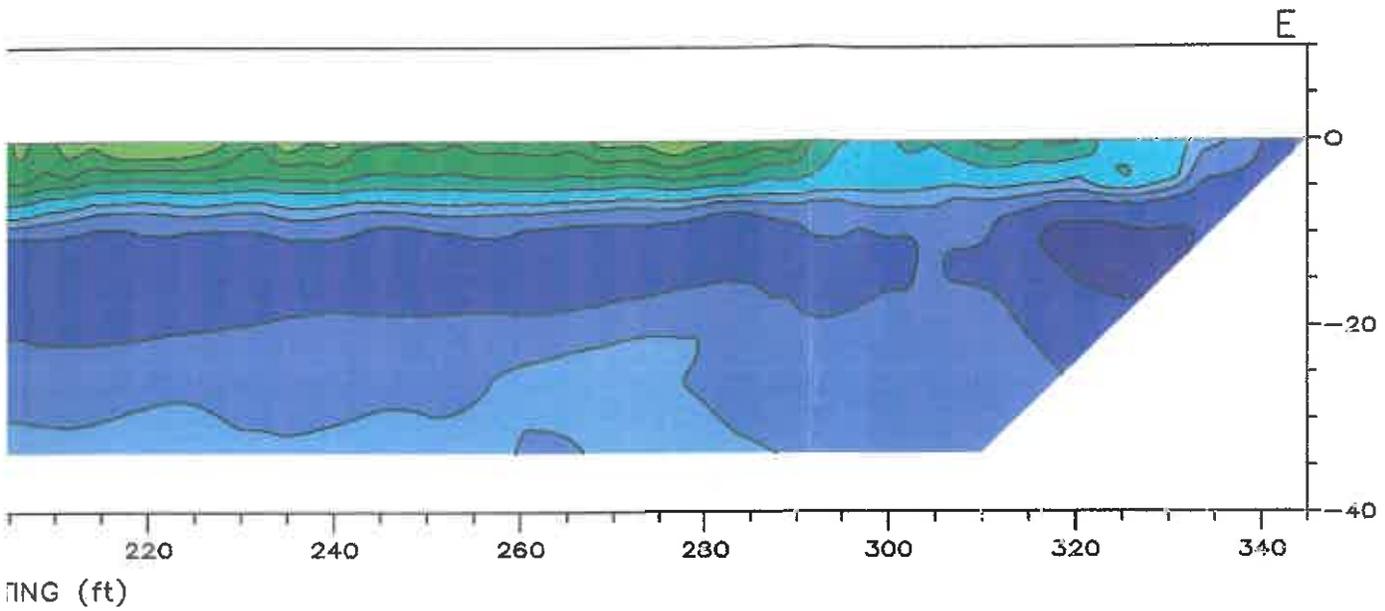
NORCAL	ELECTRICAL RESISTIVITY PROFILE LINE 870 NORTH BENICIA POST DUMPSITE		PLATE 4
	LOCATION: BENICIA, CALIFORNIA		
	CLIENT: BROWN & CALDWELL		
	NORCAL GEOPHYSICAL CONSULTANTS INC.		
JOB #: 05-141.45	DRAWN BY: G.RANDALL	APPROVED BY: DJB	
DATE: JUN, 2005

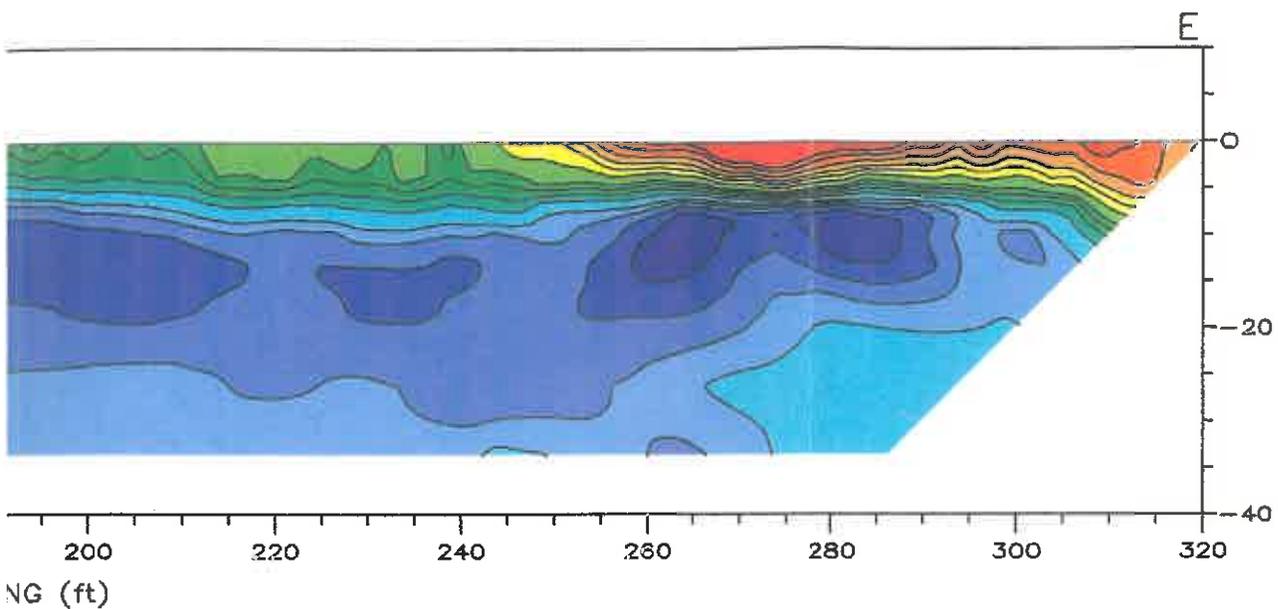
NORCAL	ELECTRICAL RESISTIVITY PROFILE LINE 710 NORTH BENICIA POST DUMPSITE		PLATE 5
	LOCATION: BENECIA, CALIFORNIA		
	CLIENT: BROWN & CALDWELL		
	NORCAL GEOPHYSICAL CONSULTANTS INC.		
JOB #: 05-141.45	DATE: JUN. 2005	DRAWN BY: G.RANDALL	APPROVED BY: DJB

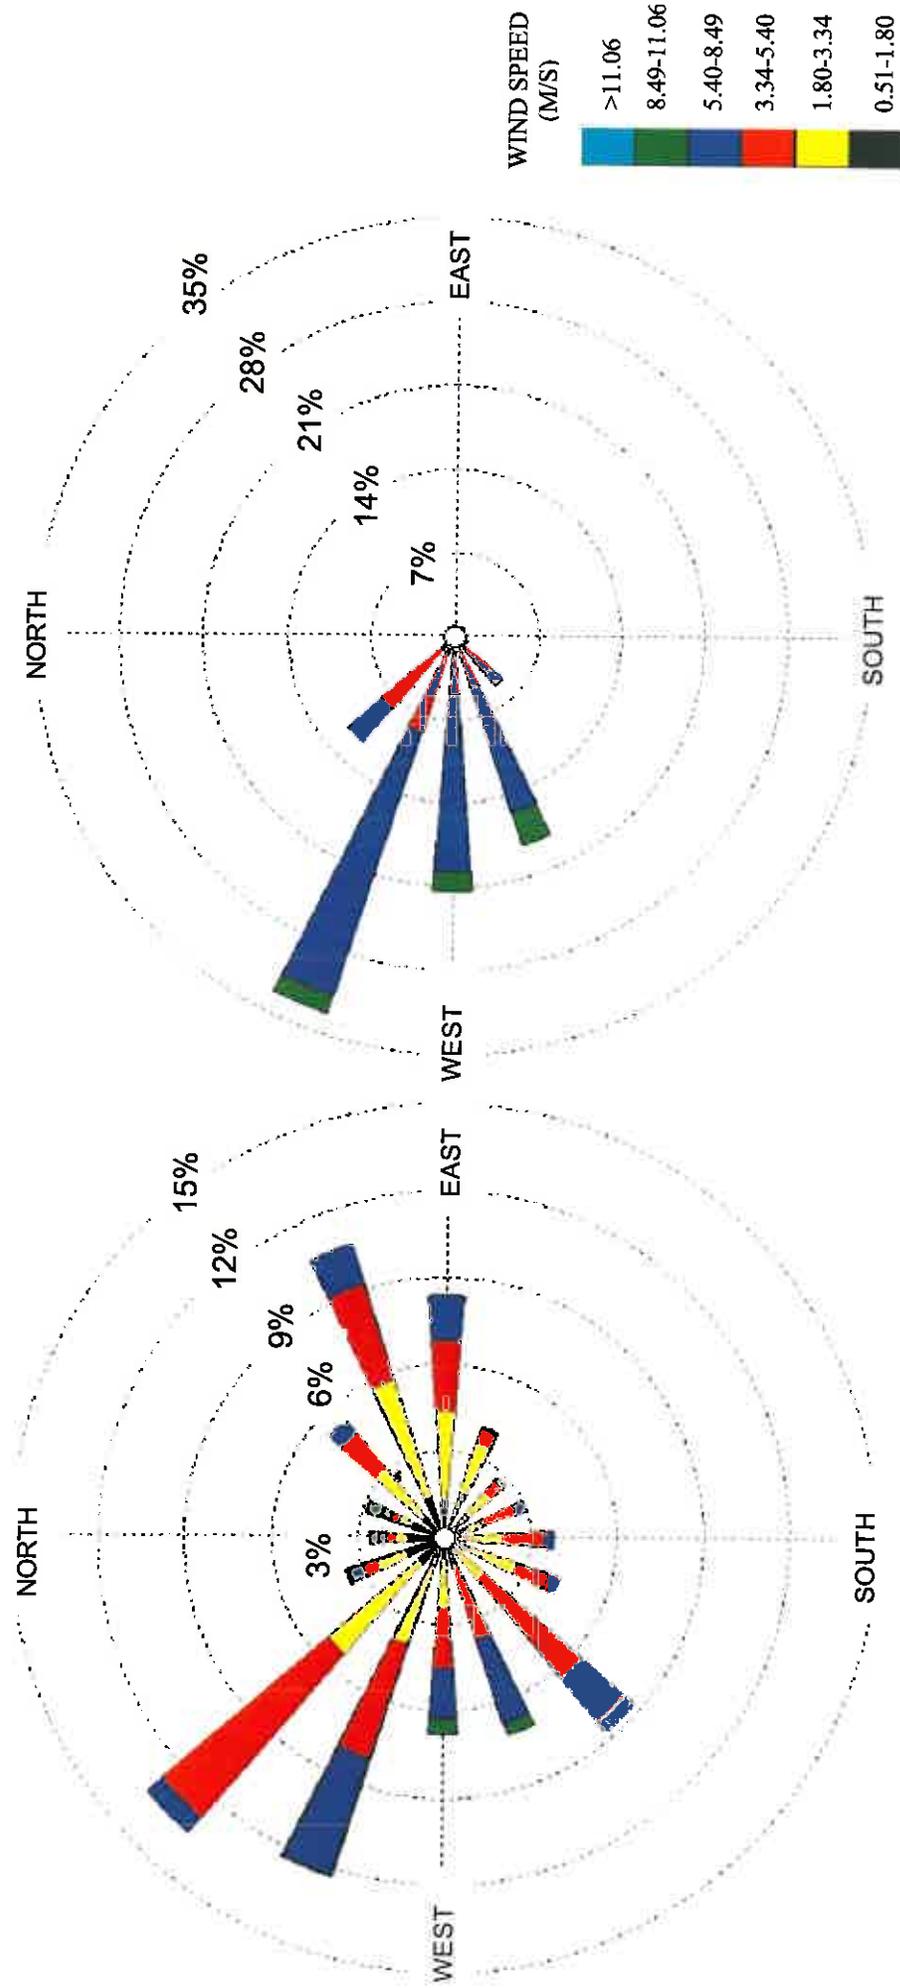
Attachment B-4: Seasonal Wind Roses at Valero (Benicia) Oil Refinery

Winter Jan-March 2000

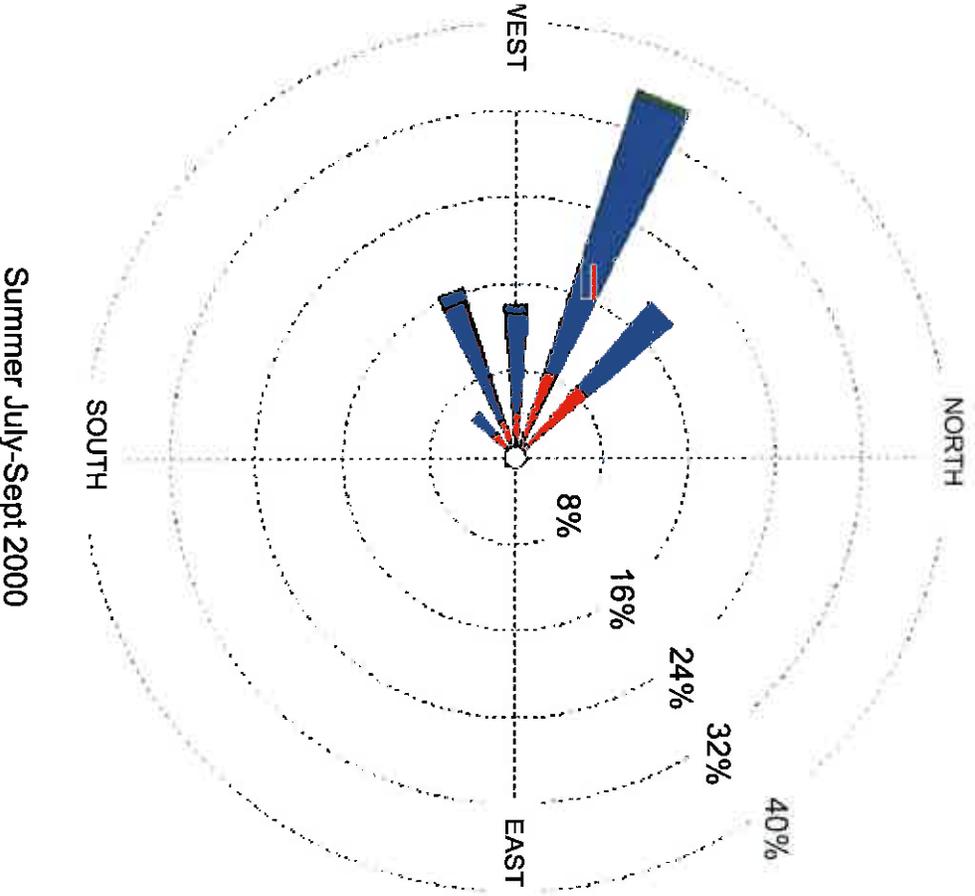
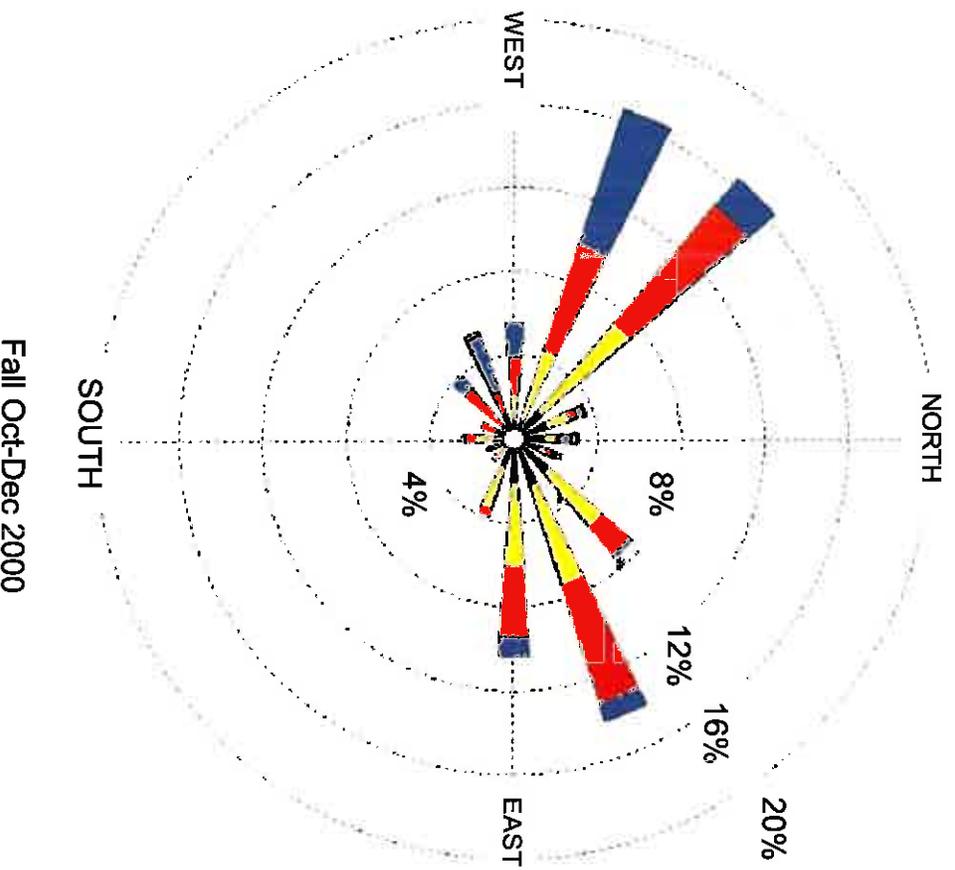
Attachment B-4: Seasonal Wind Roses at Valero (Benicia) Oil Refinery (cont.)

Note: Wedges on charts indicate direction the wind is blowing from.

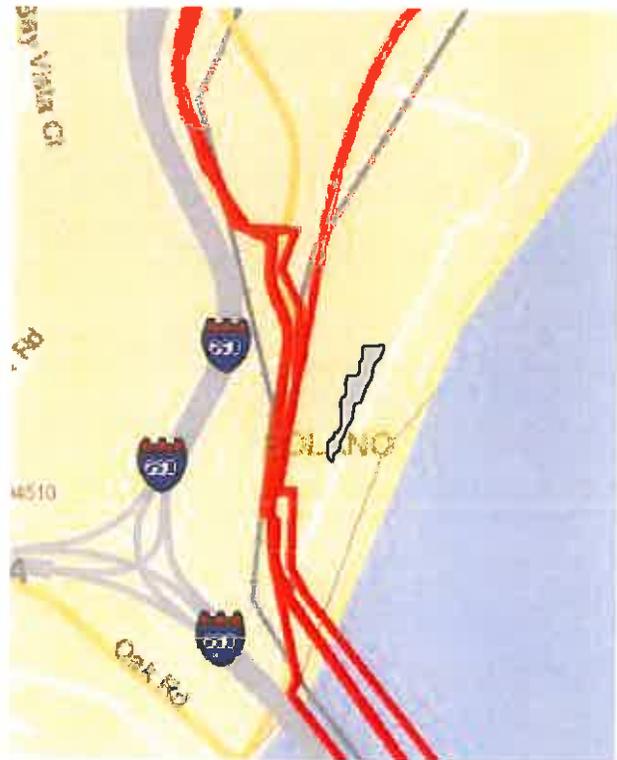
Liquid petroleum pipelines (e.g., Kinder Morgan) traverse the site in as shown in the figure to the right in red. An outline of the construction debris interpreted from the geophysical survey conducted during the Expanded SI Addendum is also shown in gray.

National Pipeline Mapping System (hazardous liquid transmission pipelines in red). Construction debris identified during the Expanded SI Addendum geophysical survey shown in gray.
