TOURTELOT CLEANUP PROJECT

TOURTELOT PROJECT ANNUAL INSPECTION AND REPORT FORM

Benicia, California

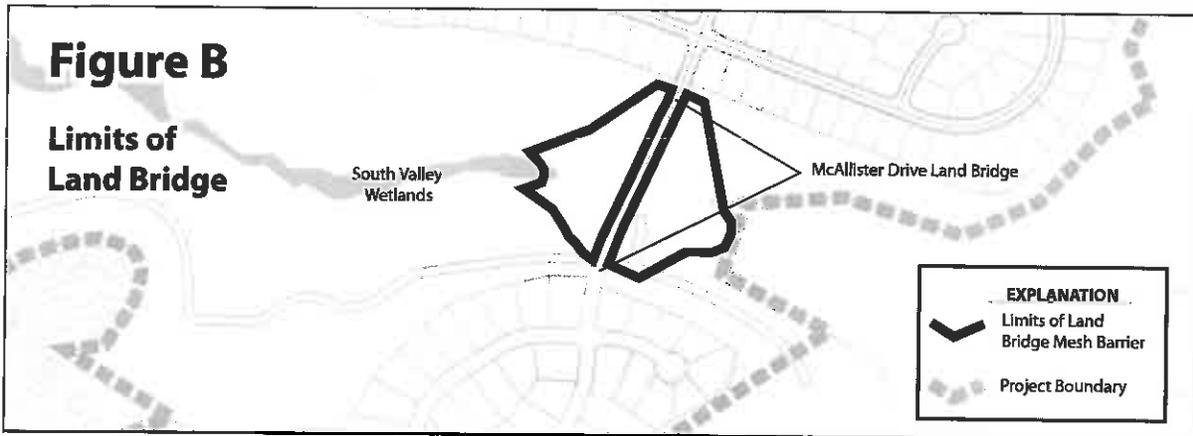
Before conducting the annual inspection of the Land Bridge Mesh Barrier, please review Section 3.3 of the O&M Plan. The Land Bridge Mesh Barrier (See Figure B) was installed to prevent unauthorized excavation into the slopes of the Land Bridge. Excavation into the slopes of the Land Bridge could result in potential exposure to OE-Energetic or OE-Like items.

A few of the many hold down pins are beginning to lift near _____ street (Append C, Pg 1 and 2)

1-2

The edges of the barrier may be prone to lifting which would affect its overall hold down strength.

The specified hold down pins are not longer effective along the _____ street.

No action is recommended, only monitoring. Vegetation will likely be an effective long term hold down.
