PRIMARY RECORD

*Resource Name or #: 1029 West Second Street

BUILDING, STRUCTURE, AND OBJECT RECORD

*B10. Significance: Theme: Benicia Downtown District

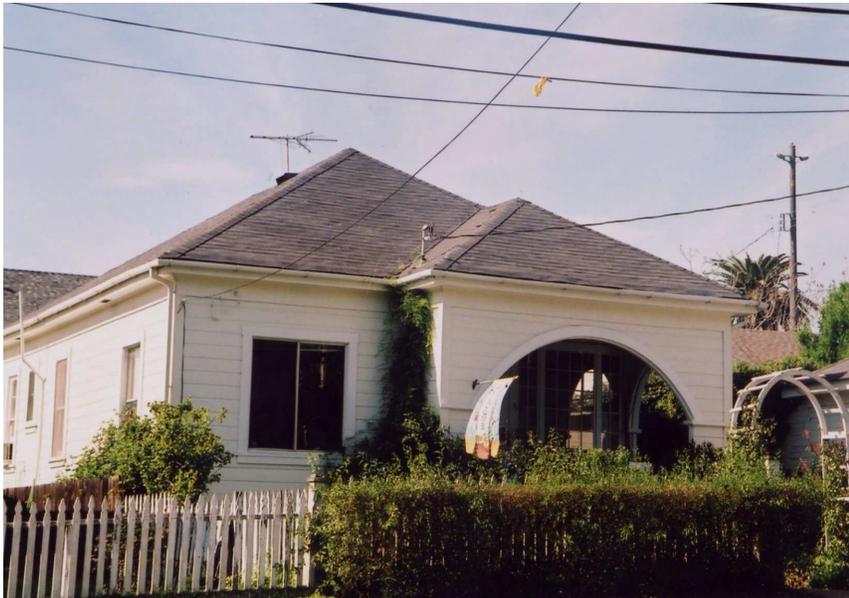
P5. Photograph or Drawing (Photograph required for buildings, structures, and objects.)

This is a rectangular plan house with an extended corner porch. The house is surmounted by a hip roof of moderate pitch which is intersected by the porch hip roof. There is a plain cornice which extends around both the house and the porch. The corner porch is covered and has large arched openings on the east and north sides. The walls surrounding these openings give the porch a semi-enclosed appearance. Fenestration consists primarily of one-over-one double hung windows except on the porch where there is a large multi-pane central window flanked by multi-pane side lights. On the south side of the front elevation the original window has been replaced with an aluminum slider, although the opening and casement are original. The house is clad with clapboard.

Front façade, view northwest

This Craftsman house was constructed circa 1920 and is an interesting example of its style. This type of wrap around heavily enclosed porch with arched openings was featured in a number of pattern books and has been adapted here to provide a strong stylistic element to an otherwise rather plain house. Overall the house retains good integrity except for the replacement of the front window. The house is not listed as a contributor in the Downtown Historic District and it was not identified in the 1989 survey as a potential contributor. However, based on its age and architectural style it should be considered for addition to the district.
