PRIMARY RECORD

*Resource Name or #: The Kullman/Sanborn House

- P1. Other Identifier:** none
***P2. .Location: *a. County** Solano
b. Address: 107 East J Street
***c. City:** Benicia **Zip** 94510
d. UTM: N/A
e. USGS Quad: Benicia T2N R3W MDM
***f. Other Locational Data (APN #):** 88-142-08

BUILDING, STRUCTURE, AND OBJECT RECORD

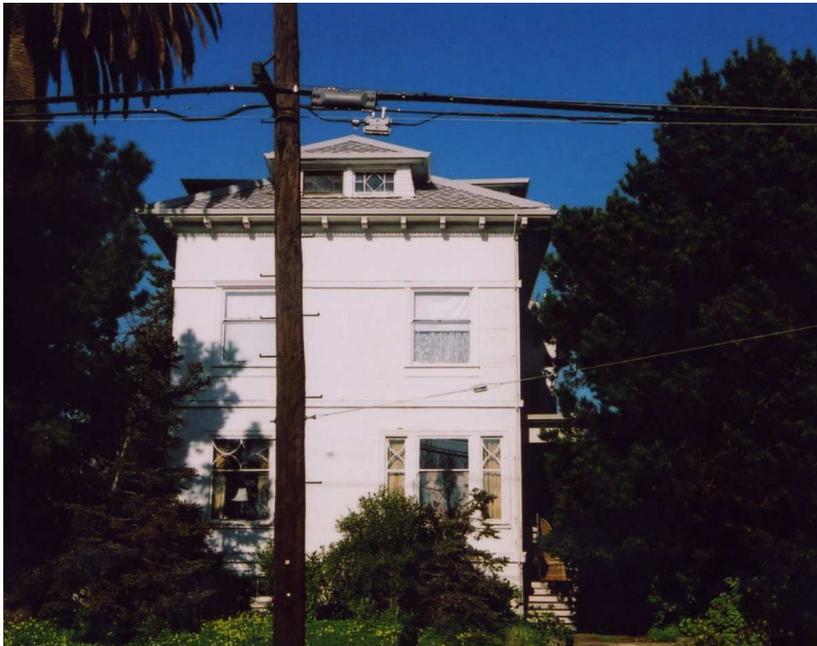
P5. Photograph or Drawing (Photograph required for buildings, structures, and objects.)

This Classical Revival House is oriented to the east with the porch and entry facing the side yard. A side elevation is presented to the street. The house has an L-shape plan and is two and one-half story. The roof is moderately hipped with wide overhangs and exposed rafter tails. A cornice with dentils extends around all four facades. Hip and gable roof dormers are found on the east, west and south slopes of the roof. The dormers have wide roof overhangs and decoratively glazed attic vent windows. A large flat roofed porch occupies three-quarters of the east elevation. It is open on the south with a stair that provides access from the street. The porch roof is supported on classical columns which are arranged in a grouping of three at the south corner. The porch has a wide plain frieze. A low rail surrounds the porch roof creating a second-story veranda. Fenestration consists of double hung, one-over-one windows of varying sizes which are arranged singly and in pairs. On the south façade the east window has narrow double hung side lights with decorative upper muntins and a double hung window on the west side has a decorative upper sash. A wooden belt course runs just above the top of the upper story window casings, visually connecting the windows of disparate size. There is a single story, hip roof wing at the rear (north) of the building. The house is clad with flat, horizontal plank siding.

P5b. Description of Photo:
Front façade, view north

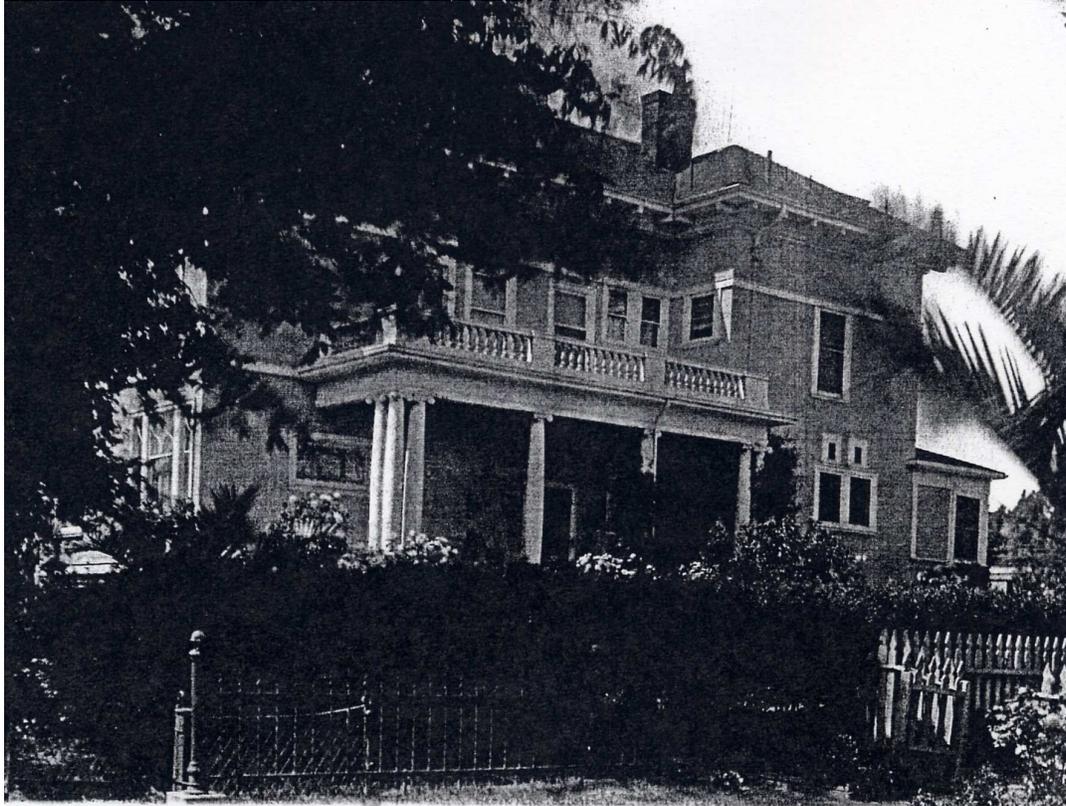
Photograph Circa 1912
