PRIMARY RECORD

*Resource Name or #: 1101 West Second Street

BUILDING, STRUCTURE, AND OBJECT RECORD

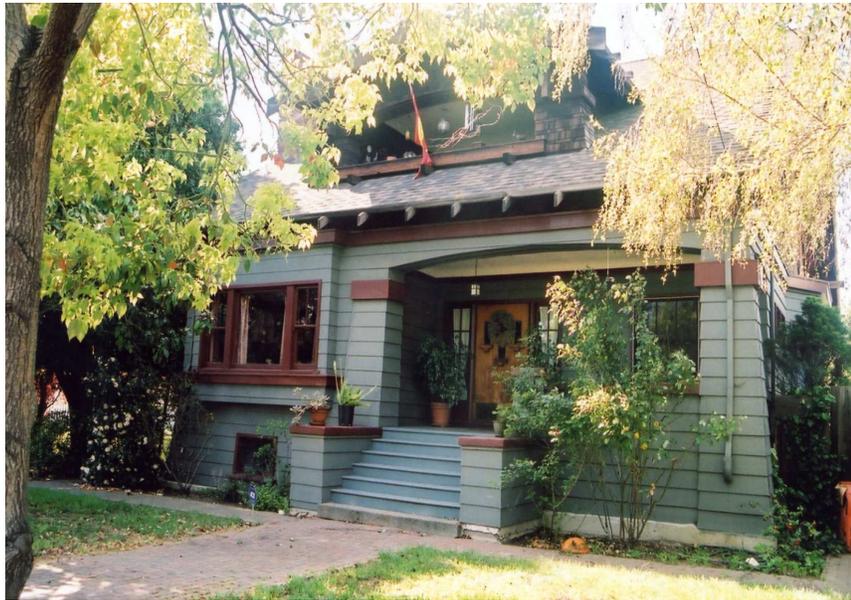
P5. Photograph or Drawing (Photograph required for buildings, structures, and objects.)

This is a fine example of a Craftsman house. One and one-half story, it is rectangular in plan. The roof is side gabled and of moderate pitch. It has wide overhangs with exposed rafters and purlins and a wide plain cornice. A front gable dormer pierces the front slope of the roof. A large cut-in porch spans three-quarters of the front elevation. The arched opening to the porch is supported on battered piers. The porch rail is closed as is the low balustrade which flanks the wooden entry steps. The original heavy oak door with decorative glazing is asymmetrically placed and is flanked by multi-light side lights. Fenestration consists of double hung windows except for the front window. This window has a central fixed panel with double hung side lights set in a slightly extended square bay. Lap siding covers the building, foundation and piers and porch rails.

Front façade, view southwest

This house is an excellent example of the Craftsman bungalow style. It exhibits the major characteristics of the style including its rectangular massing and form, moderately pitched side gable roof with exposed rafters and purlins, large porch with battered posts and horizontally emphasized fenestration. The house has been well maintained and exhibits integrity of setting, location, design, materials, workmanship and association. It is a contributing building in the Downtown Historic District and should retain this status.
