PRIMARY RECORD

- *Resource Name or #: 117 West I Street
- P1. Other Identifier: none
- *P2. .Location: *a. County Solano
- b. Address: 117 West I Street
- *c. City: Benicia Zip 94510
- d. UTM: N/A
- e. USGS Quad: Benicia T2N R3W MDM
- *f. Other Locational Data (APN #): 89-043-15

BUILDING, STRUCTURE, AND OBJECT RECORD

*Resource Identifier: 117 West I Street

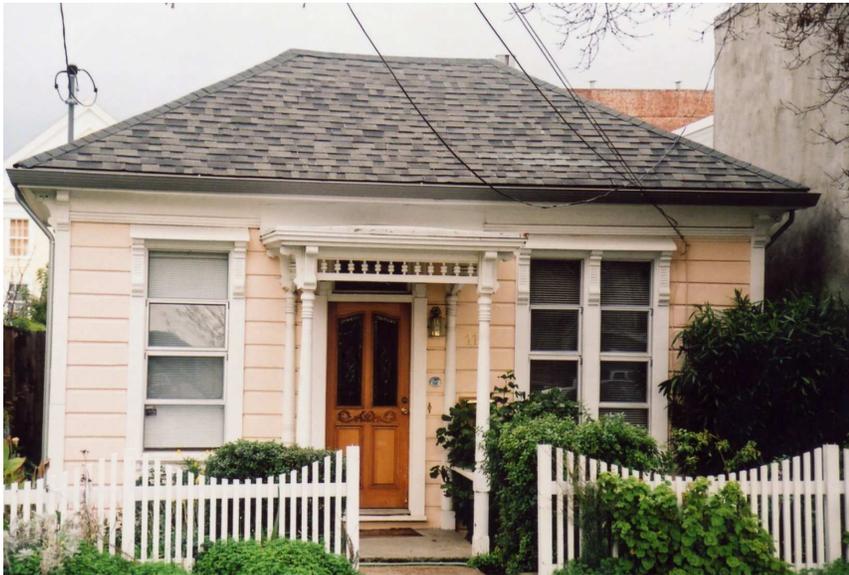
P5. Photograph or Drawing (Photograph required for buildings, structures, and objects.)

This is a small, one-story Italianate cottage with a rectangular plan. The roof is hip with overhangs supported on curved brackets. A wide cornice with a molded edge is continuous on all the elevations. The entry is covered with a centered portico that has a flat roof. The roof is supported on turned full-length posts with curved brackets. The post design is repeated in the pilasters attached to the front wall on either side of the entry. There also is a spindle work frieze. The door is a modern replacement, but the transom appears to be original. Narrow windows flank the front door, two on the east side of the front façade, and one on the west. The casings have slanted pediments supported by decorative brackets and the sills are bracketed as well. The glazing has been replaced in all the front windows with stacked hopper windows inserted into the original openings. Other fenestration is one-over-one double hung. Cladding is clapboard with corner boards.

- *P3b. Resource Attributes: HP2
- *P4. Resources Present: Building Structure Object Site District Element of District
- P5b. Description of Photo: Front façade, view north
- *P6. Date Constructed/Age: 1870
