PRIMARY RECORD

*Resource Name or #: 140 West I Street

b. Address: 140 West I Street

BUILDING, STRUCTURE, AND OBJECT RECORD

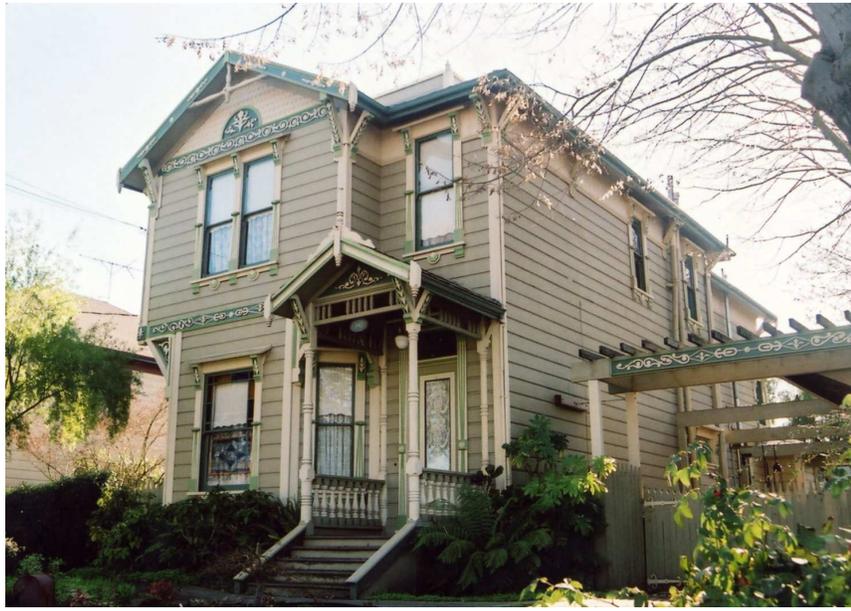
P5. Photograph or Drawing (Photograph required for buildings, structures, and objects.)

An Italianate two-story house, this residence is a large and elegant building with extensive detailing. It has a cross gable roof of moderate pitch with closed, overhanging eaves supported on decorated brackets. A projecting gable wing roof is elaborately embellished with a fascia, cornice, and gable end trimmed with applied decoration. The gable end is clad with fish scale shingles and has a turned king post. Fenestration consists of vertically emphasized one-over-one windows arranged singly and in pairs. Window casings have bracketed pediments and sills and applied decoration. On the east side of the front façade there is a lower story canted bay below a rectangular upper story. The overhanging upper story corners are supported on brackets. A narrow projecting gable roof porch covers the entry. The porch roof gable is heavily detailed with incised brackets, applied decoration, a spindle work frieze and drop newels. Turned posts support the porch roof and the porch is enclosed with a turned rail. The house is clad in clapboard. The house has a compound plan and is set on a slightly raised foundation.

P5b. Description of Photo: Front façade, view southeast
