PRIMARY RECORD

*Resource Name or #: 145 West I Street

BUILDING, STRUCTURE, AND OBJECT RECORD

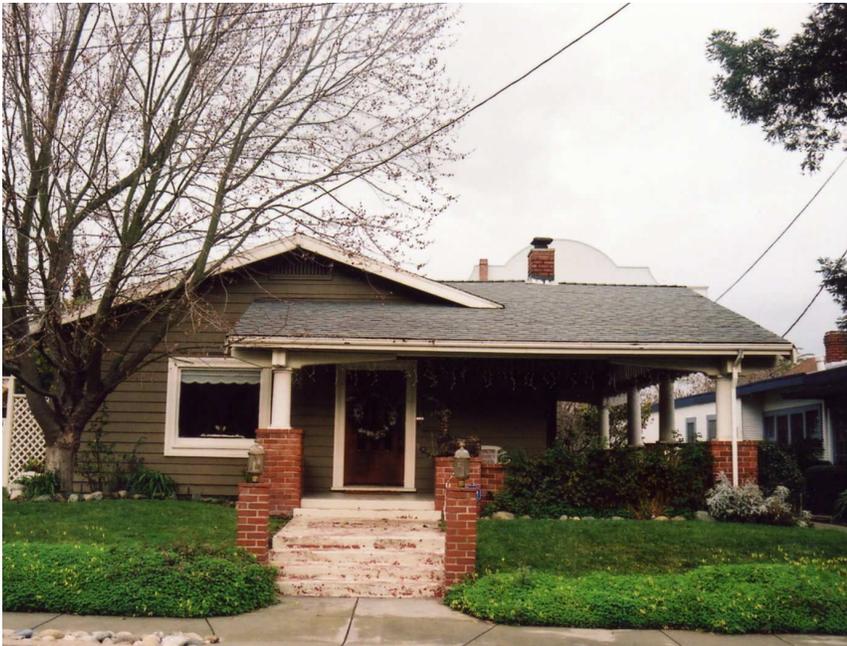
P5. Photograph or Drawing (Photograph required for buildings, structures, and objects.)

This is a Craftsman Bungalow house of rectangular plan. The roof is cross gable with wide overhangs. The gable is trimmed with a plain fascia. A large wrap around porch is sheltered under the side gable. The porch extends along the east side of the house and across half of the front façade. The roof is supported on Tuscan columns which are set on brick pedestals. A concrete stair provides access to the porch. The entry door is has long narrow vertical ribbons of glazing. Fenestration on the front façade consists of a single fixed window. The house is clad with clapboard. The long extension of the cross gable over the porch on the east fosters the visual impression that the house is much larger than it is actually.

P5b. Description of Photo: Front façade, view north

*B6. Construction History: The pedestals, porch rail, and stepped balustrade have been replaced with modern red brick.

This is one of several Bungalow houses that occur in the 100 block of West I Street. This house has had some impairment of integrity due to the replacement of the pedestals and porch rail with new red brick. The house is of an unusual design with a sweeping roof extension to the east which covers a side porch and conveys the impression of a house of larger massing and horizontal line than is actually the case. Although the integrity of materials has been compromised, the design of the house, in conjunction with its setting and association with a number of other in-fill Bungalows on the block, supports contributor status. The addition of the house to the contributor list for the Downtown Historic District should be given consideration.
