PRIMARY RECORD

*Resource Name or #: 150 West G Street

BUILDING, STRUCTURE, AND OBJECT RECORD

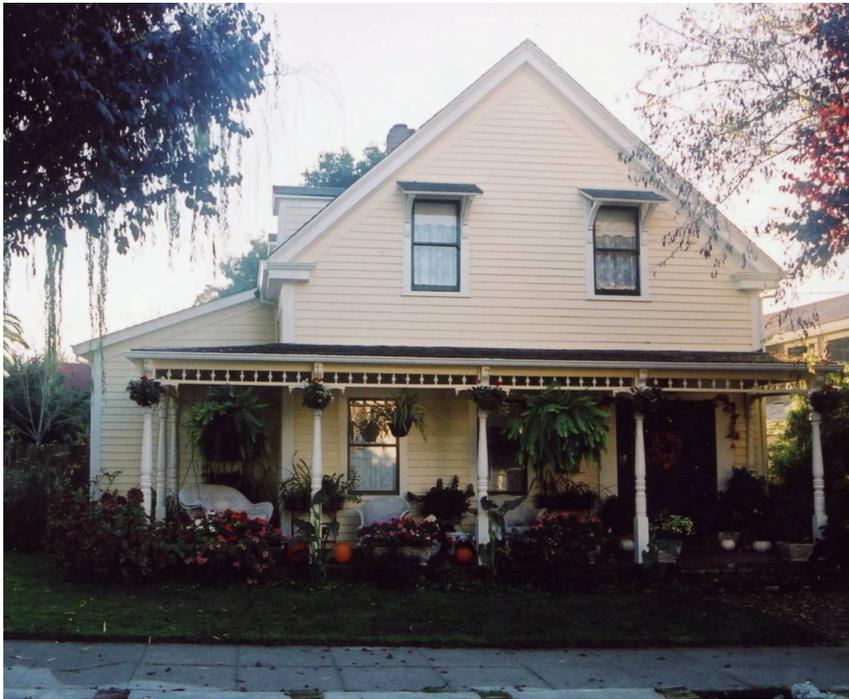
P5. Photograph or Drawing (Photograph required for buildings, structures, and objects.)

This was originally a Greek Revival house which was embellished with Victorian period detailing, particularly in the front porch. The house is L-shape in plan and is made up of a primary rectangular two-story mass with a single story shed roof addition on the east. The two-story portion of the building is surmounted by a steeply pitched front gable roof which is finished with a molded fascia and eave returns. Narrow gabled dormers are found on the eastern roof slope. Dormers of this type are found on Greek Revival townhouses, but are unusual on a simple free standing example. It is possible that the dormers were added later, but they are of a design that is consistent with the original house. Fenestration consists of single narrow one-over-one double hung windows. On the upper story of the front elevation these windows exhibit the small wooden awnings supported on brackets that are typical of Benicia houses of this period. A wrap-around covered porch extends the full length of the front façade and along the east side of the house up to the shed addition. The porch roof is slightly hipped and is supported on turned posts. A spindle frieze provides a decorative edge to the porch roof. The porch is a typical of the Greek Revival Style both in its use of turned posts and spindles and in its wrap around configuration. These were elements much more characteristic of the Victorian period and suggest that the existing porch may have been added in the period between 1890-1920 and that it replaced an earlier porch on the front façade.

Front façade, view south

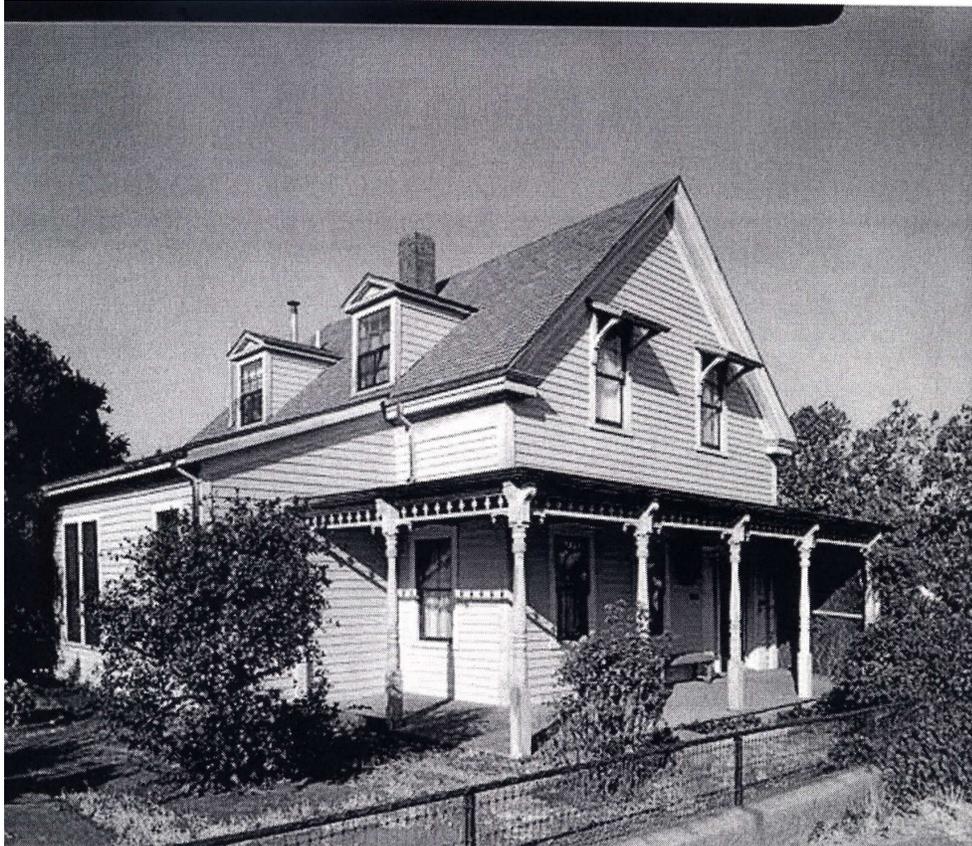
HABS photograph 1977
