PRIMARY RECORD

*Resource Name or Anderson Hotel

b. Address: 153 West E Street

*Resource Identifier: Anderson Hotel

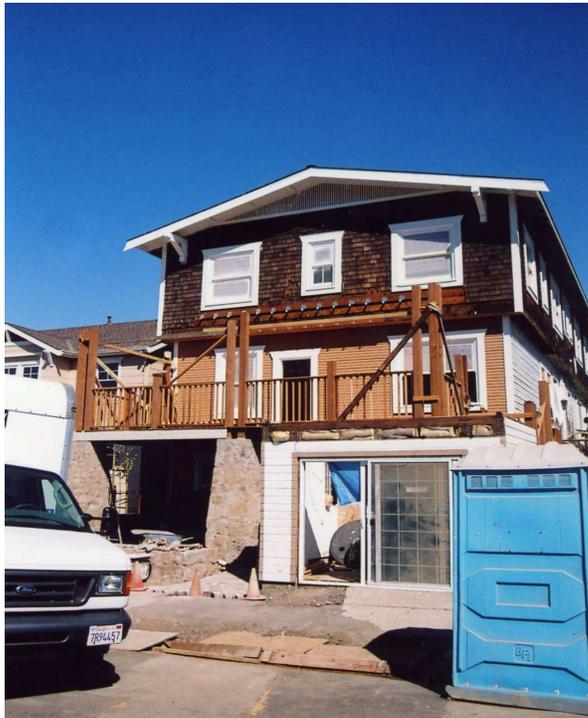
P5. Photograph or Drawing (Photograph required for buildings, structures, and objects.)

*P3a. Description This building has been moved in the last year to a location at the west end of West F Street. It is currently in the process of renovation. The building is now three story with a new lower floor added following the building's move. The building is rectangular in plan with an overhanging upper story. The roof is a low pitched gable with wide overhangs. The gable is supported on knee brace brackets. Windows are small and are arranged symmetrically along the side and gable walls. A large deck is in the process of construction across the south façade of the building at the second level. It is supported on large stone battered posts that also function to create an entrance to the building at street level. The new first floor is stone veneer, the second story is clad with narrow lap siding and the upper story with shingle.

P5b. Description of Photo: Front façade, view southwest

This building has been moved to its present site and rotated on the lot in such a manner that the building's original orientation to the street has been altered. According to California Register regulations a moved building needs to maintain its setting and orientation in order to continue to be eligible for listing. The move and the addition of a lower story are problematic in terms of design integrity. The building is not completed and should be researched and reviewed after the renovation is finished to determine if it continues to contribute to the Downtown District.
