PRIMARY RECORD

- *Resource Name or #: 163 East I Street
- P1. Other Identifier: none
- *P2. .Location: *a. County Solano
- b. Address: 163 East I Street
- *c. City: Benicia Zip 94510
- d. UTM: N/A
- e. USGS Quad: Benicia T2N R3W MDM
- *f. Other Locational Data (APN #): 89-051-17

*Resource Identifier: 163 East I Street

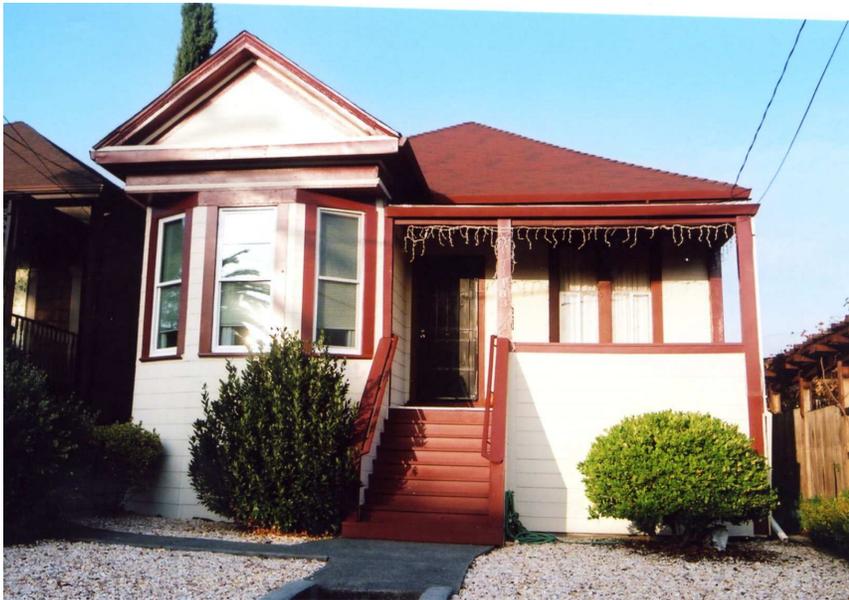
P5. Photograph or Drawing (Photograph required for buildings, structures, and objects.)

This house is one of two almost identical Queen Anne Cottages set next to each other on I Street (the other is at 159 East I Street). It is probable that the two houses were constructed by the same designer or builder. It has an L-shape plan with a principal hip roof and front cross gable. The roofs are of moderate pitch and have small enclosed eaves. The prominent front gable extends over a canted bay. The gable has a heavy molded fascia and a plain cornice. A long porch is cut-in on the east side of the house and is covered by the principal hip roof. The porch cover is supported on plain 4X4 posts. The house is set on a high foundation with a long wooden stair. The stair has a plain closed balustrade. Fenestration consists of one-over-one double hung windows.

P5b. Description of Photo: Front façade, view north
