PRIMARY RECORD

*Resource Name or #: 185 East D Street

BUILDING, STRUCTURE, AND OBJECT RECORD

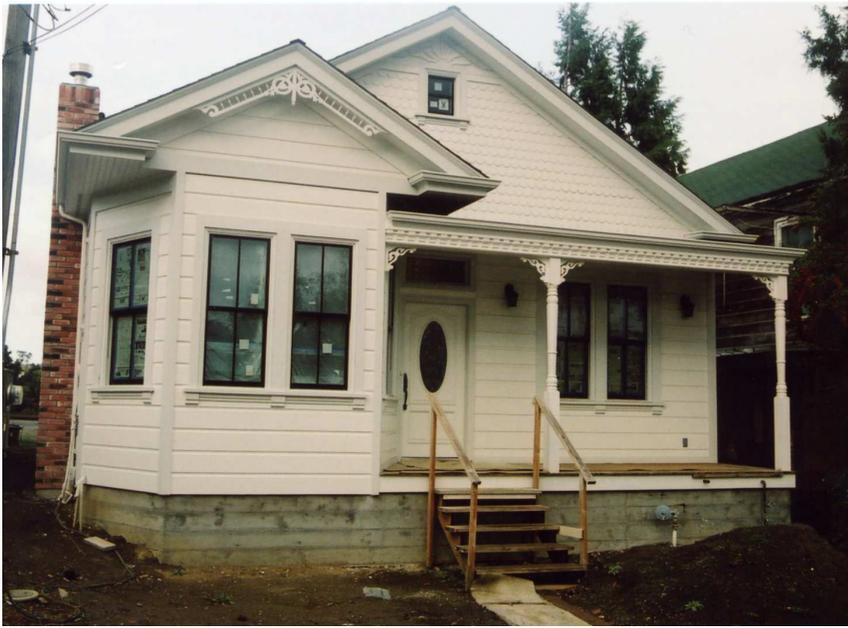
P5. Photograph or Drawing (Photograph required for buildings, structures, and objects.)

This is a one-story Queen Anne cottage with a double front gable. It is rectangular in plan with a moderately pitched roof. The front gable is trimmed with a plane fascia and eave returns. The primary gable displays a sunburst ornament and has a small, double hung gable window with a prominent sill supported on brackets. The projecting gable on the front bay has openwork trim. Eaves are wide and boxed. The primary gable end is clad with fish scale shingles, while the bay gable is clad like the house. A three-quarter length porch occupies the east side of the front elevation. It is covered by a flat roof supported on turned posts and openwork brackets. There is a frieze with a double row of dentils. The entry door has a transom. A gable roofed bay occupies the west side of the elevation. Fenestration consists of two-over-two double hung windows. Window sills are supported on brackets. Cladding is clapboard.

Front façade, view north

This is a good example of a Queen Anne Cottage. It has recently been rehabilitated to its period of significance. However, the windows have been replaced and a west eave wall chimney of used brick remains. In the case of the windows, the new sash and glazing have been inserted into the original openings. The rehabilitated building has integrity in most respects and it should be considered to become a contributor to the historic district.
