PRIMARY RECORD

- *Resource Name or #: 191 East G Street
P1. Other Identifier: none
*P2. .Location: *a. County Solano
b. Address 191 East G Street
*c. City: Benicia Zip 94510
d. UTM: N/A
e. USGS Quad: Benicia T2N R3W MDM
*f. Other Locational Data (APN #): 89-341-11

BUILDING, STRUCTURE, AND OBJECT RECORD

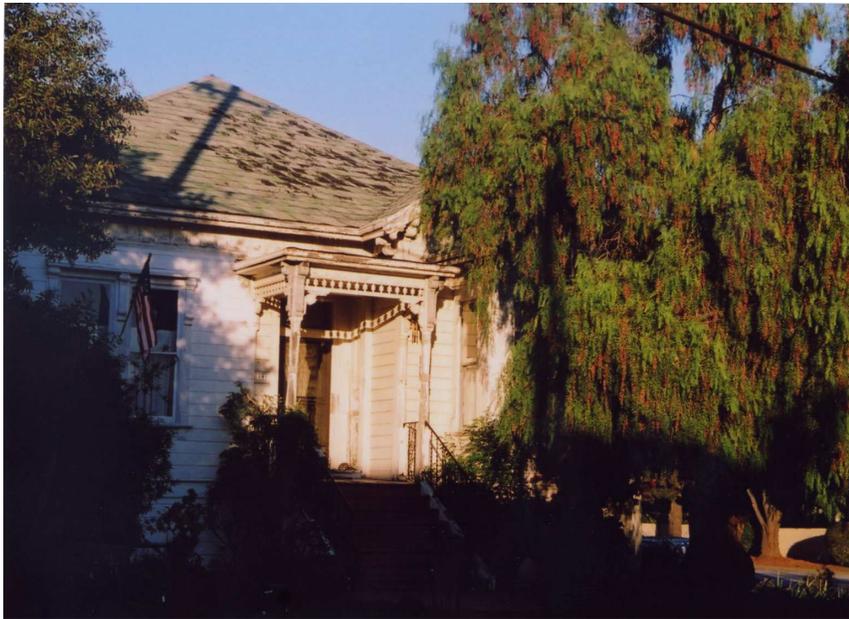
P5. Photograph or Drawing (Photograph required for buildings, structures, and objects.)

L-shape in plan, this Queen Anne Cottage has a cross hip and gable roof and is set on an elevated foundation. The front cross gable extends over a square bay which projects from the east side of the front façade. The gable is trimmed with a plain fascia that ends with a decorative drop newel. A small, square, flat roof porch is cut-in next to the gable wing and frames the entry door and transom. The porch roof is supported on turned posts with brackets and a spindle frieze. The original balustrades have been replaced with a metal rail. Fenestration consists of narrow paired one-over-one double hung windows. The window casings are elaborated with brackets supporting a pediment at the top and brackets supporting the sills at the bottom. On the east side of the house a shed roof porch was added sometime in the 1920s. This porch is externally accessed by a separate stair. Its upper wall consists entirely of one-over-one double hung windows set into wooden casings.

Front façade, view north

This house is a contributing building in the Downtown Historic District. It retains its integrity, although it is in poor condition. The treatment of the gable, the projecting square bay, the porch with its decorative elements and the windows with their elaborated casements are all character defining features of the building. The enclosed, side porch was added to the house during its period of significance. The house should continue as a contributor to the Downtown Historic District.
