PRIMARY RECORD

- *Resource Name or #:** 260 West H Street
P1. Other Identifier: none
***P2. .Location: *a. County** Solano
b. Address: 260 West H Street
***c. City:** Benicia **Zip** 94510
d. UTM: N/A
e. USGS Quad: Benicia T2N R3W MDM
***f. Other Locational Data (APN #):** 89-111-03
***P3a. Description**

BUILDING, STRUCTURE, AND OBJECT RECORD

*Resource Identifier: 260 West H Street

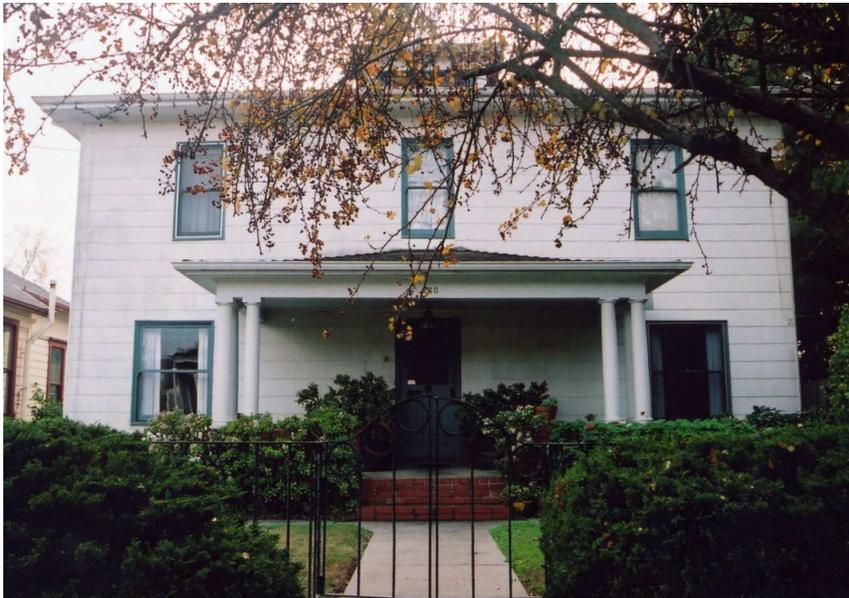
P5. Photograph or Drawing (Photograph required for buildings, structures, and objects.)

This rectilinear or four-square house was constructed in the first decade of the 20th century. It is rectangular in plan with a low hip roof. The roof has wide closed overhangs and a low hip roof dormer that pierces the front slope. Windows and doors are arranged symmetrically. Windows are one-over-one double hung. A wide centered hip roofed porch provides the primary visual focus of the front elevation. The porch is supported on full-length classical columns with a plain frieze. The house is clad with asbestos shingle.

- *P3b. Resource Attributes:** HP2
***P4. Resources Present:** Building Structure Object Site District Element of District
P5b. Description of Photo: Front façade, view
***P6. Date Constructed/Age:** Circa 1910
 Prehistoric Historic Both
***P7. Owner and Address:**
Virginia Johnson
260 West H Street
Benicia, CA 94510
