BUILDING, STRUCTURE, AND OBJECT RECORD

*Resource Name or 327 Gull Point Court

*Resource Name or #: 327 Gull Point Court

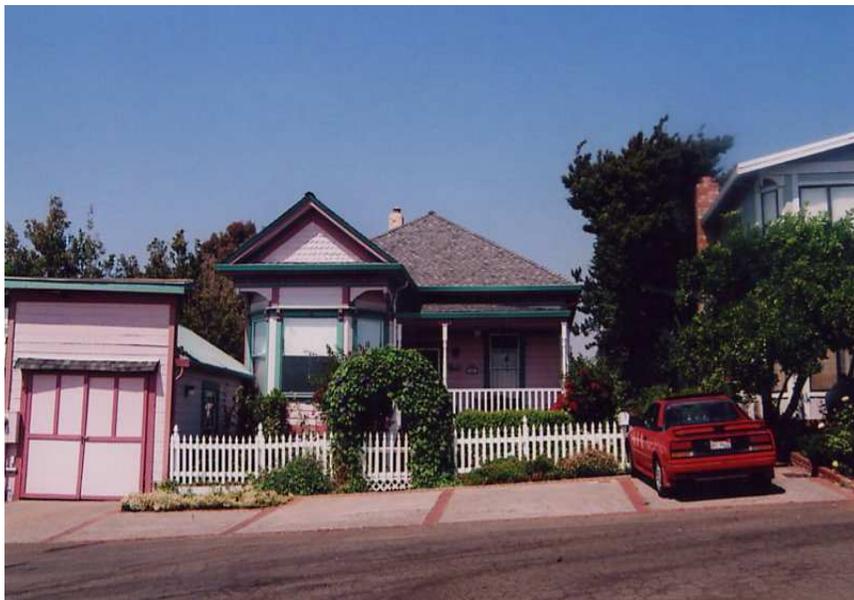
P5. Photograph or Drawing (Photograph required for buildings, structures, and objects.)

This is a typical Queen Anne Cottage constructed circa 1890s. The building is L-shape in plan and is set on a raised foundation. The principle mass of the house is surmounted by a steeply sloped hip roof, while a front projecting wing has a front gable roof. The projecting gable is an important decorative element in the design with wide gable overhangs and a decorative barge board and fascia. The gable end is supported on decorative brackets and has fish scale shingle infill in the gable. The front wing culminates in a canted bay with one-over-one double hung windows. An inset porch occupies the east side of the front elevation and is covered by the primary roof which is supported on turned posts. The porch is enclosed with low wood rail and accessed via a wooden stair. Fenestration is double hung. A circa 1920s single car garage is located to the west of the house. It is gable roof with a false front parapet.

P5b. Description of Photo: Front façade, view north

This is a typical Queen Anne Cottage characterized by a prominent front gable with elaborate decorative treatment, a porch with turned posts and wooden rail, a canted bay, and one-over-one double hung windows. The building is in excellent condition and retains integrity of design, materials, workmanship, setting, location, feeling and association. It lies outside the boundaries of the Benicia Downtown Historic District. Although a good example of its style and period it would not qualify for individual listing in the National or California Registers. If it were incorporated within the district boundaries it would qualify as a contributing property. The contributing property would include the house and the garage.
