\*Resource Name or 333 East K Street

- P1. Other Identifier:
- \*P2. .Location: \*a. County Solano
- b. Address: 333 East K Street
- \*c. City: Benicia Zip 94510
- d. UTM: N/A
- e. USGS Quad: Benicia T2N R3W MDM
- \*f. Other Locational Data (APN #): 88-151-11

## BUILDING, STRUCTURE, AND OBJECT RECORD

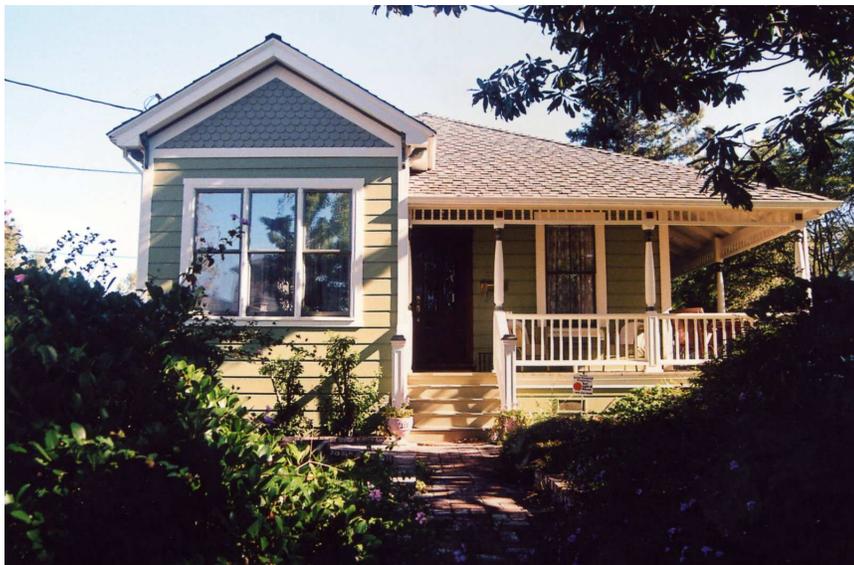
**P5. Photograph or Drawing** (Photograph required for buildings, structures, and objects.)

This building is a good example of a Queen Anne cottage with a wrap around porch treatment. The house is L-shape in plan and is set on a slightly raised foundation. The principal roof is hip with a cross gable on the west side. The gable is trimmed with a fascia with eave returns and a plain verge board. The gable end is clad with fish scale shingles. The primary roof extends to cover the porch which is located on the east side of the front elevation and on the east side of the house. It has a spindle work frieze. The porch roof is supported with turned posts and the porch is enclosed with an open turned rail. The projecting wing on the west side of the front elevation has a ribbon of double hung windows occupying much of the wall surface. This is a prominent feature of the façade. Otherwise, fenestration consists of single double hung one-over-one windows. The house is clad with lap siding. The house has been meticulously rehabilitated.

Front façade, view north
