\*Resource Name or St. Dominic's Catholic Church

- P1. Other Identifier:**  
**\*P2. .Location: \*a. County**  
**b. Address:** 475 East I Street  
**\*c. City:** Benicia **Zip** 94510  
**d. UTM:** N/A  
**e. USGS Quad:** Benicia T2N R3W MDM  
**\*f. Other Locational Data (APN #):** 89-061-14

**BUILDING, STRUCTURE, AND OBJECT RECORD**

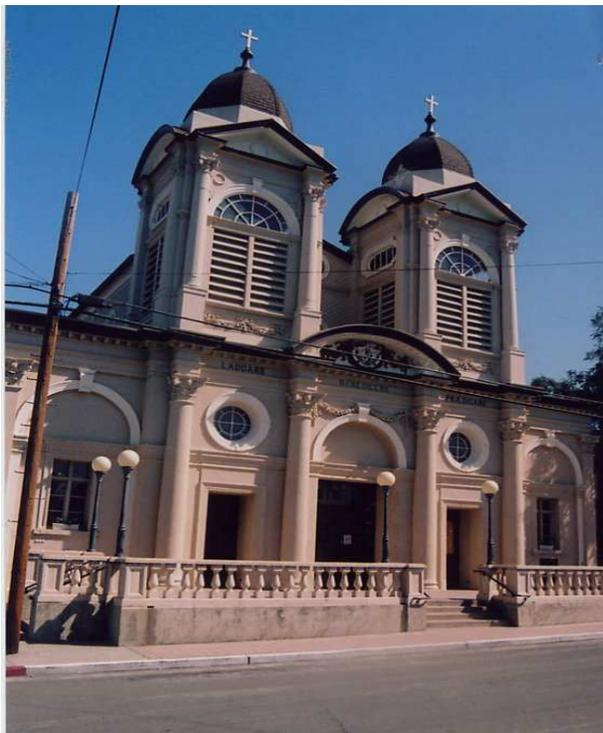
St Dominic's Church was constructed in the 1890s as part of a larger church and monastery complex which had been founded in Benicia in 1854. The present church replaced an earlier church building in the same location. The brick building is essentially rectangular in plan with a five-bay front. It is one-story with a two-story central nave surmounted by a front gable roof. The front of the church is dominated by two elaborate domed towers. The towers exhibit pedimented gables with engaged columns and pilasters. The belfrie openings are louvered. A large cross is mounted on the dome of each tower. The flat front roof exhibits a wide denticulated cornice. Bays are separated by engaged Corinthian columns. A large double entry door with side lights is centered on the front elevation, flanked by lesser doors on both sides. The central entry is surmounted by an arched pediment supported on Corinthian columns and enhanced with swags of a garland design. The flanking entries have circular windows located above the architraves. All entries are recessed. Deeply set casement windows are found in the outer front bays and flank the door arrangement.

**P5b. Description of Photo:** Front façade, view northwest
