# PRIMARY RECORD

\*Resource Name or 600 East Second Street

b. Address: 600 East Second Street

## BUILDING, STRUCTURE, AND OBJECT RECORD

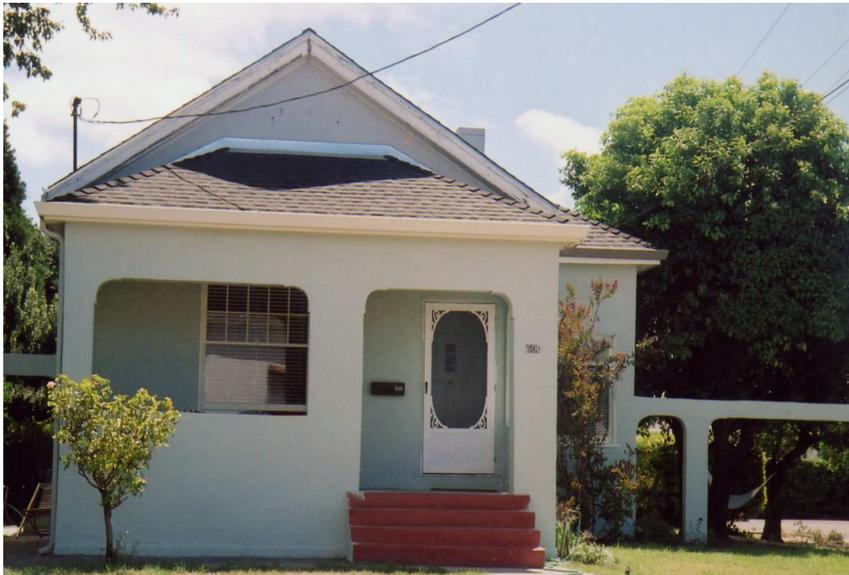
**P5. Photograph or Drawing** (Photograph required for buildings, structures, and objects.)

This house is a small Vernacular front gable house which was originally constructed in the 1870s or 1880s. In the more recent past the house was reclad with stucco, a concrete porch was poured and the porch cornice and posts were replaced with a stucco "window" opening. This is a treatment similar to that applied to several other houses in Downtown Benicia circa the 1950s. As in the case of the other houses, the stucco finish suggests an attempt to remodel a 19<sup>th</sup> century home into a Mediterranean style residence, but without altering the form or massing or roof line of the house to conform with the conventions of the style.

Front façade, view east

The house is listed as a possible contributor to the Downtown District. However, the alterations have seriously impaired its integrity of design, materials, workmanship, feeling and association. It is not eligible for listing.
