PRIMARY RECORD

*Resource Name or 622 First Street

b. Address: 622 First Street

*c. City: Benicia Zip 94510

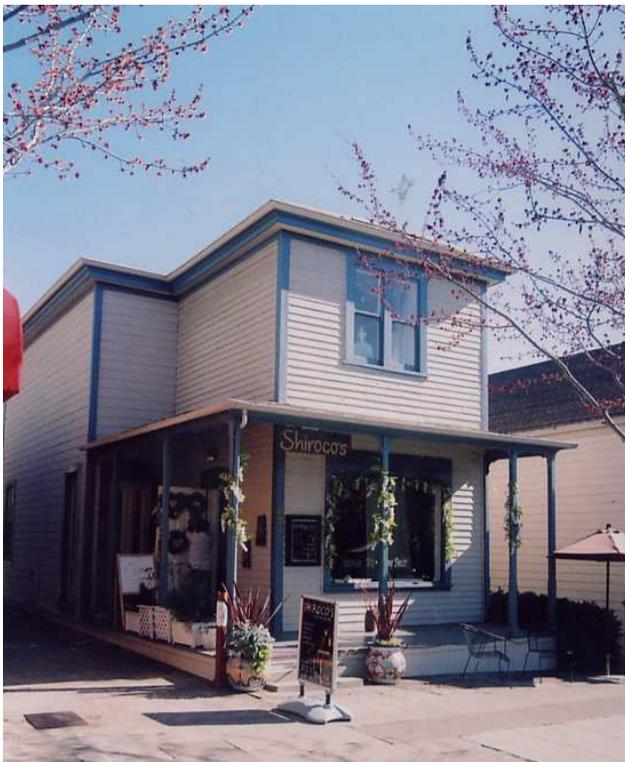
P5. Photograph or Drawing (Photograph required for buildings, structures, and objects.)

This is an L-shape plan two-story commercial building of wood frame construction. It was built circa 1910s-1920s. A building of similar form appears at the same location on the 1913-1942 Sanborn Map. The building has a compound hip roof of low slope with eave overhangs. A plain wooden cornice runs around all the building elevations. A shed roof porch is located in the L of the building and extends around the front façade. It is supported on plain posts. Fenestration consists of single and paired one-over-one double hung windows. The principal window in the front elevation has been altered and is plate glass. The building is clad with narrow lap siding.

P5b. Description of Photo: Front façade, view southeast

The building is an example of a simple free-standing vernacular commercial structure. It is consistent with the one and two story commercial structures that characterize the main commercial street of Downtown Benicia. The alteration of the front window at the first level of the building impairs the integrity of design and materials, but overall the building retains sufficient integrity to convey its style and property type. The building is currently a contributor to the Benicia Downtown Historic District and should continue in this status.
