PRIMARY RECORD

*Resource Name or #: 636 First Street

b. Address: 636 First Street

*c. City: Benicia Zip 94510

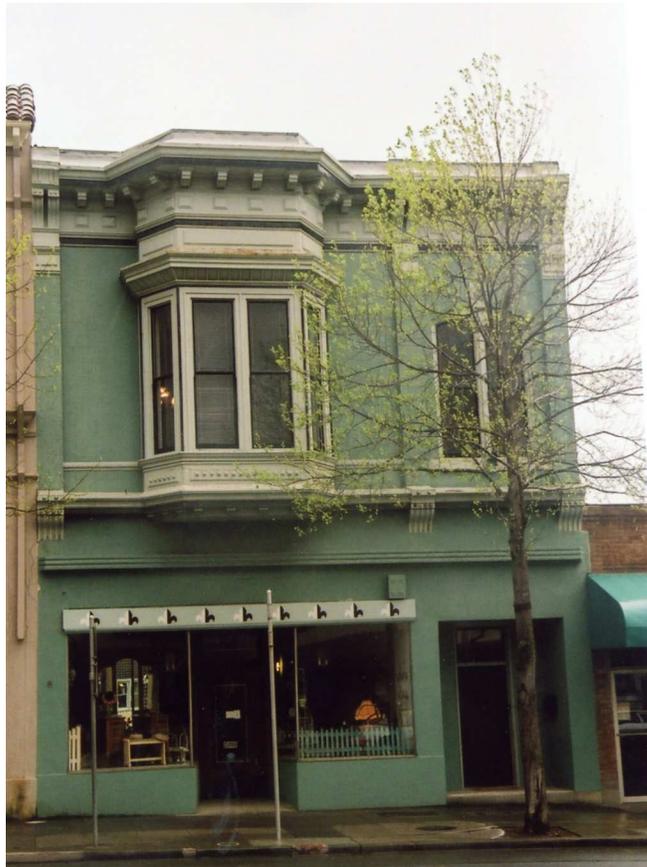
P5b. Description of Photo:

This is a Victorian commercial building with a lower story storefront and an upper story residential/office space. The building was constructed in the 1880s and was originally a jewelry store. The building has a flat roof with an elaborate eave and cornice treatment. The eave overhang is supported on brackets and the wide cornice is punctuated with applied woodwork in a square motif. A canted bay is located on the second story front façade and is a prominent feature of the building. It is centered between pilasters which demarcate the main store building from the second story entrance. The pilasters exhibit elaborate bracketing and crowns. The second story projects slightly beyond the lower story façade and is supported on brackets. The storefront is typical of its building type and period with a central recessed entrance flanked by canted store windows. The door is glazed with a transom. A second entry is located to the south of the store front. It is recessed with a replacement door and original transom and provides access to the second story. The building is clad with stucco.

Front façade, view east

This building appears on the 1886 Sanborn map as a jewelry store. The building retains its character and clearly conveys its period of construction. However, its integrity of materials has been compromised by the addition of stucco cladding and the replacement of the original storefront glazing and the second story entry door. Despite these changes the building still has a strong historic presence and some excellent detailing, especially on the second story façade. The building contributes to the Downtown Historic District and should continue to do so.
