# PRIMARY RECORD

\*Resource Name or 640 East Second Street

b. Address: 640 East Second Street

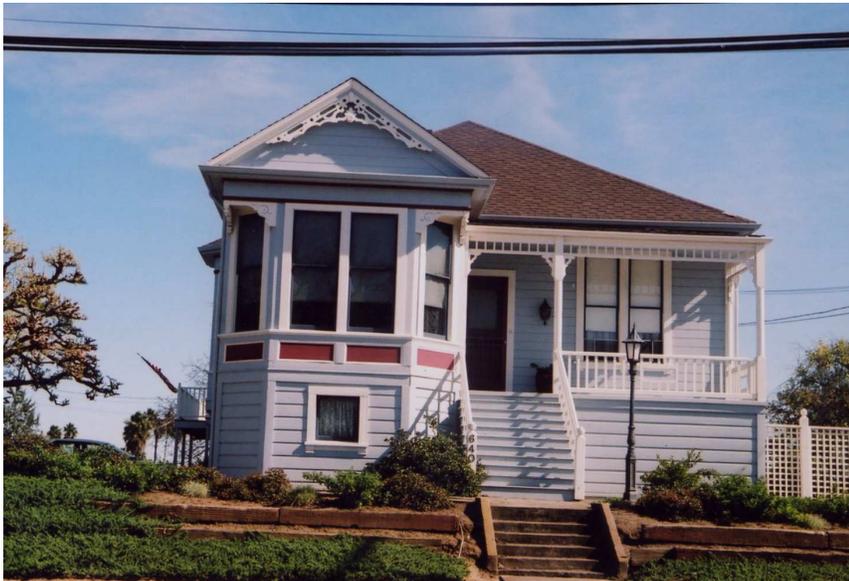
This is a typical Queen Anne Cottage which has been carefully rehabilitate. The building is set on a high foundation and is L-shape in plan. It has a cross hip and gable roof. The projecting front gable is closed with a plain fascia and a lace-like gable ornament. The north side of the front façade has a canted bay with paired front windows and raised decorative panels under the sills. The south side of the front façade is occupied by a porch which is covered by the primary hip roof. The porch roof has a spindle frieze and is supported on turned posts with brackets. The porch is enclosed with a low open rail. Fenestration consists of one-over-one vertically emphasized double hung windows arranged in pairs and singly. There is a second canted bay on the north façade. Cladding is clapboard.

Front façade, view east
