PRIMARY RECORD

*Resource Name or #: 820 First Street

BUILDING, STRUCTURE, AND OBJECT RECORD

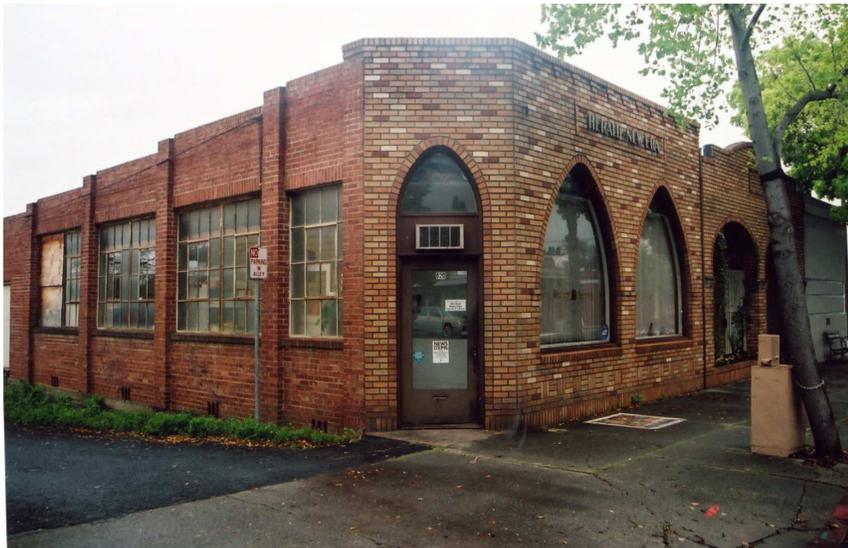
P5. Photograph or Drawing (Photograph required for buildings, structures, and objects.)

This circa 1920s building is one-story and of masonry construction. The building has a flat roof with decorative front parapet which is stepped on the side of the building. The front parapet is topped with a row of headers and a dentil brick cornice. The front entry is turned to the corner facing onto the street at an angle. The entry is in the form of a Gothic Revival arch and is set off by a surround of headers. The door has a transom set into the arch. The front windows are in the form of large Gothic Revival arches with fixed single light glazing. The window casing is composed of brick headers. The brick in the front elevation is varied in tones and is laid in a decorative pattern on the lower wall with a row of soldiers at the base along the foundation. On the side elevations the building takes on a much more industrial quality with plain red brick walls and multi-light metal sash industrial windows which span the wall between structural posts.

Front façade, view southeast

This one-story commercial building is a good example of a 1920s commercial/office building of small proportions. The front masonry work shows evidence of excellent craftsmanship. The building retains its integrity in all aspects. It contributes to the Downtown Historic District and should continue to retain this status.
