U.S. Army Corps of Engineers

Engineering Evaluation/Cost Analysis Former Benicia Arsenal Solano County, California

May 1999

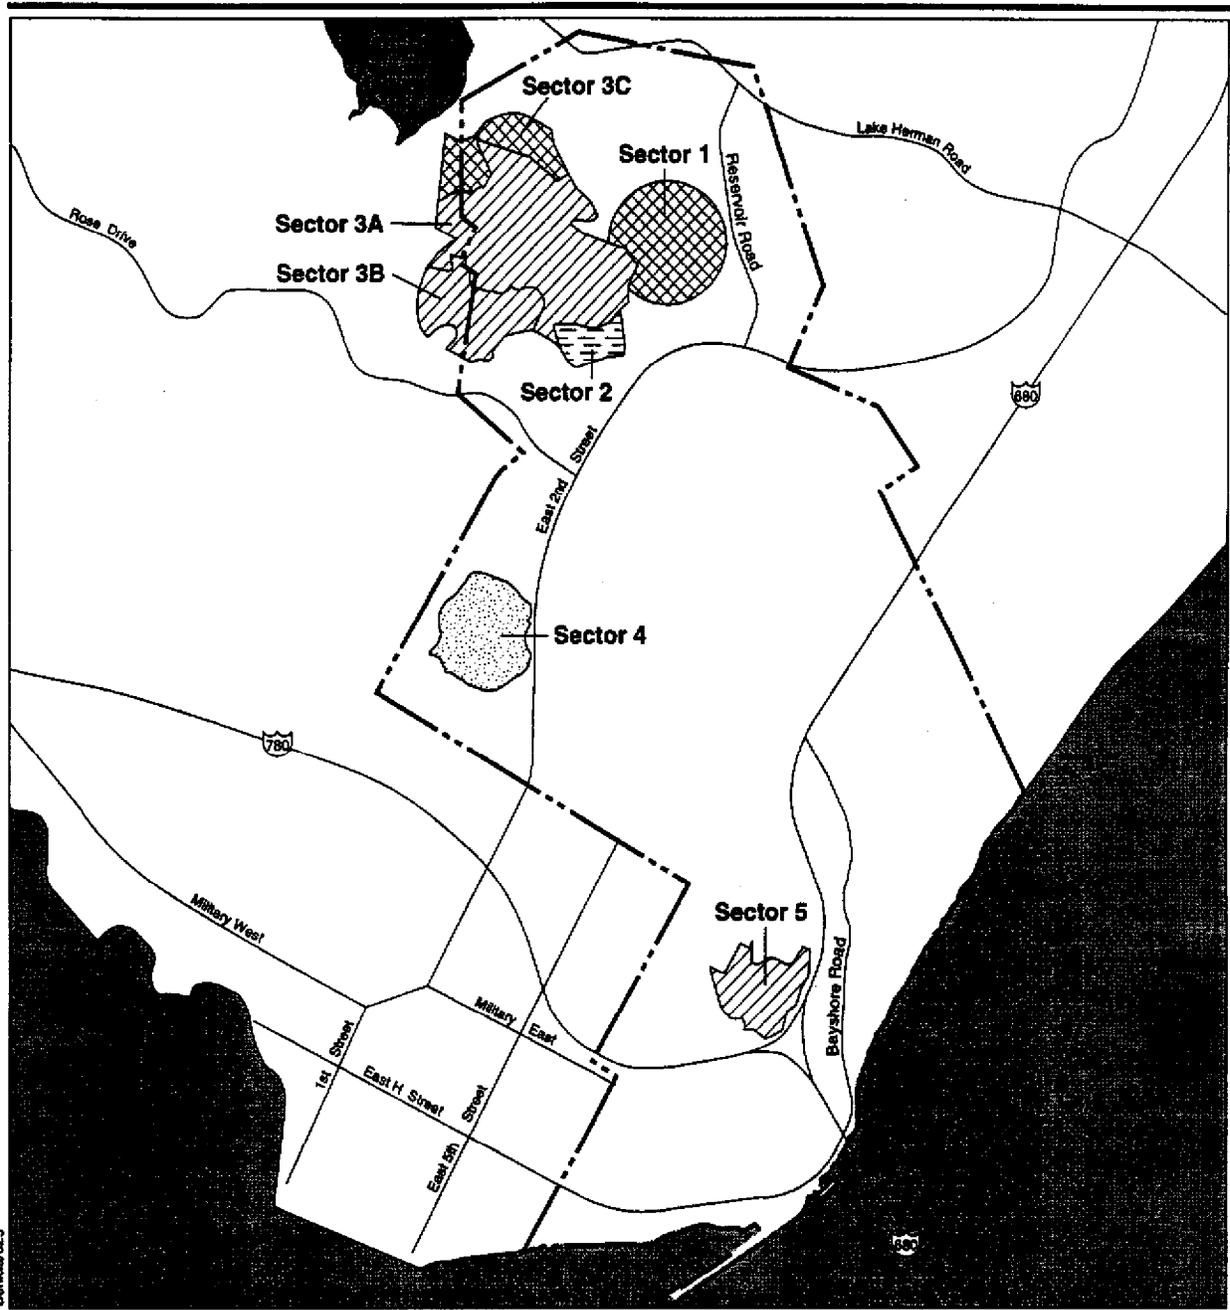
- Sector 1 Revetment Area (66 acres)
- Sector 2 Artillery Test Area (15 acres)
- Sector 3A Tourtelot Property (131 acres)
- Sector 3B Tourtelot Property (47 acres)
- Sector 3C City Property Adjacent to Tourtelot Property (34 acres)
- Sector 4 Demolition Site on Exxon Property (54 acres)
- Sector 5 Camel Barn Area (35 acres)
- Grid OT01 Overturned Truck Area (0.23 acre)

Recommended Clearance Areas

- 22
- 23 • Sector 1 - No Further Action is recommended.
- 24
- 25 • Sector 2 - A surface clearance of the valley walls with a subsurface clearance
26 of the valley floor is recommended. Following the clearance action, warning
27 signs should be posted on existing trails and fences.
- 28
- 29 • Sectors 3A and 3B - A subsurface clearance to a depth of 4 feet is
30 recommended.
- 31
- 32 • Sector 3C - No Further Action is recommended.
- 33
- 34 • Sector 4 - It is recommended that warning signs be posted on the existing
35 fence that surrounds the sector and is maintained by the property owner.
- 36
- 37 • Sector 5 - A subsurface clearance to a depth of 4 feet is recommended.
- 38

39 Figure ES-1 outlines the general location of the areas for which clearance actions
40 are recommended.

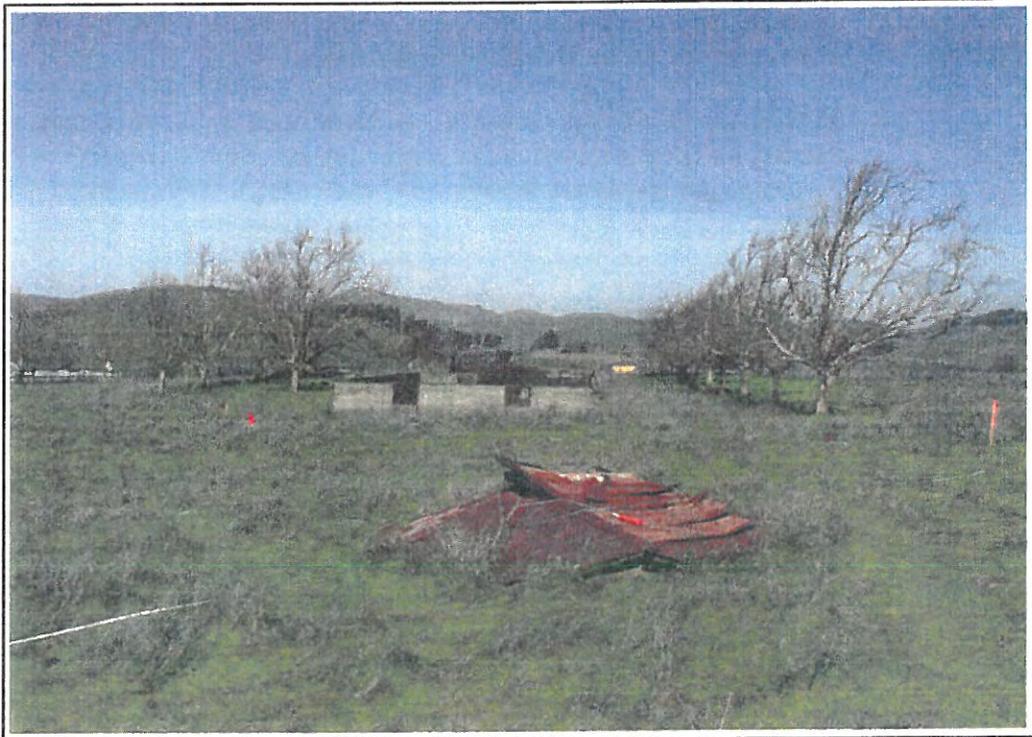
Photo 2-1. Sector 1 - Revetment Area.

25 **Description.** Sector 1 consists of a total of 68 acres and is in the north-central
 26 area of the Former Benicia Arsenal (see Figure 2-2). The sector is relatively flat
 27 and is characterized by short grasslands (Photograph 2-1), buildings, roads,
 28 fences, and paved areas.
 29

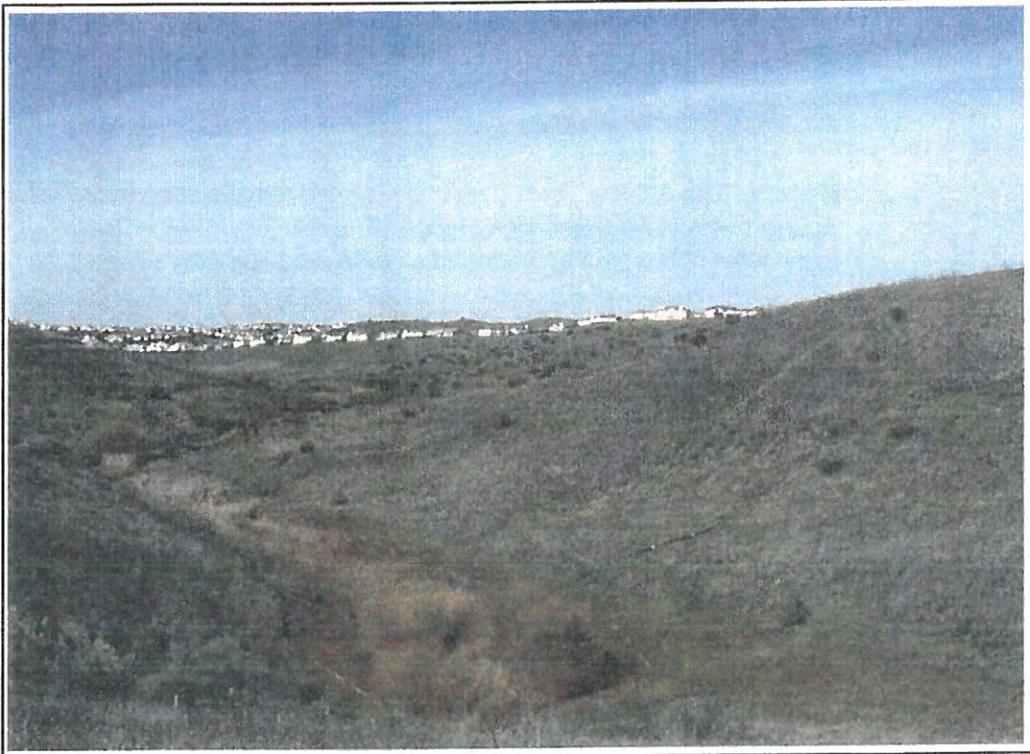
Photo 2-3. Sector 3 - Tourtelot Property.

41 **Description.** For analysis purposes, Sector 3 was divided into three subsectors
42 (3A, 3B, and 3C), which are situated in the northwestern section of the Former
43 Benicia Arsenal. The Sector 3 boundary is irregularly shaped and is generally
44 defined to the south and west by existing homes and graded building pads. The
45 northern boundary roughly coincides with the former lease boundary of the
46 arsenal. The south and east boundaries follow the former lease/army owned land
47 property boundary (Tourtelot Property Boundary). Sector 3A is generally marked
48 by steep terrain and was developed as a subsector based on future land use
49 (residential). Sector 3B is southwest of Sector 3A and is adjacent to residential
50 homes in the area (Photograph 2-3). Sector 3B was developed based on future

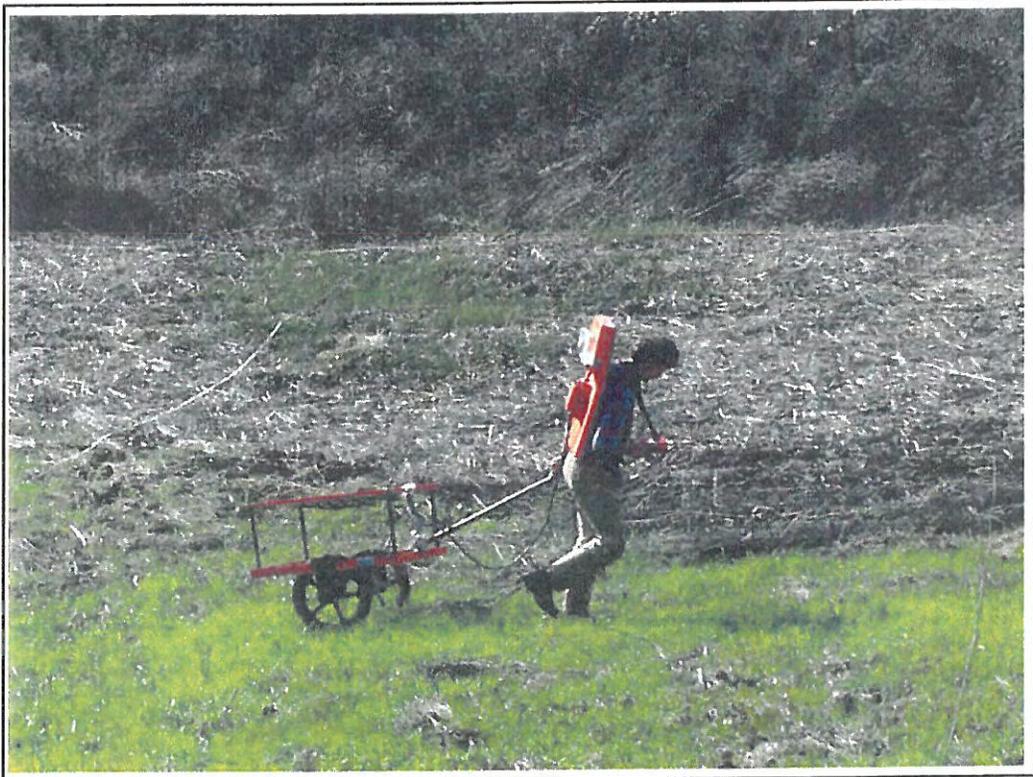
Photo 2-5. Geophysical Mapping.

36 The Tourtelot Property was investigated by using previously collected
37 magnetometer data (for Sectors 3A and 3B). For all other sectors, a Geonics
38 EM61 High-Sensitivity Metal Detector was used to detect and map the location of
39 subsurface anomalies (Photograph 2-5) and record the geophysical character of
40 the majority of the selected grids during the EE/CA field investigation. A total of
41 84 grids (19.28 acres) were geophysically mapped using the EM61. Previously
42 collected magnetometer data was used to identify anomalies for a total of
43 20 grids within Sector 3.
44

45 From the standpoint of the geophysical survey, the main difficulty was associated
46 with sloping terrain and washes impeding uniform travel over the grids.
47 Geophysical survey transects were laid out to limit the impact of these types of
48 obstacles; however, three grids (one in Sector 1 and two in Sector 4) were unable
49 to be geophysically mapped because of steep terrain.

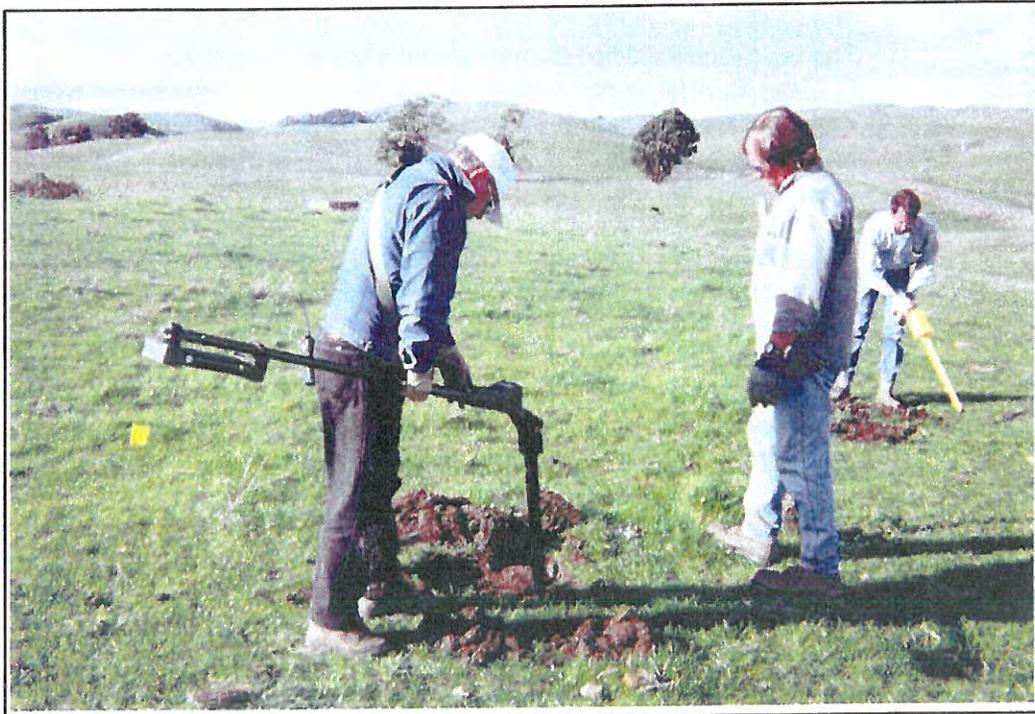
Photo 2-6. Geophysical Verification.

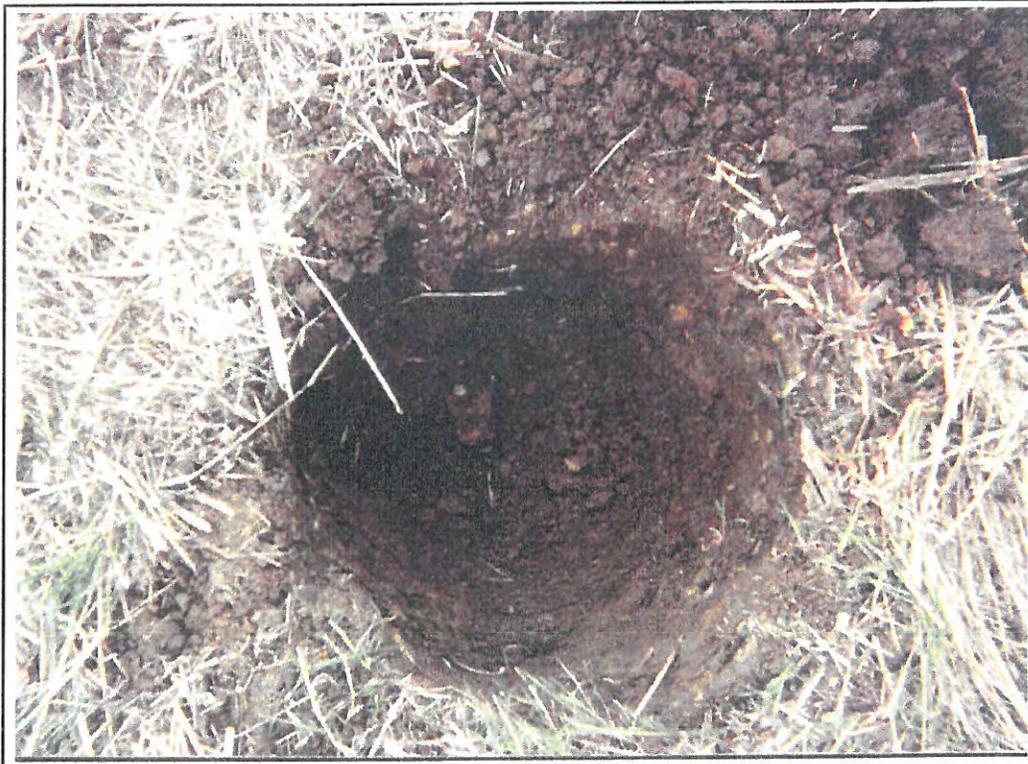
Photo 2-8. Anomaly Excavation.

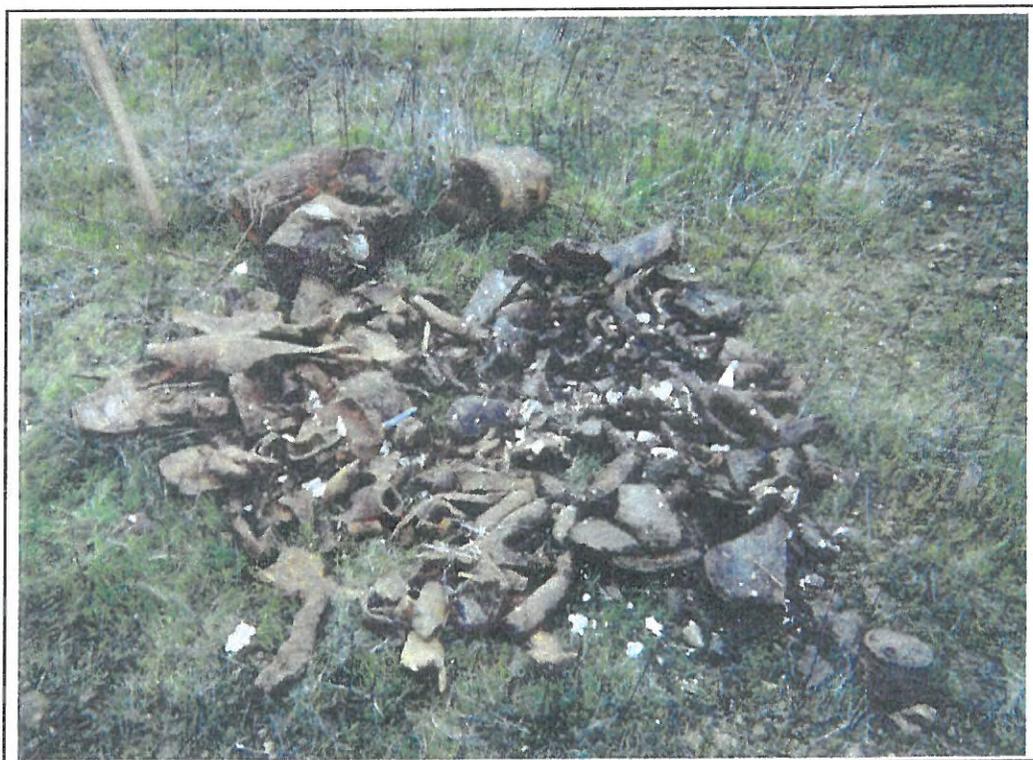
Photo 2-9. Ordnance and Explosives (OE) Scrap.

44 OE scrap includes inert items such as gravel or plaster filled Howitzer rounds,
45 expended 105-mm projectiles, and fragments of functioned ordnance. All other
46 items found during the field investigation are referred to as non-OE scrap. Non-
47 OE scrap indicates those items that are non-ordnance-related. These items
48 include, but are not limited to: wooden boxes, wire, banding material, trash, auto
49 parts, and nails.

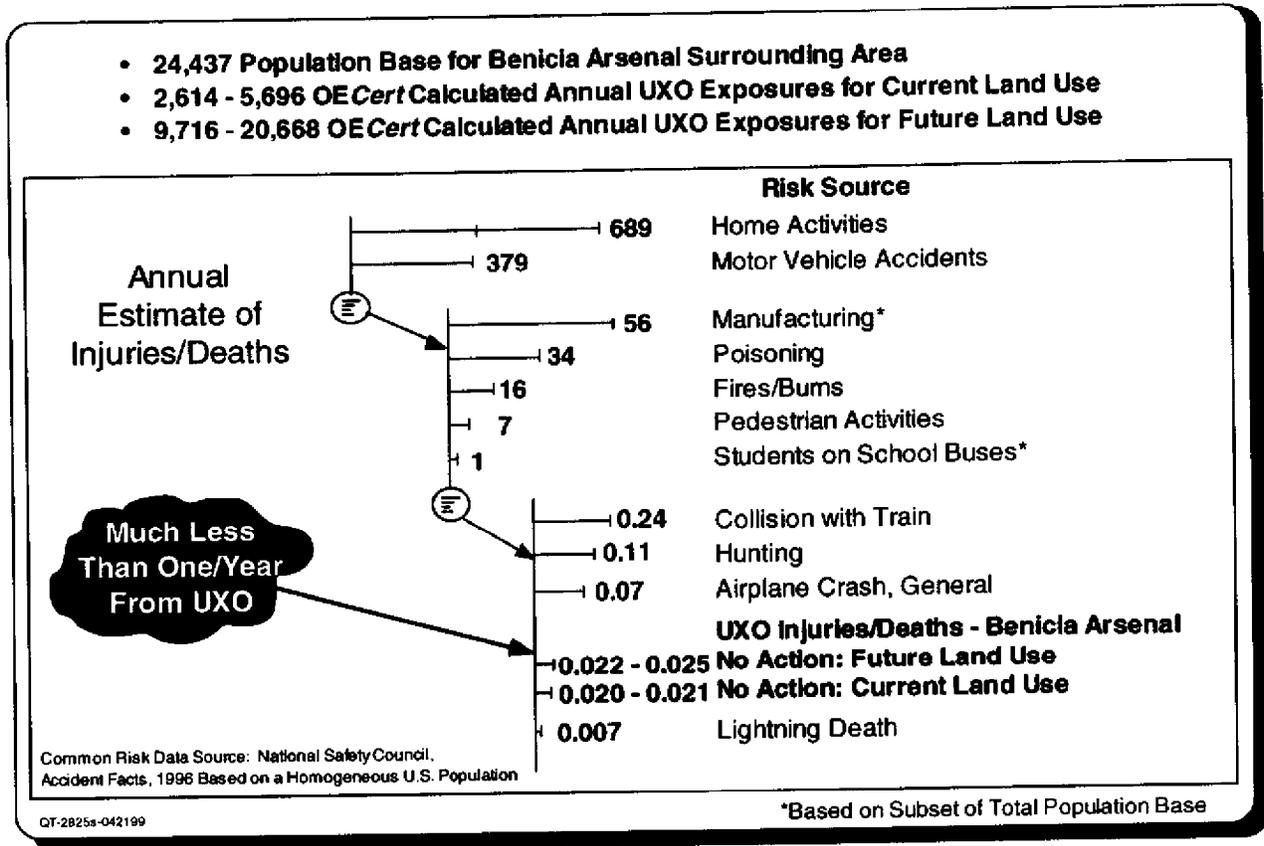
Figure 2-9. Former Benicia Arsenal Comparative Annual Risk Estimate

Each site's common risk population basis was used to convert the total number of injuries and deaths to a chance or probability of individual risk. Similarly, a site's chance for injury or deaths due to UXO was also calculated using the site's population basis with the estimated number of accidents over a 1-year period (Figure 2-9). Based on data presented in this figure, there are 689 annual projected injuries or deaths caused by activities in the home, 379 projected injuries or deaths caused by motor vehicles, and significantly less than one projected injury or death caused by exposure to UXO at the Former Benicia Arsenal (QuantiTech, 1999).
