# FUEL STORAGE TANK REMOVAL ACTION REPORT

Environmental Investigation at the Formerly Used Defense Site (FUDS)  
at the Benicia Arsenal, Benicia, California

## FINAL

May 2005

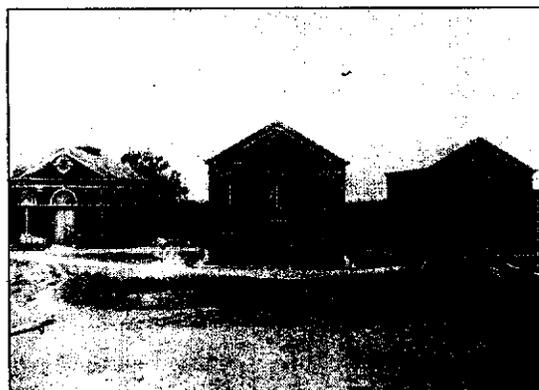
Photo 1. Looking southwest at Buildings 55, 56, and 57, from left to right. (Circa Early 1900s)

The 50 Series Complex is a collection of buildings within the central portion of Area I. The complex was originally constructed as three separate workshop buildings (Building 55, Building 56, and Building 57) between 1876 and 1884 (Photo 1). The remodeling of the original buildings occurred over many phases and included the addition of eight buildings and the removal and relocation of three buildings. Important features within the 50 Series Complex included a former smokestack/incinerator, degreasers, dip tanks, forges, firing ranges and USTs. Low-lying marshland areas to the west of the complex were filled in the 1920s during site development.

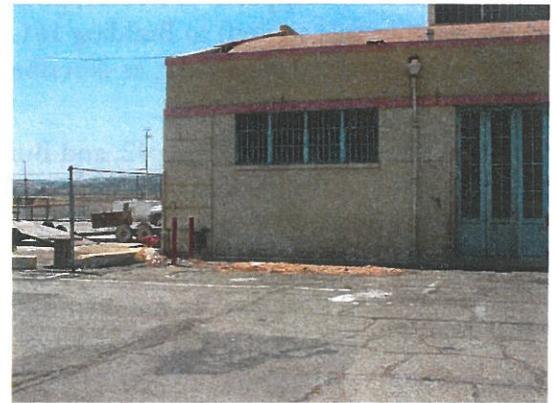
The historic ASTs no longer exist at either Buildings 88 or 89. No visible signs of a former AST were identified at Building 88. Based on information provided by the current owner and the presence of bollard holes in the asphalt, it is likely that the former AST at Building 89 was located near the northwest corner of the building. (Photo 2).

Photo 2. Looking south at suspected former AST location, northwest corner of Building 89. Photo taken 5/28/2004.

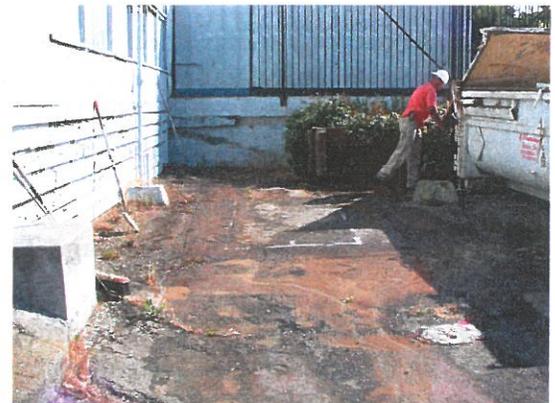
**Building 31.** A 1,000-gallon single-walled steel tank was located near former Building 31. Based on the results of the analytical samples, the tank was likely used to hold diesel fuel. The tank was located south of former Building 31, at the southwest corner of the existing J.R. Schneider building (Figures 3-1 through 3-5, Photo 3). The tank was 11 feet long and four feet in diameter, and the ends of the tank were orientated approximately north-south.

Photo 3. Looking north at Building 31 UST location, marked with white outline. Photo taken 5/24/2004.

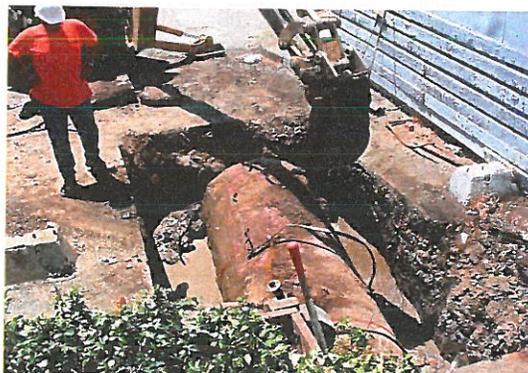
The fill port of the tank extended to the ground surface and was uncapped allowing infiltration of rainwater. Surface asphalt was removed using a saw-cutter and the soil around the tank was excavated with a backhoe to uncover the tank. The tank was strapped to a concrete pad to prevent it from floating in groundwater, which covered approximately the bottom half of the tank in the excavation. The groundwater elevation was approximately 38-inches bgs. The tank appeared to have small holes from rust in several locations along the waterline but was otherwise in good condition. The thin walls of the tank were punctured during excavation activities and the contents (rainwater/groundwater with a petroleum odor) emptied into the excavation as the tank was removed. Styrofoam packing material flowed out of the tank with the water.

Several pipes were found connected to the tank and were, if possible, removed. Most pipes were connected at the north end of the tank, which is also where the fill port was located. One pipe extended to the southwest, across Jackson Street, towards Building 161. The locations of the pipes and their current status are shown on Figures 3-1 through 3-5. Below the asphalt and approximately 6-inches of sand and gravel fill, dark brown silty sand was encountered that had no visible stains until approximately 6-inches above the waterline. Near the waterline the soil was stained black along the north and west edges of the excavation and had a strong petroleum odor. The excavation and tank are shown in Photo 4.

Photo 4. Building 31 UST excavation.  
Photo taken 5/24/2004.

The tank site was closely confined by the presence of a building to the west, a large wooden planter box and concrete wall to the north, and a driveway ramp to the east. Although impacted soil was observed to the north and west sides of the excavation, the presence of the planter box, ramp, and building prevented any over excavation in these directions to remove impacted soil.

Suspected DoD sources appear to have impacted soil on the north and northeast sides of the former UST at Building 31; however, the existing building and planter box prevent any overexcavation. Groundwater is impacted with fuels and solvents. The solvents are related to other sites in close proximity to Building 31. An evaluation of risk is recommended for the residual fuels in soil and the solvents in groundwater at this tank site.

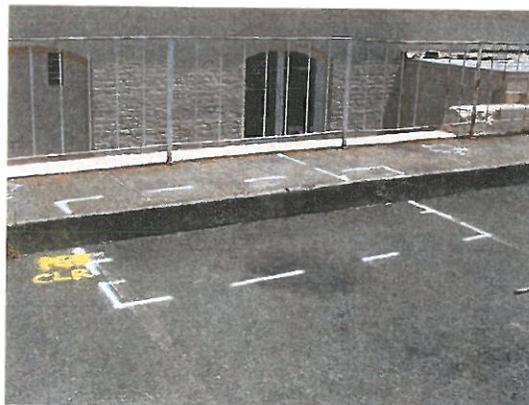
A 400-gallon single-walled steel tank was located at Building 47. Based on the results of the PA, the tank was historically used to hold heating oil for the building. The tank was located on the west side of the building, partway under the asphalt parking lot and partway under the sidewalk, as shown in Figure 3-6, Figure 3-7 and in Photo 5.

Photo 5. Looking east at Building 47 and UST location, marked in white outline. Photo taken 5/24/2004.

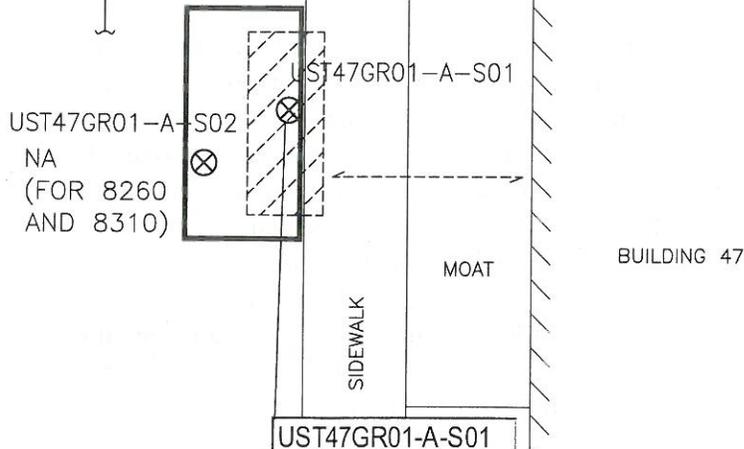
FIGURE  
3-6

PROJECT NUMBER 25952-007	DATE 2-4-05	TITLE Fuel Storage Tank RA Report, Former Benicia Arsenal, Benicia, California Building 47 UST Site Map and Detected Fuel, Solvent, and Polyaromatic Hydrocarbons in Soil	FIGURE 3-7
		2701 Prospect Park Drive Rancho Cordova, CA 95670 (916) 444-0123 (916) 635-8805 fax

Analytical results at Building 47 indicate that the soil beneath the former UST was not significantly impacted from leaks or spills. Analytical results for metals are shown on Figure 3-6. Analytical results for TPH-g organics, TPH-d organics and TPH-mo and lead are shown on Figure 3-7, which also shows the results of other detected parameters.

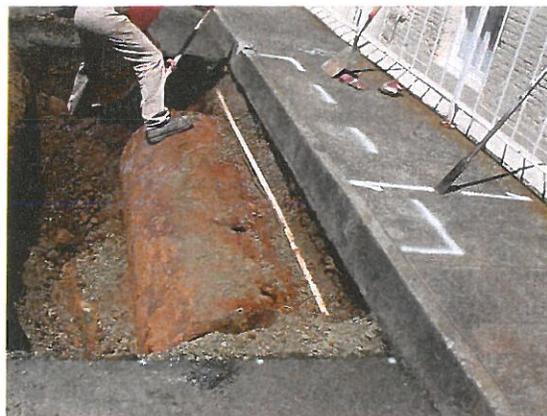
Surface asphalt was removed using a saw-cutter and the soil around the tank was excavated with a backhoe to uncover the tank. The tank was in good condition. The tank piping had been previously removed, leaving open holes along the top of the tank. The tank was filled with water with an oily sheen and petroleum odor and had a layer of sludge or dirt at the bottom. During the uncovering of the tank, no stains were observed in the soil around and beneath the tank. No groundwater was encountered. The excavation and tank are shown in Photo 6.

Photo 6. Building 47 UST excavation. Photo taken 5/24/2004.

The contents of the tank were pumped to a temporary holding tank for future disposal, and the tank was removed from the excavation and transported to a disposal facility. During removal of the tank contents and the tank itself, a small amount of the water (approximately 10 gallons) was spilled into the excavation. Soil impacted by this water was removed with the excavator and placed into a soil bin for disposal. Mr. Gary Riley of the RWQCB and Mr. Mike Rees of Solano County Environmental Health Department confirmed that any significantly impacted soil had been removed prior to backfill of the excavation.

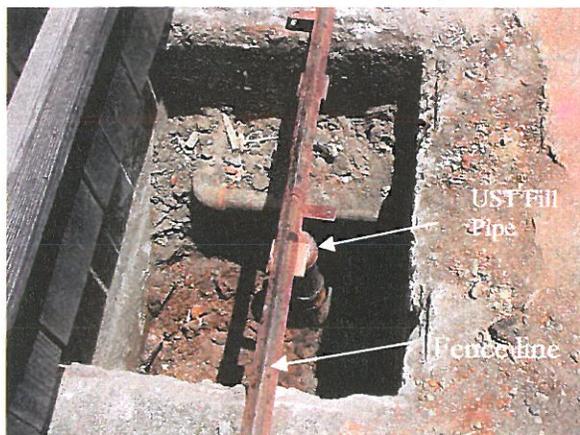
As part of the ROE agreement to perform geophysical surveying at Building 161, a visual inspection was also performed of a pipe riser located in a vault near the suspected tank location. The vault is located under a fence along Jackson Street (see Photo 7 and Appendix B, NORCAL Report).

Photo 7. Building 161 UST fill pipe located in vault. Photo taken 5/28/2004.

When the cap was unscrewed, it was found that the pipe opened into a steel UST, approximately 4 feet in diameter. The tank appeared to contain waste oil to a depth of approximately 3 feet above the bottom of the tank. Based on limited probing performed in the vault, it appears likely that the UST extends to the east lengthwise from the vault location. It also appears likely that the pipe running from the Building 31 UST site (noted above in description of Building 31 removal activities) connects to the tank. During removal of the UST at Building 31, this pipe was extended above the restored pavement and capped.
