# TOURTELOT CLEANUP PROJECT

## TOURTELOT PROJECT ANNUAL INSPECTION AND REPORT FORM

Benicia, California

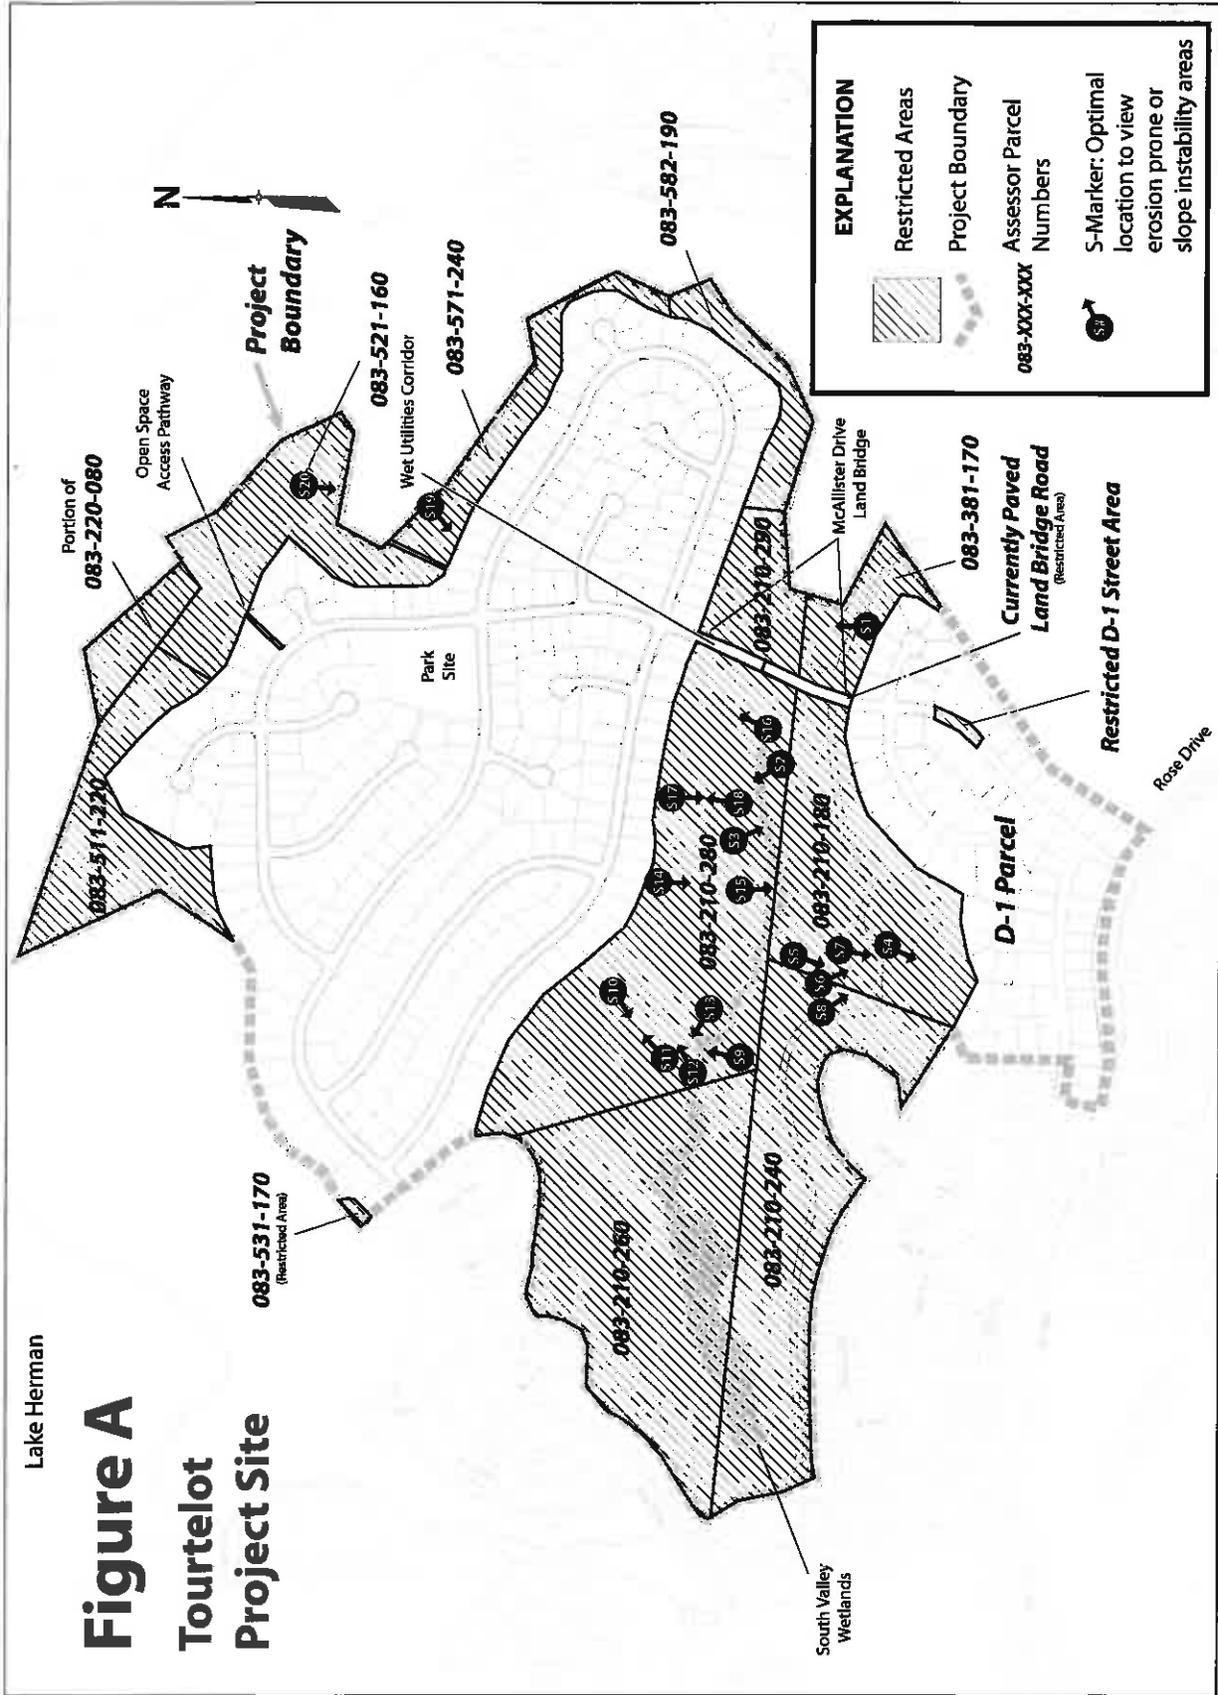
The Tourtelot Project Site consists of approximately 220 acres located in the northwest corner of the former Benicia Arsenal, north of Rose Drive and west of East 2nd Street (see figure A). From 1944-1960 the Tourtelot property was leased to the U.S. Army as part of the Benicia Arsenal. In 1989 the City zoned the property for residential use. In 1996, the property owner discovered that the site contained ordnance and explosives (OE) that the Army had left on the property. The discovery of ordnance was reported to the City of Benicia, the United States Army Corps of Engineers (USACE) and the California Department of Toxic Substances Control (DTSC). The property was secured and the property owner began working on further investigation and cleanup.

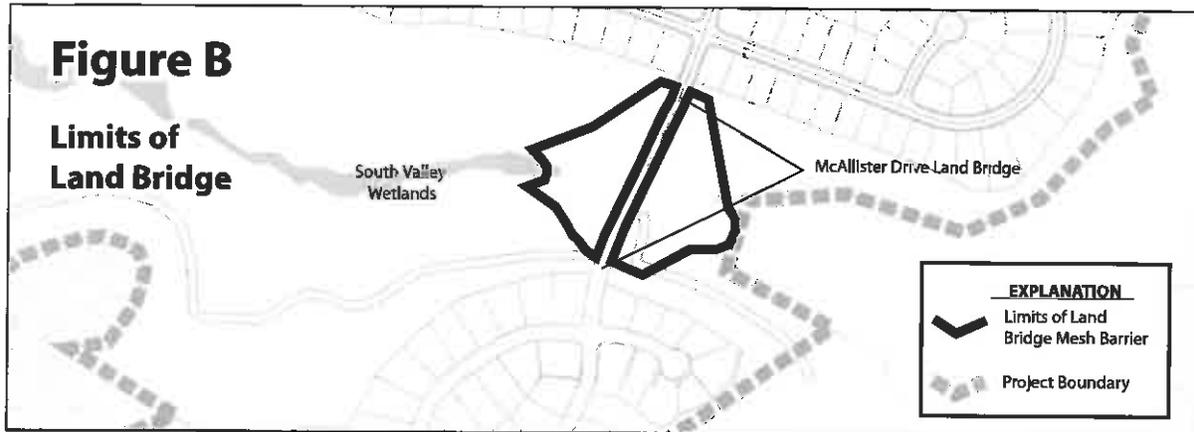
Before conducting the annual inspection of the Land Bridge Mesh Barrier, please review Section 3.3 of the O&M Plan. The Land Bridge Mesh Barrier (See Figure B) was installed to prevent unauthorized excavation into the slopes of the Land Bridge. Excavation into the slopes of the Land Bridge could result in potential exposure to OE-Energetic or OE-Like items.
